# OAK RIDGE LEVEL II RESERVOIR DAM NJ 00014

## PHASE 1 INSPECTION REPORT NATIONAL DAM SAFETY PROGRAM.

Oak Ridge Reservoir Dam (NJ 00014).  
Passaic River Basin. Pequannock River,  
Morris County, New Jersey.  
Phase I Inspection Report.

| REPORT DOCUMENTATION PAGE | | READ INSTRUCTIONS<br>BEFORE COMPLETING FORM |
|---|---|---|
| 9. PERFORMING ORGANIZATION NAME AND ADDRESS<br>Langan Engineering Assoc., Inc.<br>970 Clifton Ave.<br>Clifton, N.J. 07013 | | 10. PROGRAM ELEMENT, PROJECT, TASK<br>AREA & WORK UNIT NUMBERS |

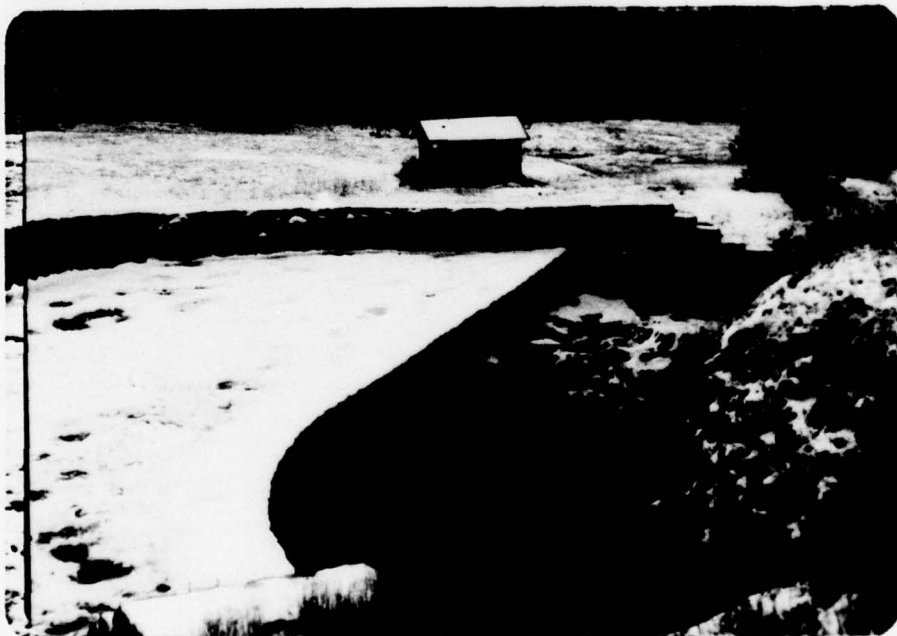
The concrete spillway has cracked and spalled. The spillway wing walls also have small cracks. The paved spillway apron has substantially depressed approximately one foot below the top of the bottom section of the spillway wall. The original construction may have been performed in this manner.

Paved spillway apron leading to rock gorge.

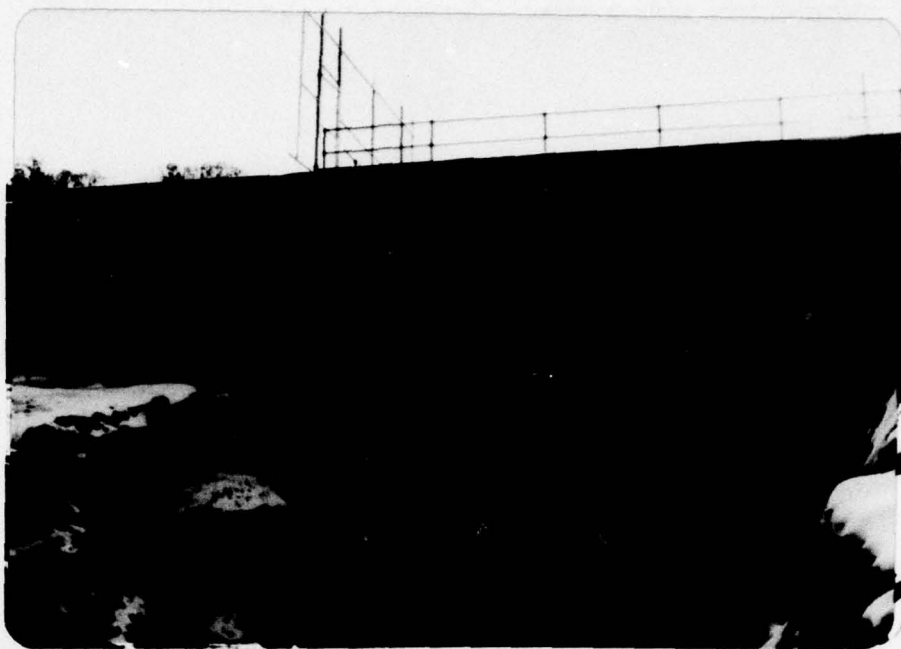
| VISUAL EXAMINATION OF | OBSERVATIONS | REMARKS OR RECOMMENDATIONS |
|---|---|---|
| OUTLET STRUCTURE | Appears satisfactory with minor<br>spalling of concrete surface. Brush between<br>outlet structure embankment and spillway. | Brush should be removed. |

Concrete deterioration at upstream surface of 30 November 1978 outlet chamber.

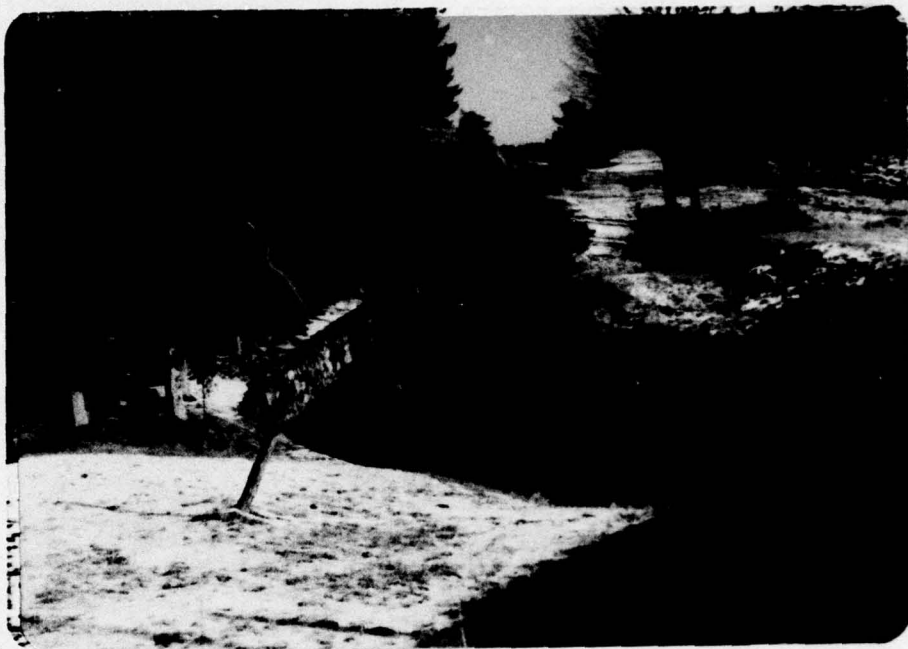
| VISUAL EXAMINATION OF | OBSERVATIONS | REMARKS OR RECOMMENDATIONS |
|---|---|---|
| CONDITION<br>(OBSTRUCTIONS,<br>DEBRIS, ETC.) | Appears generally satisfactory. Small amount of debris in channel above bridge over Berkshire Valley Road. | Debris should be removed. |

Discharge channel. Looking upstream  
from Berkshire Valley Road.

**(3) Debris should be removed from the spillway discharge channel.**
