GROPPS LAKE DAM

NJ 00235

⑥ PHASE 1 INSPECTION REPORT
NATIONAL DAM SAFETY PROGRAM.

GROPPS LAKE DAM (NJ00235)CORPS OF ENGINEERS ASSESSMENT OF GENERAL CONDITIONS

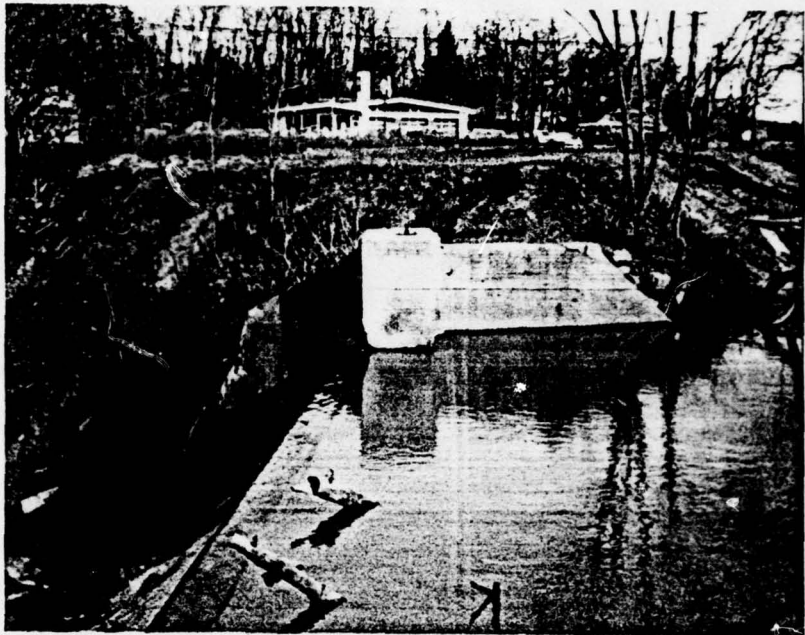
View of crest looking North East December, 1978

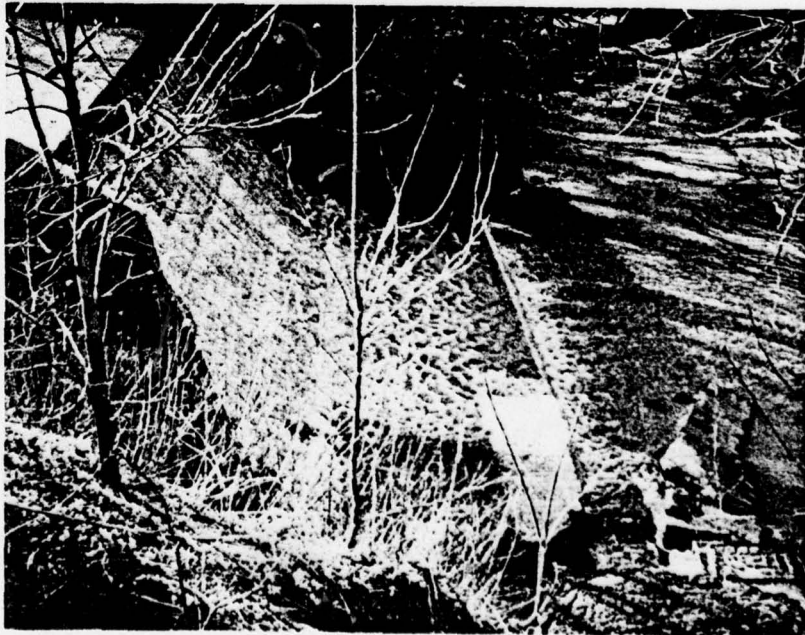
View of splash apron December, 1978

(1) The downstream edge of the splash apron should be protected (at least temporarily) by dumping riprap into the stilling basin.

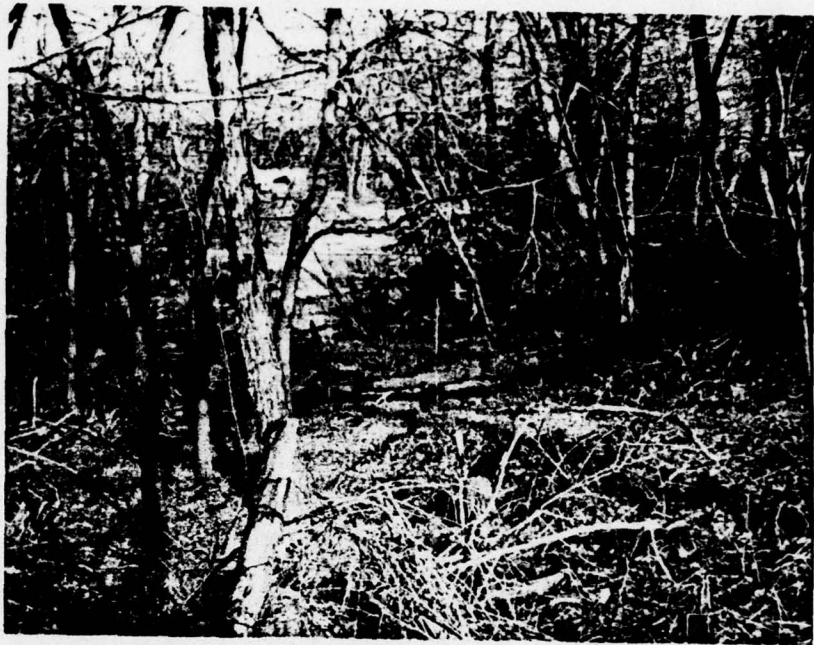
Downstream channel

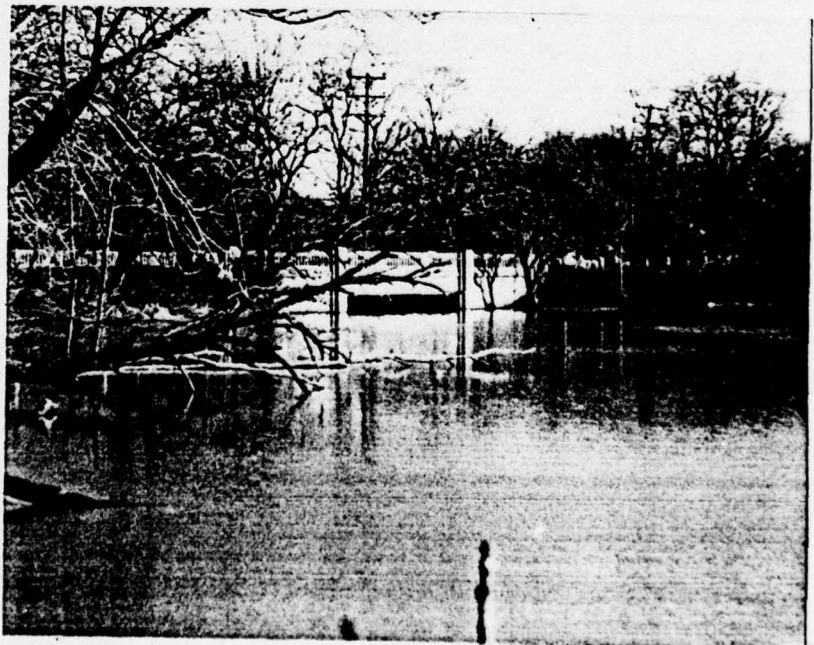
Bridge upstream from dam

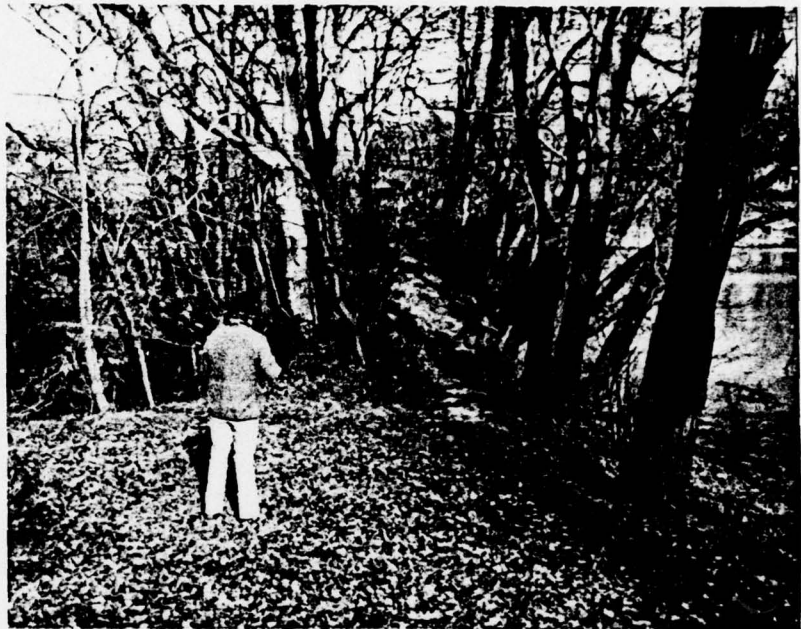
Crest of left embankment

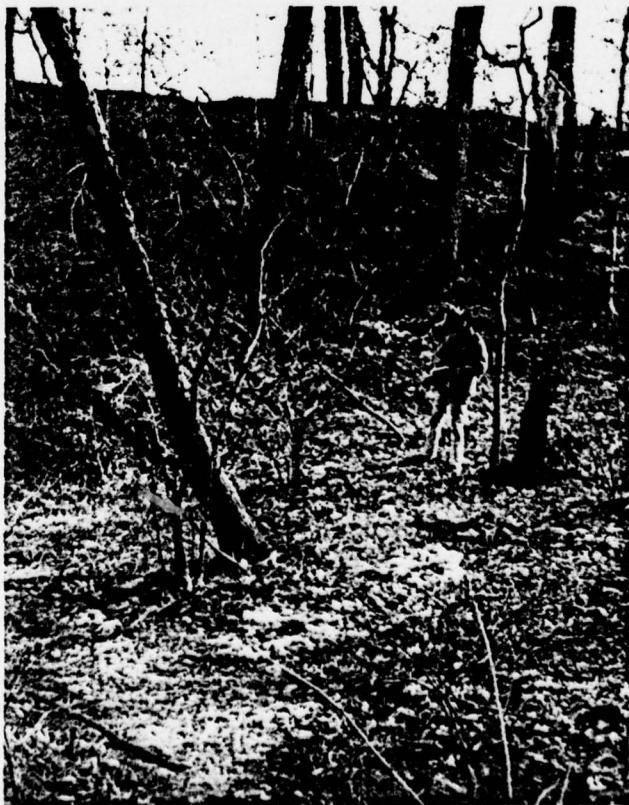
discolored by an orange silt, indicating a movement of fines from the soil. The back-slopes are in a more uniformly graded condition but are heavily wooded with several large stumps in evidence. Immediately below the left abutment, a drainage swale has eroded down the backslope due to surface run-off from the higher natural terrain to the south.

Seepage behind left embankment

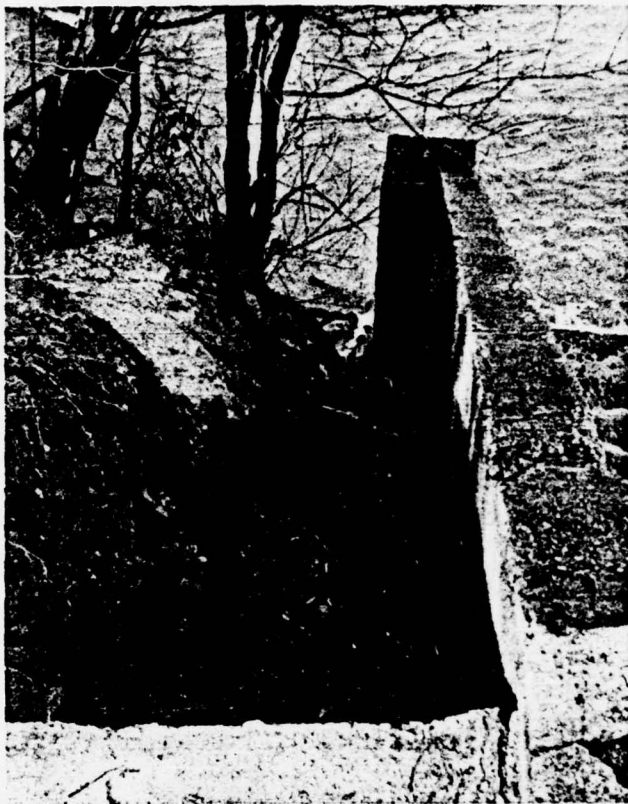
Erosion behind left wingwall structure

(3) The eroded areas between the wingwalls should be refilled and provided with slope protection.

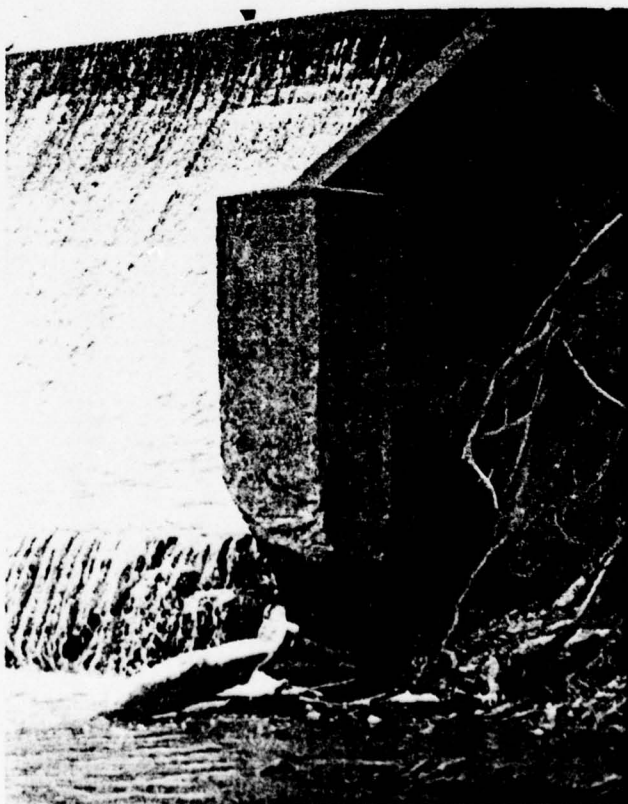
Undermining of left wingwall structure

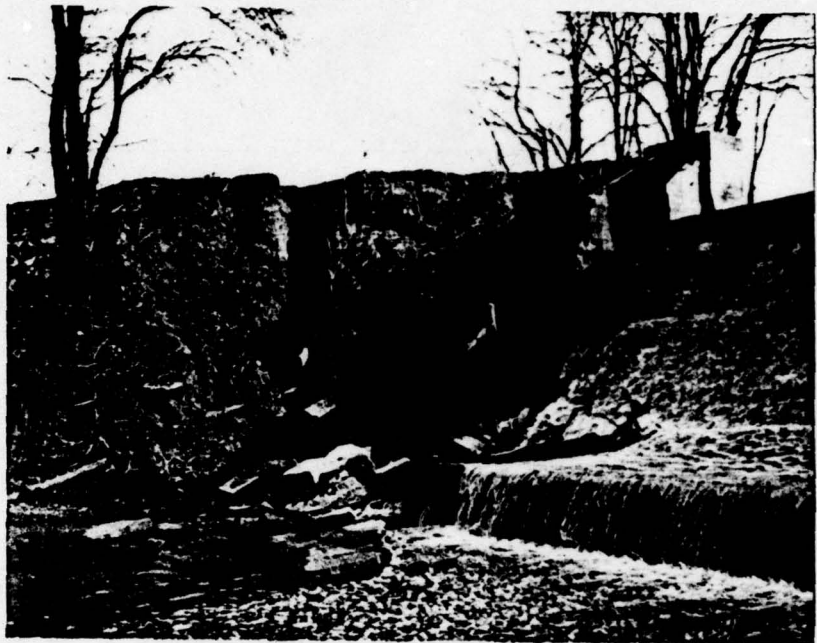
Cracks approximately 4' deep in right embankment. Sloughing behind right wingwall and right retaining wall.

Erosion of right embankment

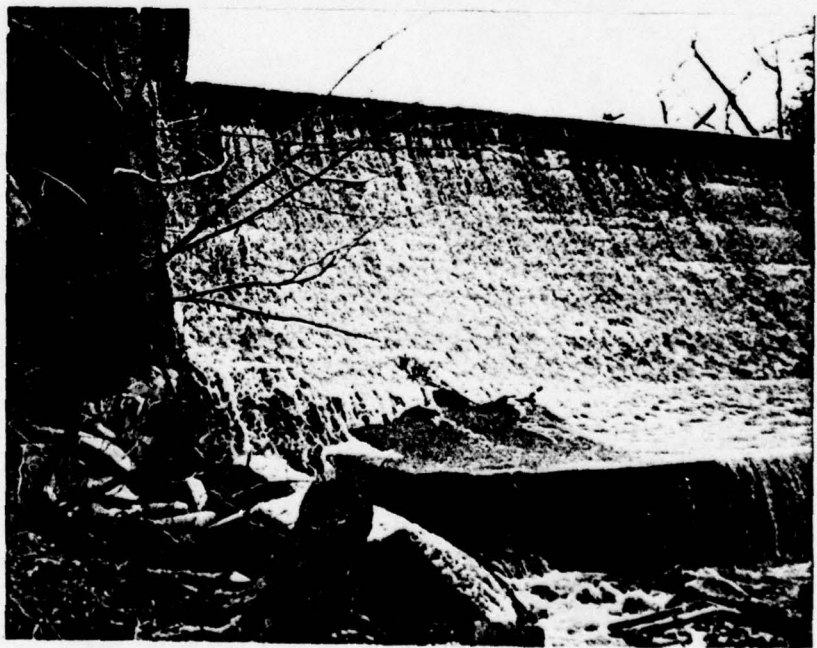
None observed, but entire apron undermined.

Undermining and separation of splash apron

(2) The undermined apron should be backfilled and/or pressure grouted.

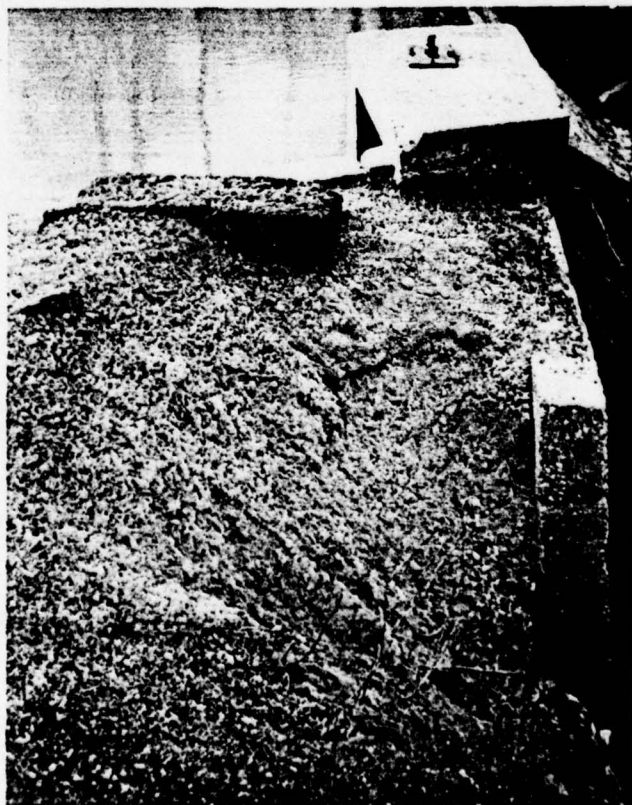
Sloughing and structural cracking at right wingwall

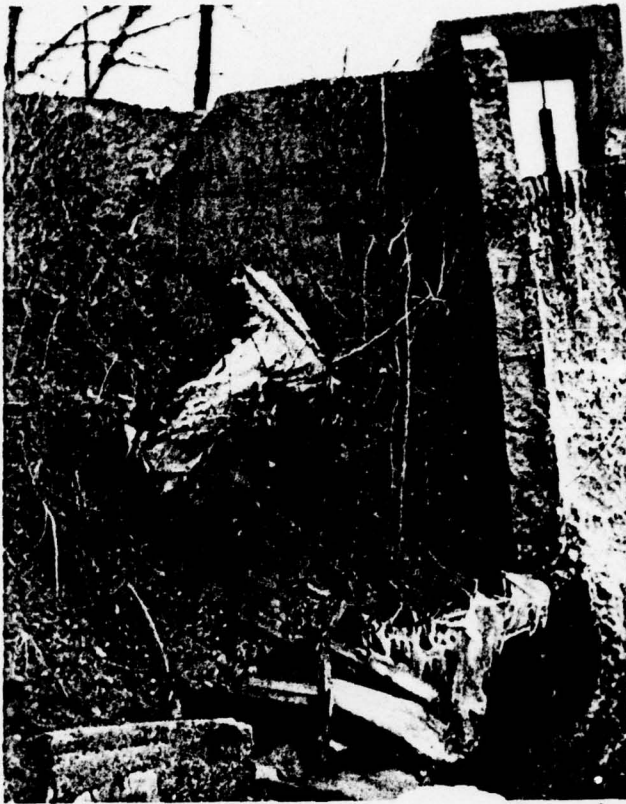
Deterioration of right wingwall structure

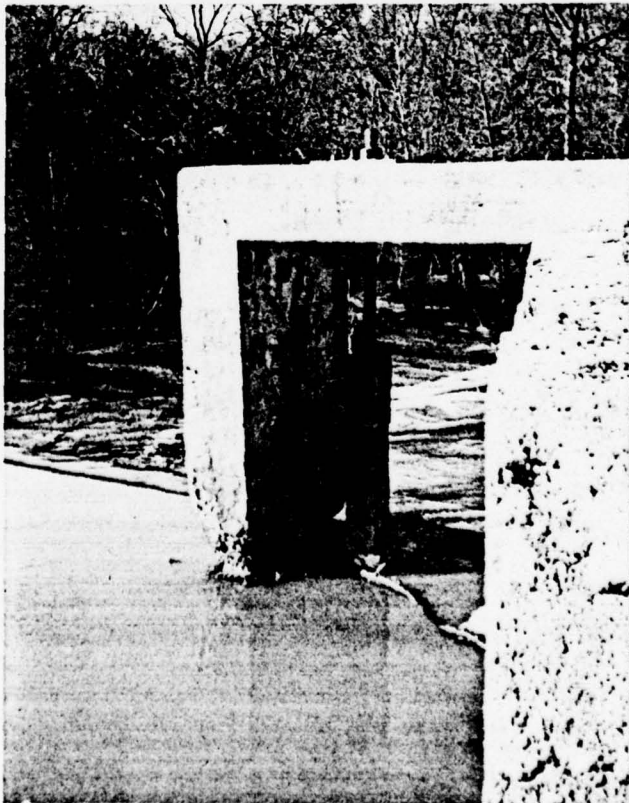
The only regulating component at the dam is the 36" diameter concrete sluice. Parts of the operating mechanism are missing and the concrete housing for the controls is in an advanced state of deterioration. No maintenance of this facility has been performed for a considerable period.

Deterioration of floodgate structure

(4) The sluice gate should be repaired and its entrance cleared of debris and silt.
