RARITAN RIVER BASIN  
AMBROSE BROOK, MIDDLESEX COUNTY  
NEW JERSEY

**LAKE NELSON DAM**

**NJ 00376**

**PHASE 1 INSPECTION REPORT  
NATIONAL DAM SAFETY PROGRAM.**

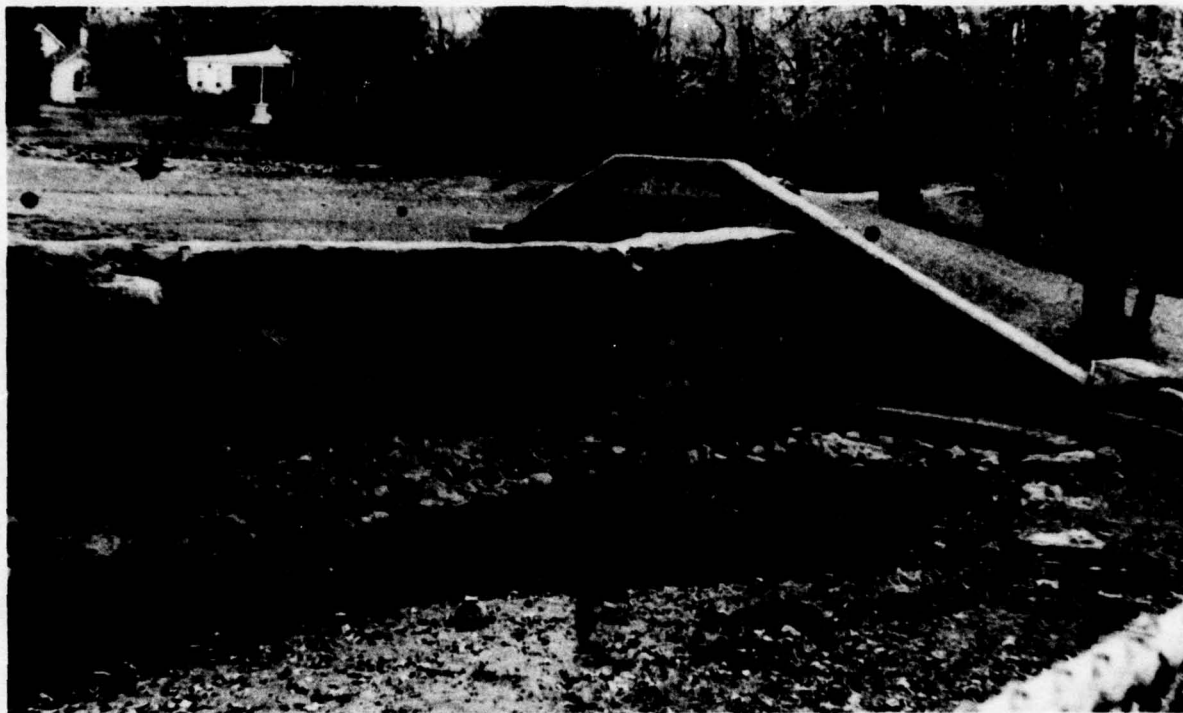
Photo A View of southern half of spillway (Oct. 28, 1973)  
(Photo courtesy of Haefeli Engineering, P.A.)

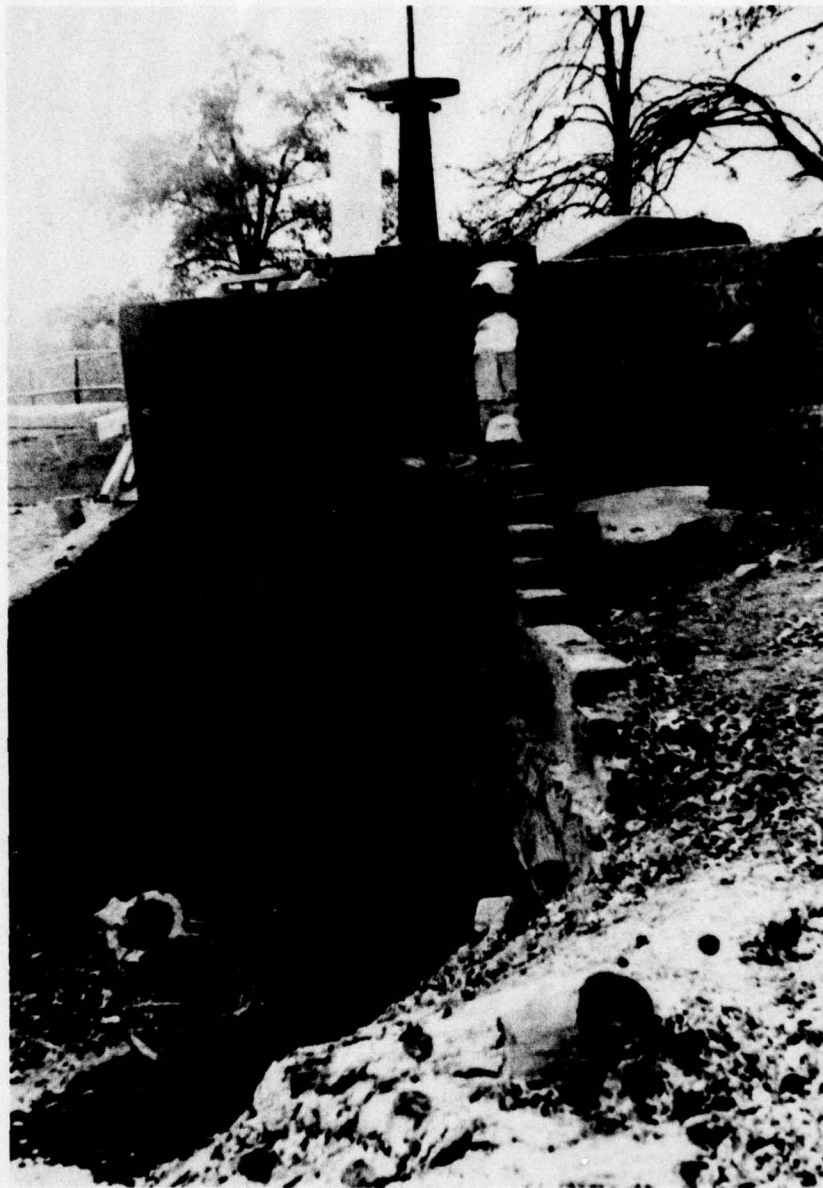
Photo C View of intake to outlet works looking  
downstream (Oct. 28, 1973)  
(Photo courtesy of Haefeli Engineering, P.A.)

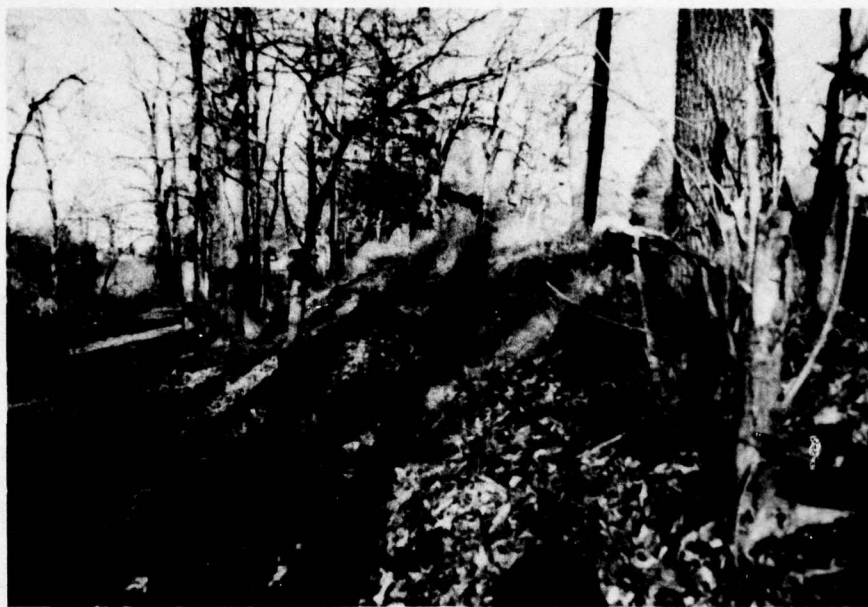
The embankment is covered with a relatively dense growth of mature trees (Photos 1, 2 and 3). A gully, approximately 20 feet long by 3 to 5 feet wide and 1 to 2 feet deep, was noted on the downstream face of the dam

Photo 1 View of downstream face of south embankment  
looking north

- f. The cracks and spalls in the concrete wing walls should be repaired.**
- g. The gully on the downstream face of the south embankment should be filled with suitable material and compacted.**
- h. Riprap should be placed at sections on the upstream face of the embankment where the original riprap has been removed or dislodged.**
- i. A permanent extension should be added to the outlet pipe valve so that it can be operated from the top of the adjacent wing wall.**
- j. A program of annual inspection of the dam should be initiated.**

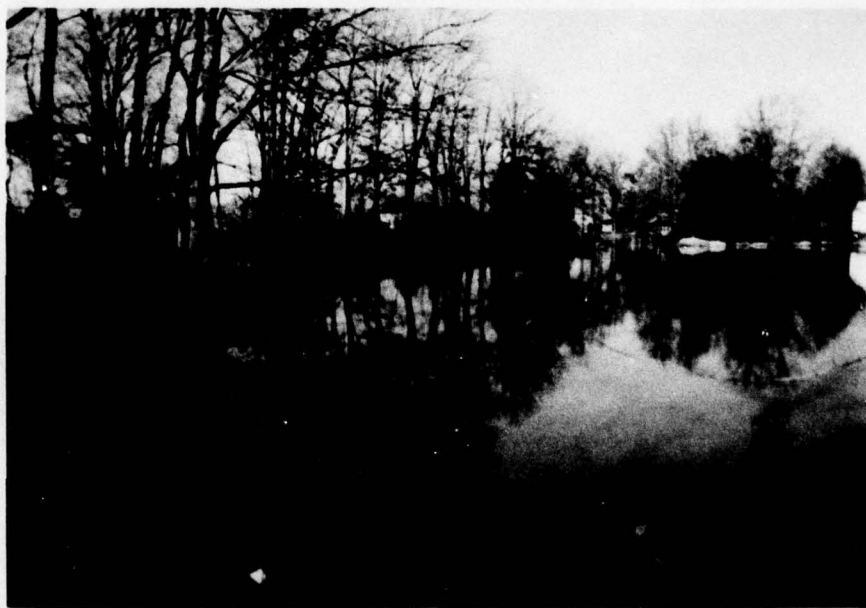
Photo 2 View of upstream face of dam from south  
abutment looking north

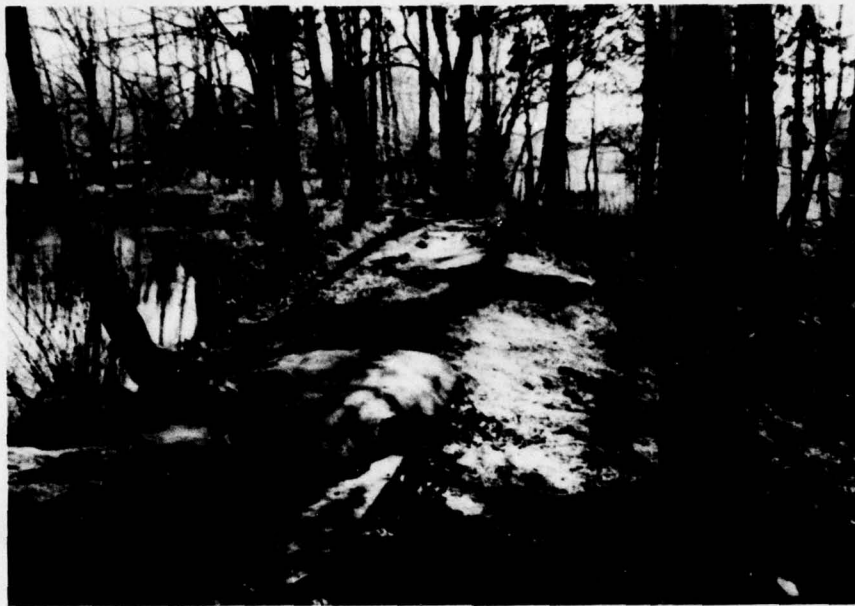
The remains of the emergency spillway consisting of a broken concrete slab approximately 20 feet long is located on the crest of the dam just south of the left spillway abutment (Photo 3). The top of this broken concrete slab is several inches higher than the average elevation of the embankment crest which is approximately 1.5 feet below the top of the concrete wing walls. The emergency spillway thus serves no function.

Photo 3 View of embankment crest looking south from spillway

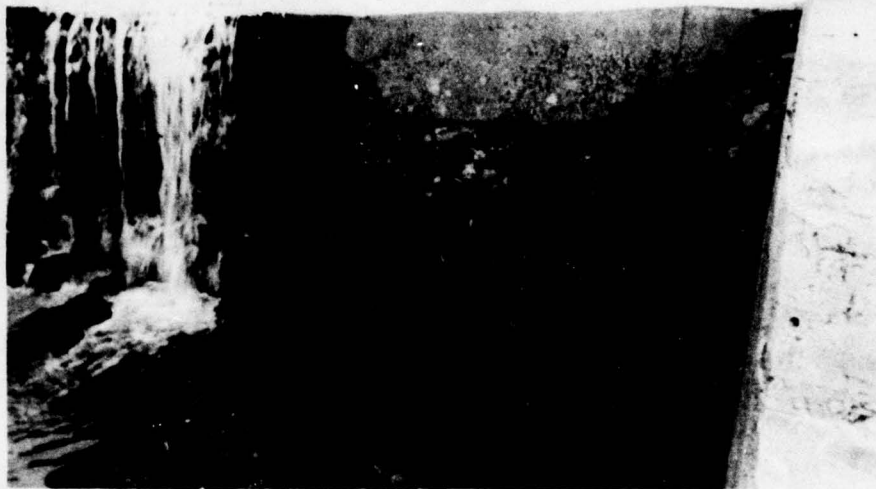
A breach in the spillway crest adjacent to the left (south) wing wall, about 10 feet long and 2 to 3 feet deep, has been filled with concrete; the surface of which is now approximately 3 inches higher than the rest of the spillway crest. Rubble masonry beneath this concrete cap has been partially undermined, and water was observed leaking through this section of the spillway (Photo 5).

Photo 5 View of downstream face of spillway at left  
(south) abutment

b. The downstream edge of the spillway sill should be repaired at areas showing erosion.

d. The eroded portion of the spillway beneath the concrete cap should be repaired, and the concrete cap should be reconstructed.

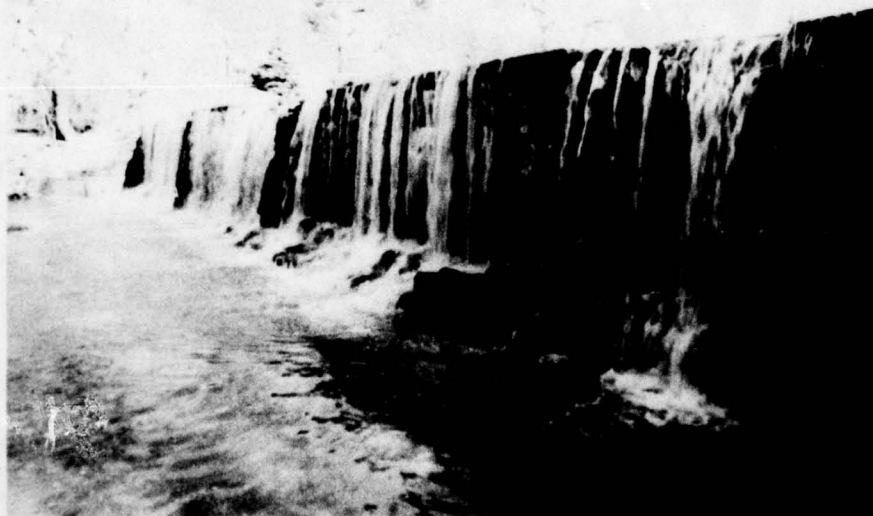
Photo 6 View of downstream face of spillway looking  
north

c. The base of the two buttresses at the northern end of the downstream face of the spillway should be repaired.

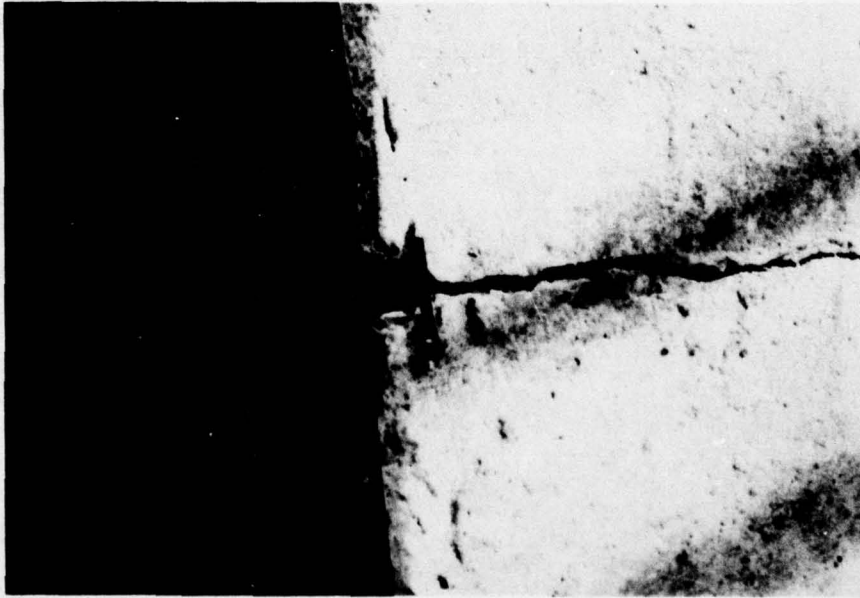
Cracking and spalling of the concrete wing walls at each abutment of the spillway was noted. A vertical crack 1/8 to 1/4 inch wide, plus spalling of the concrete on the surface adjacent to the crack were noted in the center of the left (south) wing wall (Photo 7). Cracking and displacement of about 1/2 inch were also noted in the left wing wall just downstream of the downstream edge of the spillway crest (Photo 8). Nearly vertical cracks were

Photo 7 Vertical view of crack  
at center of left (south)  
wing wall

f. The cracks and spalls in the concrete wing walls should be repaired.

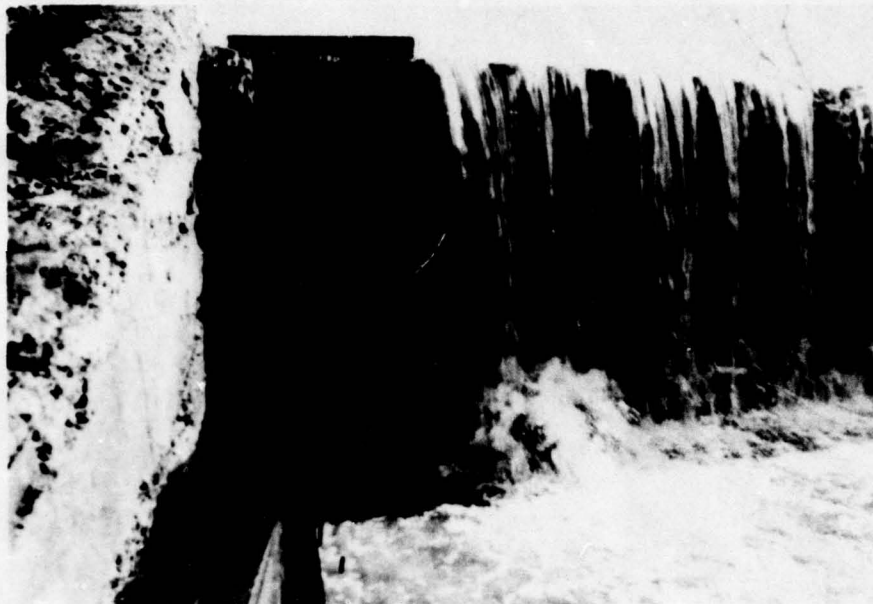
The intake to the outlet works was submerged during inspection and could not be observed; however, flow through the outlet conduit indicates that there is leakage around or through the outlet pipe.

Photo 10 View of downstream face of spillway showing outlet conduit  
(Board placed on spillway crest is not part of the structure)
