ATLANTIC COAST BASIN  
MILL CREEK, OCEAN COUNTY  
NEW JERSEY

# MANAHAWKIN LAKE DAM

**NJ 00057**

## PHASE 1 INSPECTION REPORT NATIONAL DAM SAFETY PROGRAM

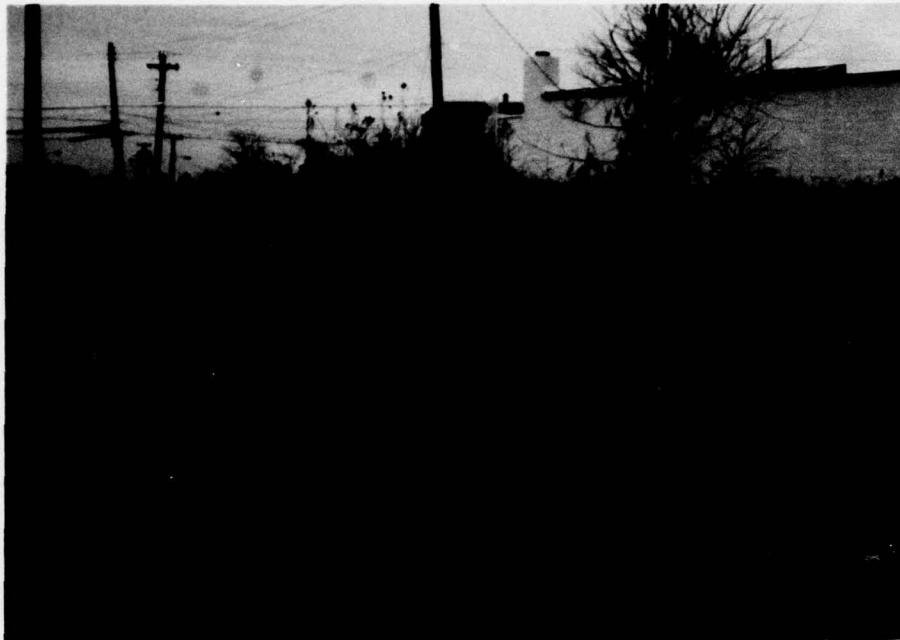
PHOTO 9

BULKHEAD ALONG EAST SIDE  
OF DOWNSTREAM CHANNEL
