STONY BROOK DAM  
NO. 3

NJ 00389

PHASE 1 INSPECTION REPORT

6 NATIONAL DAM SAFETY PROGRAM

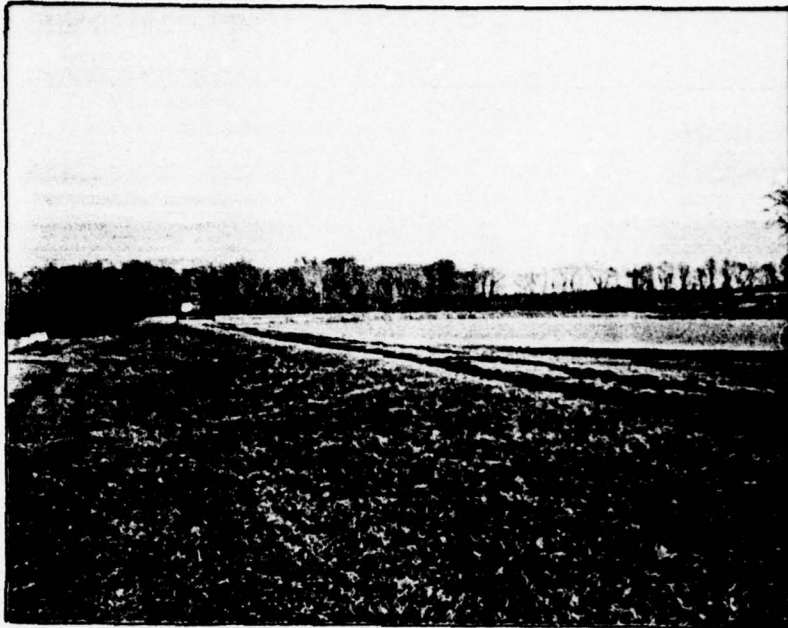
Looking East

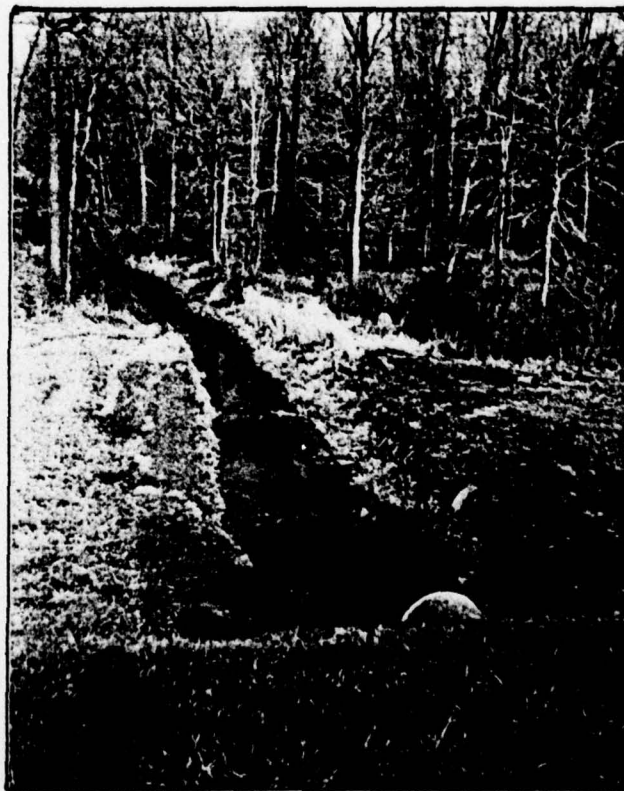
View downstream

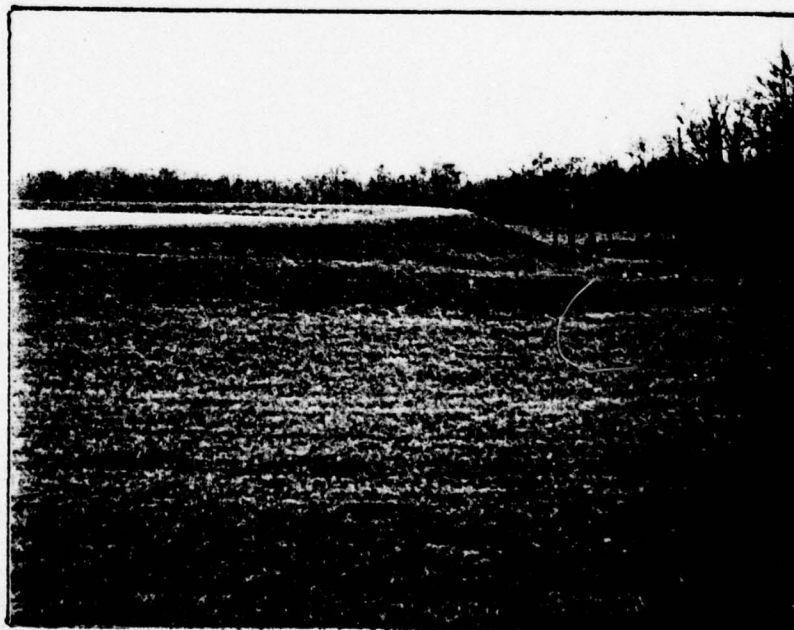
View of auxiliary spillway

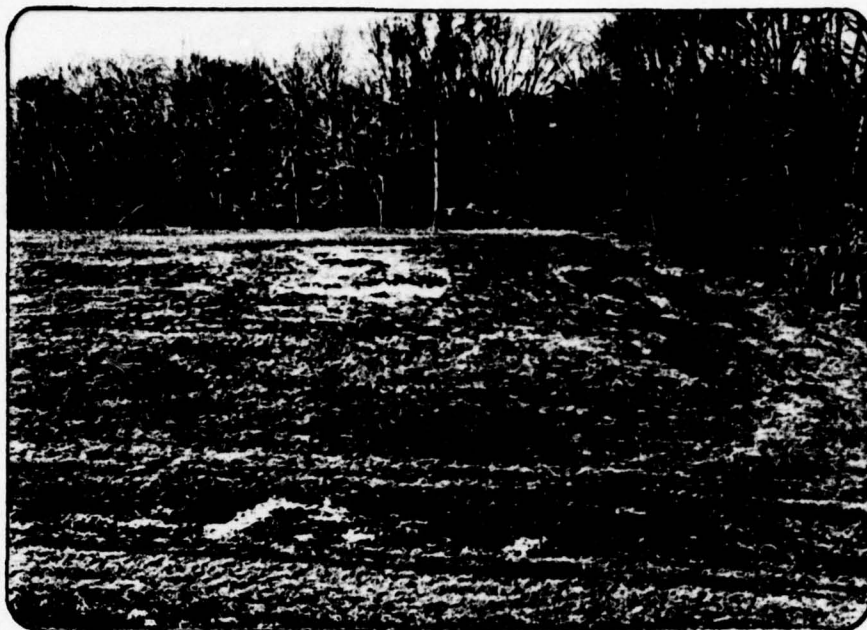
Seepage at toe

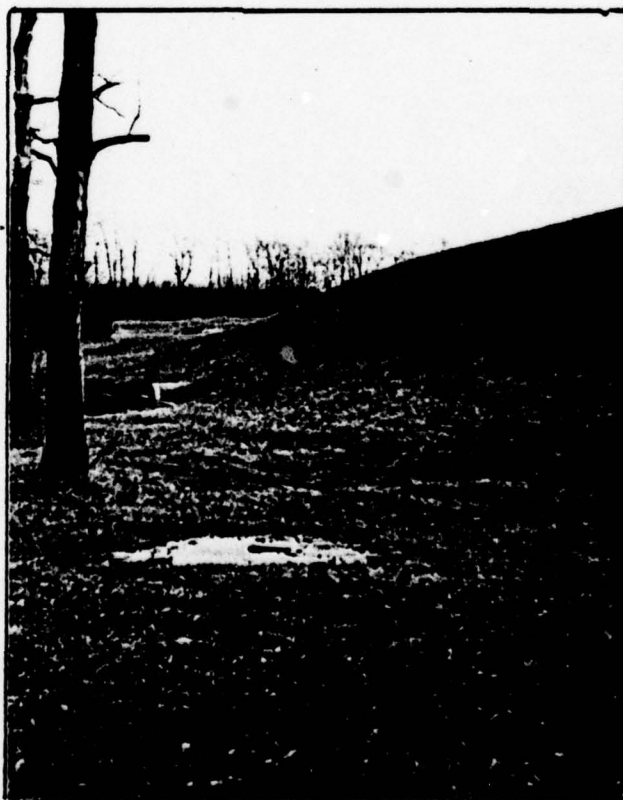
Seepage at toe of left embankment

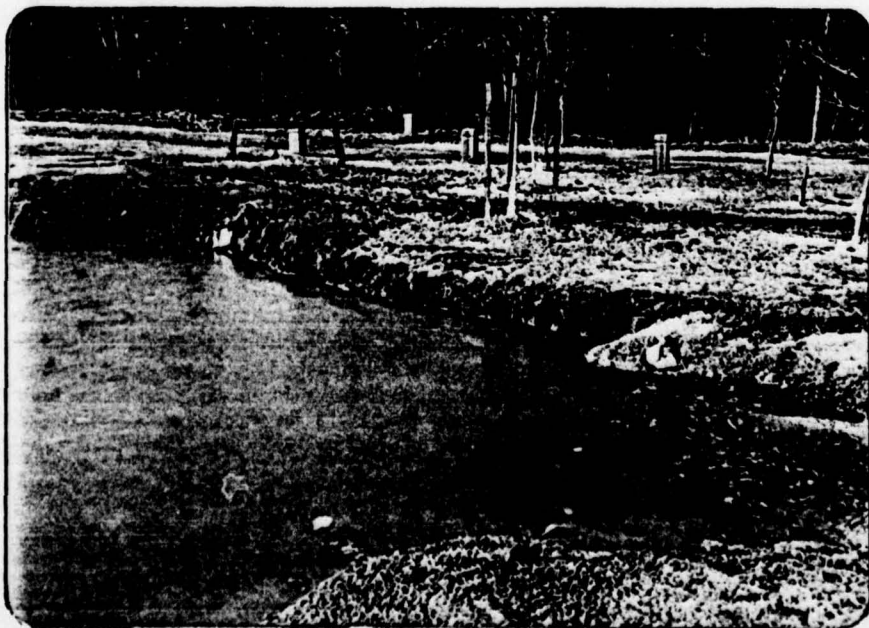
View downstream
