# ASSUNPINK DAM NO. 18 NJ 00452

## ⑥ PHASE 1 INSPECTION REPORT NATIONAL DAM SAFETY PROGRAM.

ASSUNPINK DAM NO. 18 (NJ00452)

PHASE I INSPECTION REPORT  
NATIONAL DAM INSPECTION PROGRAM  
NAME OF DAM: ASSUNPINK DAM SITE NO. 18 FED #NJ00452  
AND NJ ID #591

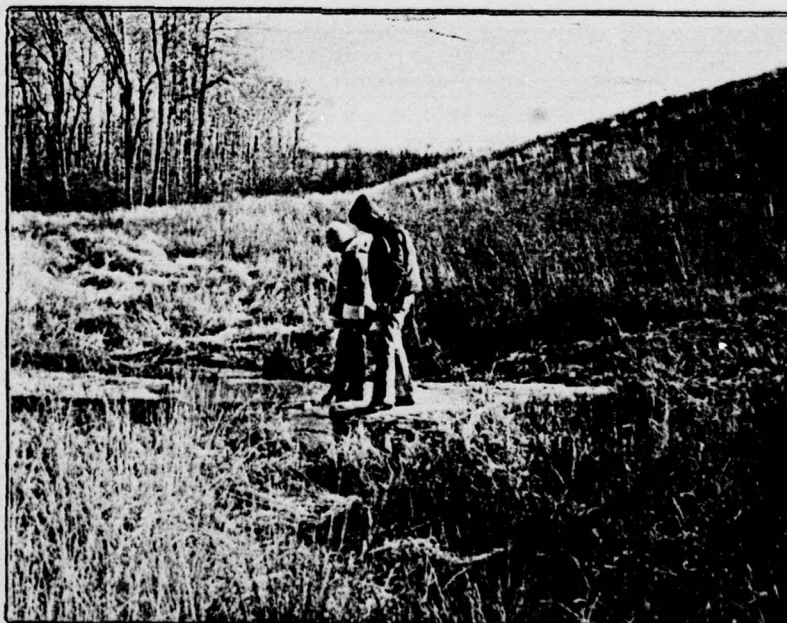
Stream at toe of right embankment

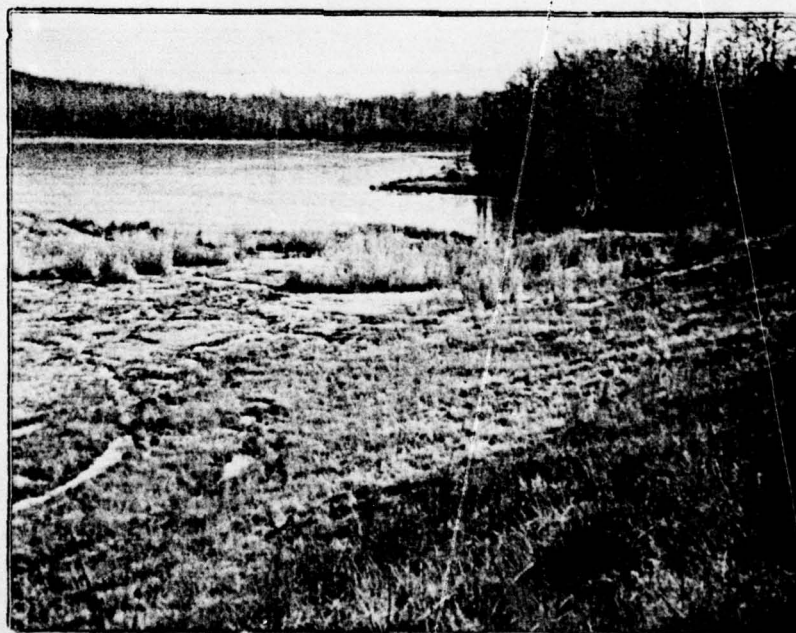
Auxiliary spillway inlet

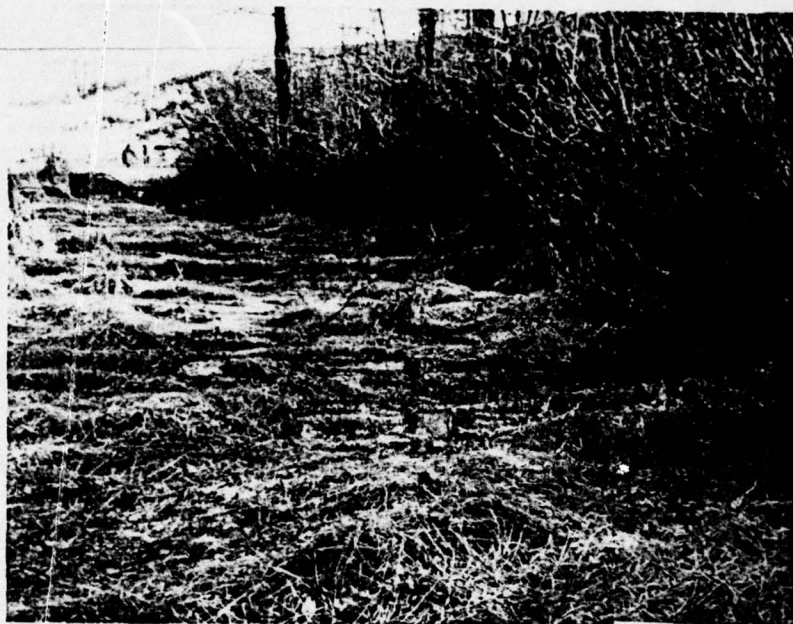
| VISUAL EXAMINATION OF | OBSERVATIONS | REMARKS OR RECOMMENDATIONS |
|---|---|---|
| | Seepage downslope of left embankment - occurred below tree level. Could be<br>a combination of seepage and natural runoff. (infiltrated railway)<br>Ground saturated and water flowing towards downstream channel. Numerous<br>patches of "ice flowers" along channel probably caused by recent rain. Water<br>expelled to surface by frost. | |

Seepage at toe of left embankment

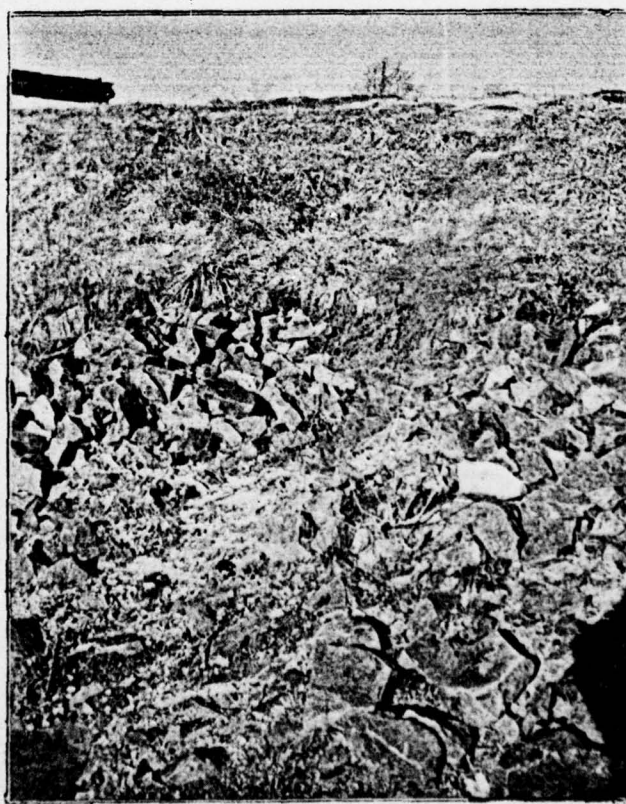
Although there are no major undercut areas, the vehicular traffic has done considerable damage to the graded slopes and in one area, a dirt road has been actually established due to the repeated usage. Numerous patches of "ice flowers" were noticed on the frozen backslopes but these are most probably caused by recent rains rather than deeper, subsurface seepage. Riprap has been displaced on the upper zone of the foreslope directly opposite the deepwater intake.

Displaced riprap directly opposite intake structure

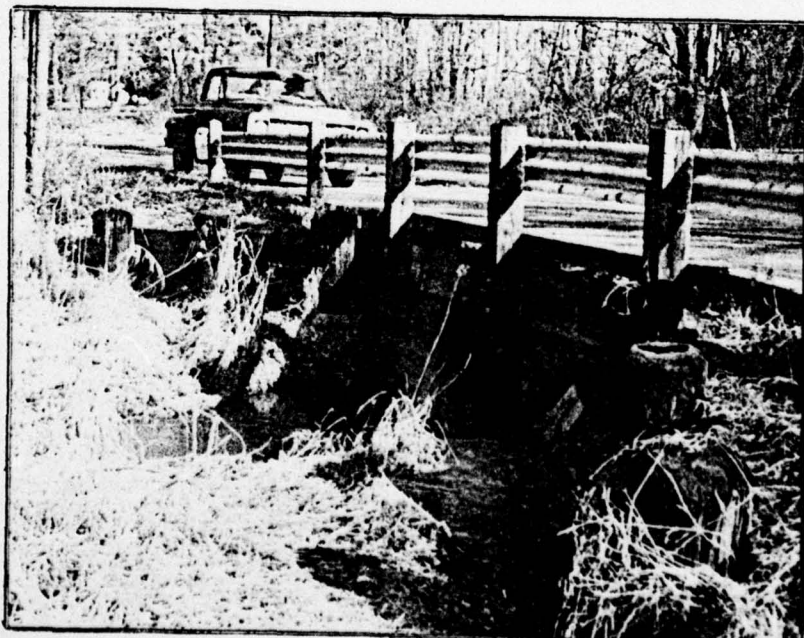
Bridge downstream from dam
