**ANDOVER ROD
AND GUN CLUB DAM
ALLEGANY COUNTY, NEW YORK
INVENTORY NUMBER NY 439**

**PHASE 1
INSPECTION REPORT
NATIONAL DAM
SAFETY PROGRAM**

Name of Dam: Andover Rod and Gun Club Dam

Date of Inspection: August 31, 1978

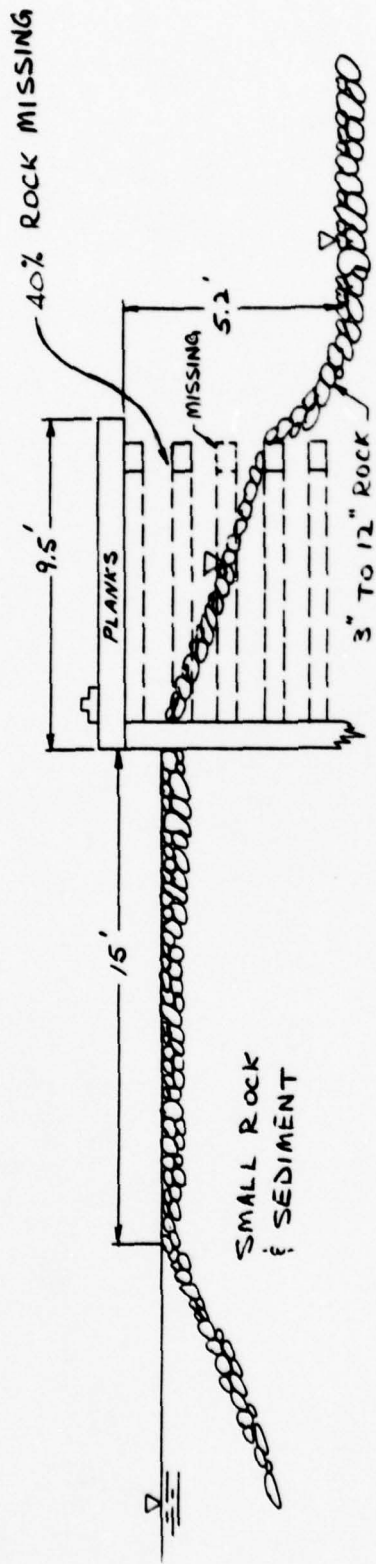
MAXIMUM SECTION
 LEAKAGE SECTION
 SCALE: 1" = 5'

- a. General: The Andover Rod and Gun Club Dam was inspected by L. Robert Kimball and Associates personnel on August 31, 1978 accompanied by Howard Burdick, supervisor of the Town of Andover.
- b. Dam: Visual inspection revealed a large hole in the center portion of the timber crib section. The upstream planking was broken and missing and one of the downstream cross ties was absent. Approximately 40 percent of the rockfill was removed. All discharge (estimated at .75 cfs or 337 gal/min) was through this portion of the dam (See cross section Appendix E).
