RARITAN RIVER BASIN
NORTH BRANCH RARITAN RIVER
SOMERSET COUNTY
NEW JERSEY

RAVINE LAKE DAM

NJ 00362

PHASE 1 INSPECTION REPORT NATIONAL DAM SAFETY PROGRAM

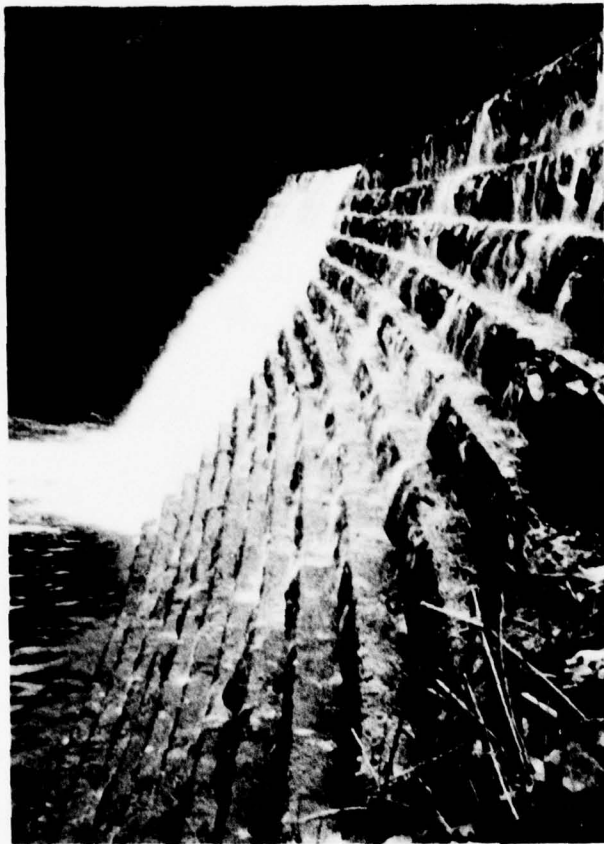
The dam was inspected for signs of settlement, seepage, spalling, cracking and any other evidence of undesirable behavior which might affect the stability of the structure. Because water was flowing over the entire length of spillway, much of the downstream face of the dam was not accessible for inspection (Photo 1).

Photo 1 - Downstream
face of dam looking
west.
(December 4, 1978)

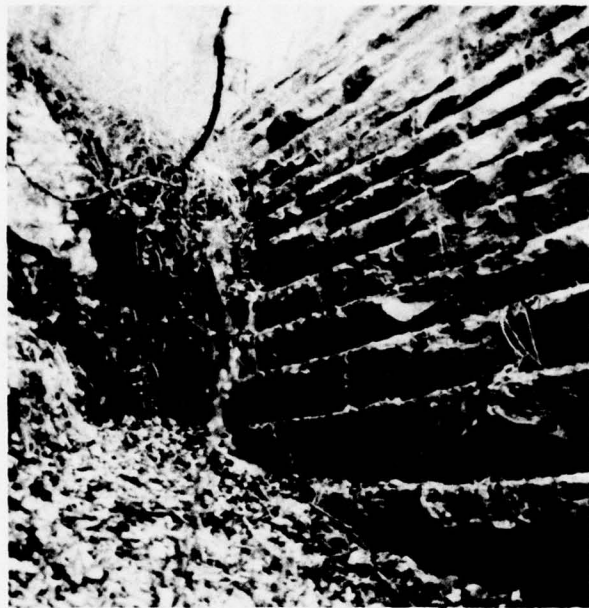
At the junction of the dam and the right abutment there was seepage of about 3 gpm at a point 11 feet below the dam crest (Photo 3). The seepage appears to be originating in the abutment and probably represents flow through joints or fractures in the bedrock.

Reports were obtained on 5 previous dam inspections dating from 1915 to 1973. These reports are included herein as Appendix D. The leakages through the dam at the right abutment which were noted in the present inspection are apparently the same as those reported in previous inspections. The report by Agpar Associates in 1973 noted a sewage odor from seepage at the right abutment. This odor was not detected during the present inspection and it is suggested that the odor may have resulted from seepage of stagnant reservoir water under conditions of thermal stratification that could have prevailed at the time of the former inspection.

Photo 3 - Seepage at
right abutment causing
iron-stained mineral
deposits.
(December 4, 1978)

(2) Repair leaks in the dam and seepage in the right abutment. Replace loose mortar.

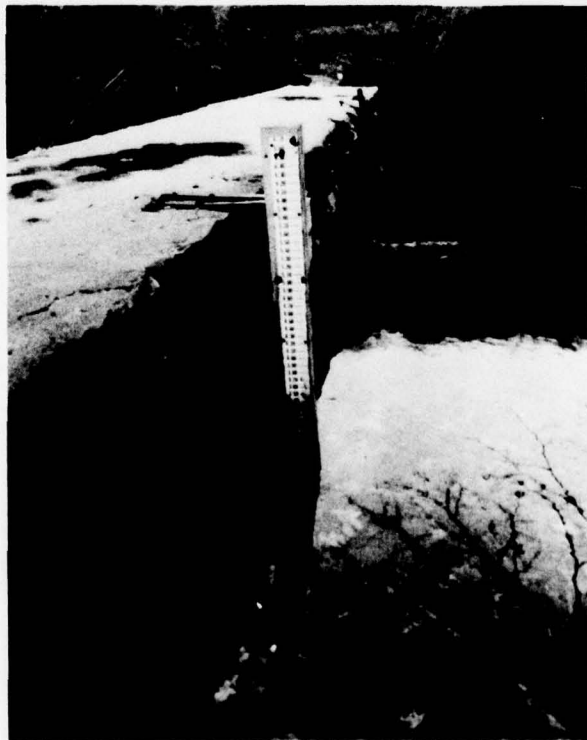
Little of the upstream face of the dam was visible. The mortar on the uncoursed rubble wall appeared to be sound, insofar as could be observed (Photo 4).

Photo 4 - Upstream left
side of dam, showing
uncoursed rubble masonry,
staff gage and log boom
above intake structure.
(December 4, 1978)

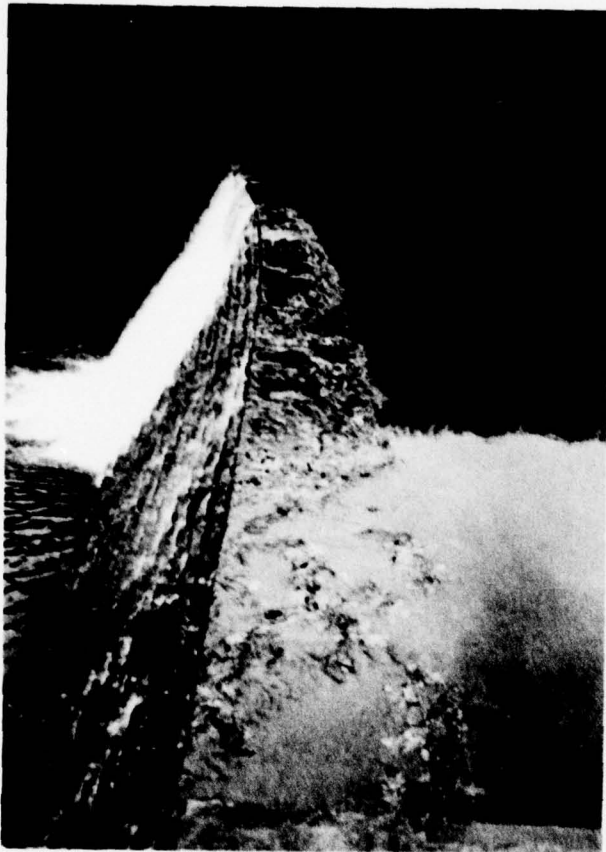
At the time of inspection the major flow of water was through the depressed central section of the spillway, with lesser flow over the storm overflow sections on either side. Although it was not possible to closely inspect the spillway, the uniform flow of water indicated that there were no major discontinuities or failures of the sill (Photo 5).

Photo 5 - View of
spillway looking west.
(December 4, 1978)

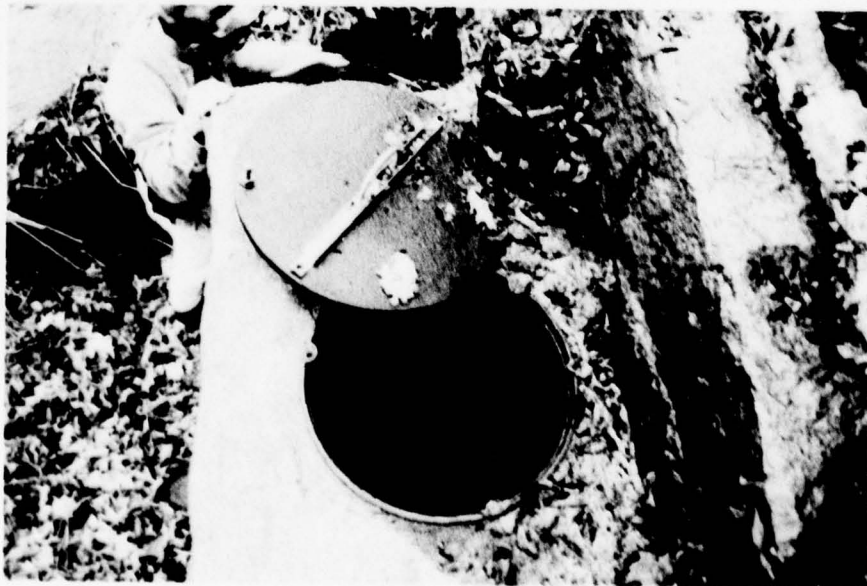
The manhole housing the 6-inch outlet valve on the left side of the dam was dry and appeared to be in satisfactory condition (Photo 6). A log boom is installed over the inlet in the reservoir (Photo 4).

Photo 6 - Valve chamber for 6-inch outlet on
left side of dam. (December 4, 1978)

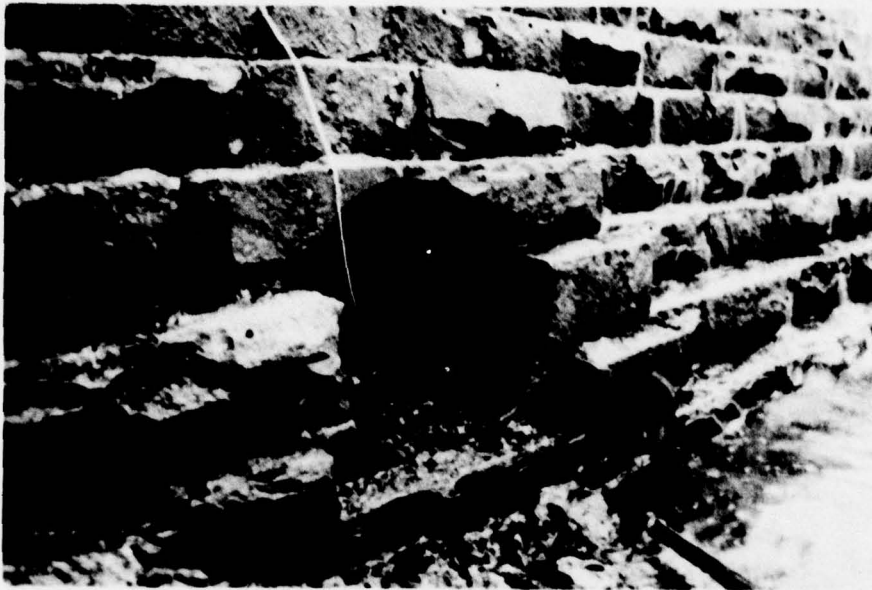
The 48-inch emergency outlet on the right side of the dam showed no indication of leakage (Photo 7). An 8-inch thick granite slab with a 4-inch diameter hole in

Photo 7 - 48-inch emergency outlet on right side of dam. (December 4, 1978)

(2) At the same time, check the condition of the emergency gate valve and determine why the valve is so difficult to operate. Make any necessary repairs.

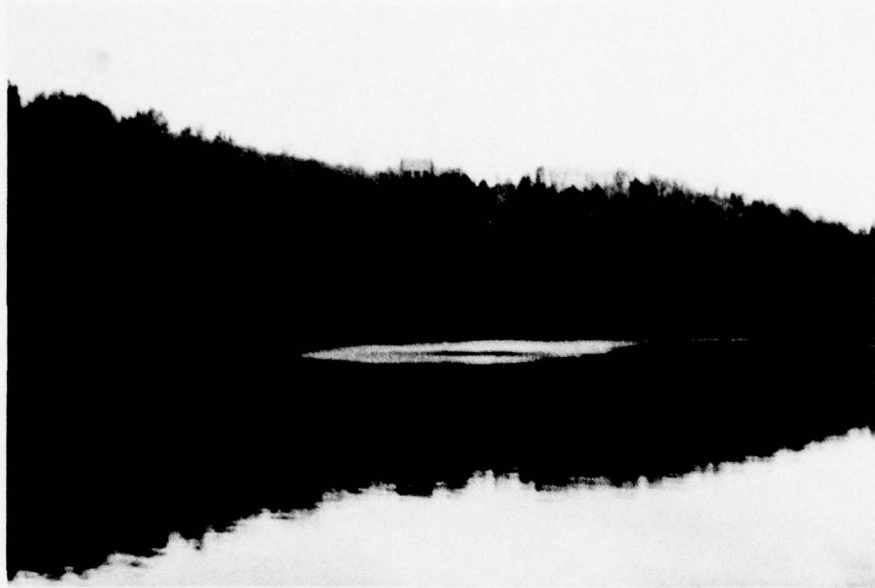
Water in the reservoir appeared to be clean and without odor. Only a minor amount of debris was noted, but the steep wooded slopes do afford debris potential (Photo 9). The slopes appear to be stable and there is no indication of previous slides. Some sedimentation was noted at the abutments. Previous reports indicate a siltation problem.

Photo 9 - Reservoir, looking toward west bank from dam. (December 4, 1978)

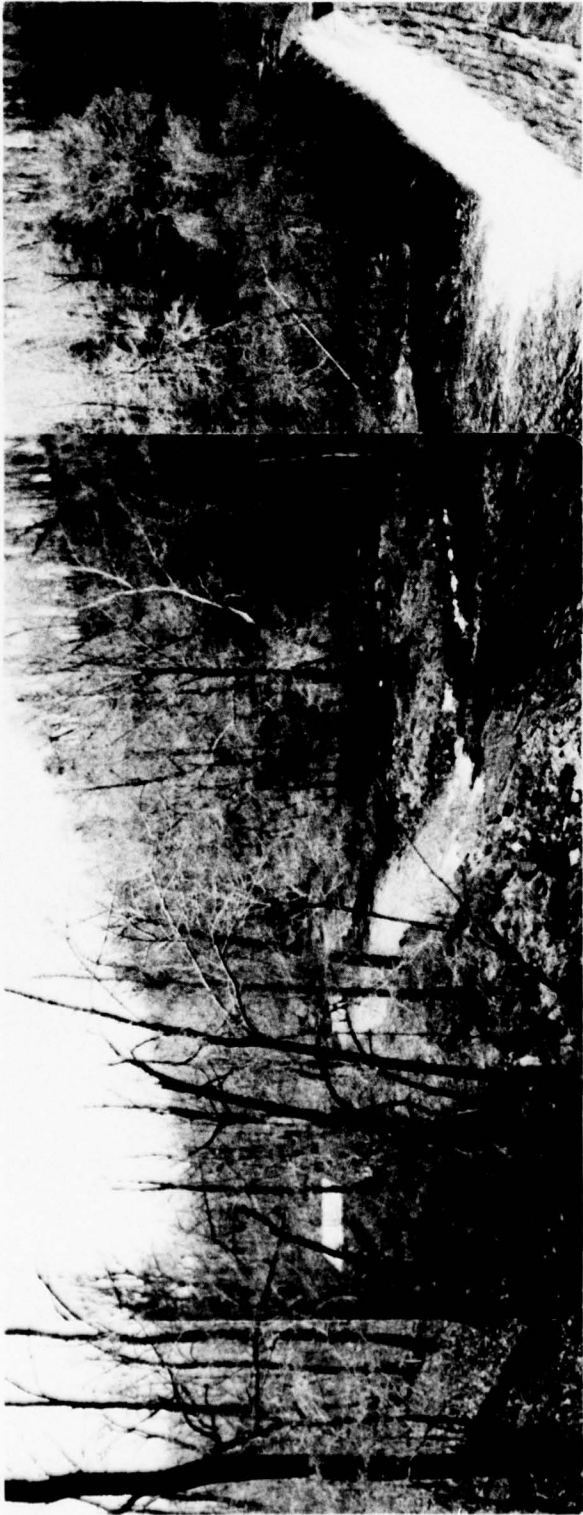
A stilling pool extends about 200 feet downstream of the dam. The river below the pool is slightly meandering and has a steep gradient (Photo 11). Slopes on the right bank are steep and wooded and those on the left bank are moderately steep. A bridge about $\frac{1}{4}$ mile downstream has partially failed and 2 of the arched openings have been filled with gravel (Photo 12). Several houses are located on the left bank near this bridge.

Photo 11 - Stilling pool and downstream channel.
Pump house on left bank. (December 4, 1978)
