**ATSION LAKE DAM**

**NJ 00041**

**PHASE 1 INSPECTION REPORT  
NATIONAL DAM SAFETY PROGRAM**

**DEPARTMENT OF THE ARMY**

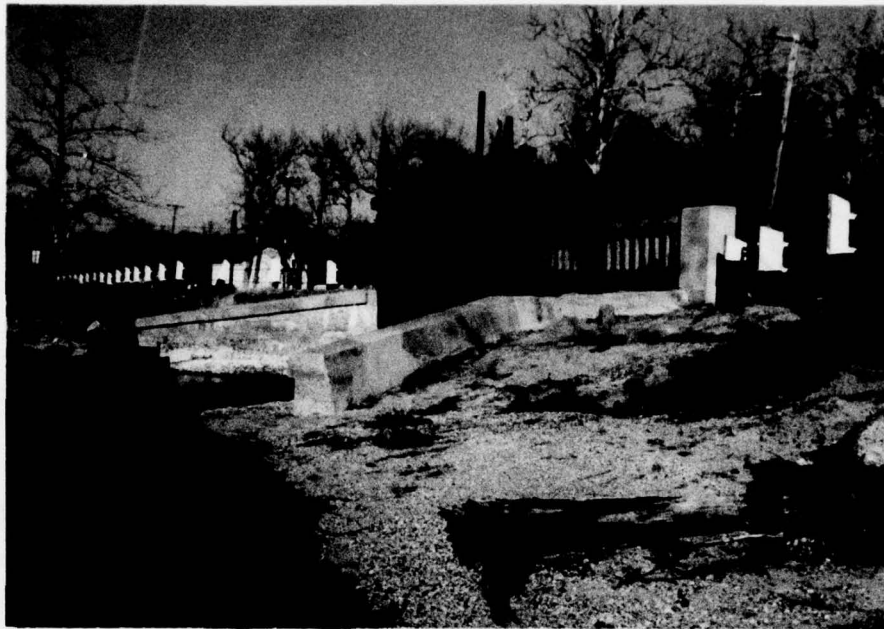
PHOTO 1

Steel sheet piling along the upstream face of embankment on either side of the spillway appeared to be structurally sound but its surfaces are severely rusted.

SPILLWAY APPROACH CHANNEL.  
RUSTED STEEL SHEET PILING.

5. Thoroughly inspect the steel sheet piling and take any necessary remedial action. Construct a concrete cap on the upper portion of the sheet piling to restore the conditions of 1942 at which time the N.J. Highway Department reportedly installed a concrete cap.

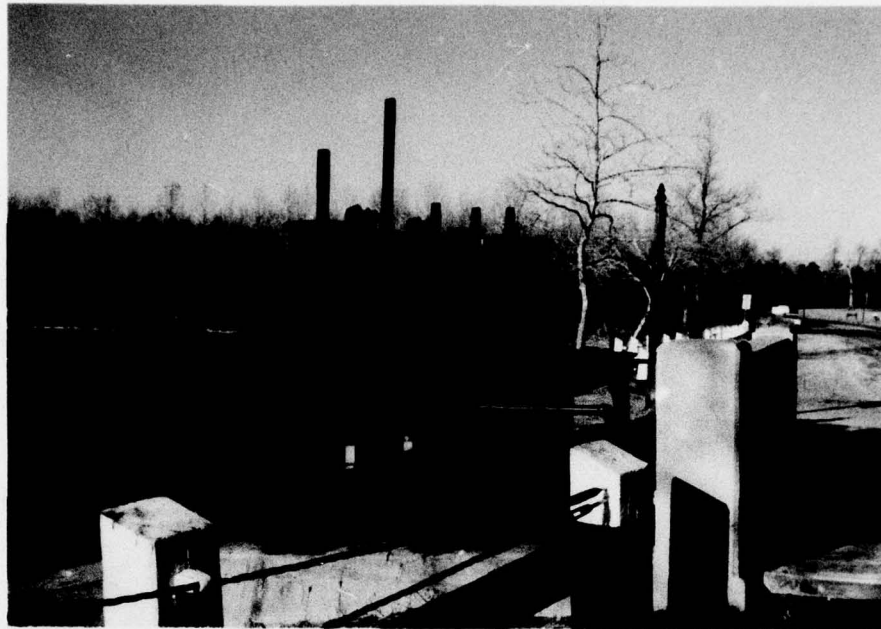
PHOTO 3

GATE OPERATING MECHANISM AND  
TIMBER WALKWAY

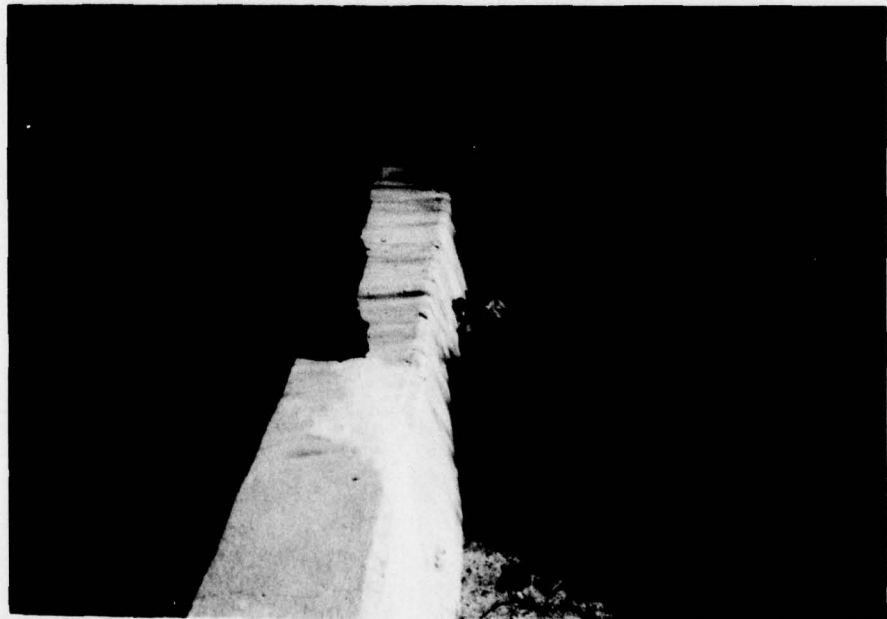
PHOTO 6  
BROKEN CONCRETE IN DOWNSTREAM  
WINGWALL OF BRIDGE

The concrete bridge, although appearing structurally sound, contains a significant number of cracks and spalls which should be repaired in the near future by sand blasting, grouting where needed and coating with epoxy.

1. Trees and brush on the dam embankment should be removed. All trees and brush should be cut at the ground surface.
2. The concrete bridge should be thoroughly inspected and repaired as outlined below:

- a. Drain the lake to an elevation equal to the bottom of the gates.
  - b. Sand blast all concrete and pressure grout all major cracks and patch spalls and eroded surfaces.

- c. Apply an epoxy preservative coating to all surfaces.
3. Repair or replace the timber slide gates.
4. Fill and compact all eroded surfaces of the embankment and restore a suitable grass cover to all surfaces.
