JONES RIVER BASIN
ISAAC BRANCH, KENT COUNTY
DELAWARE

WYOMING LAKE DAM

DE 00034

**PHASE 1 INSPECTION REPORT
NATIONAL DAM SAFETY PROGRAM**

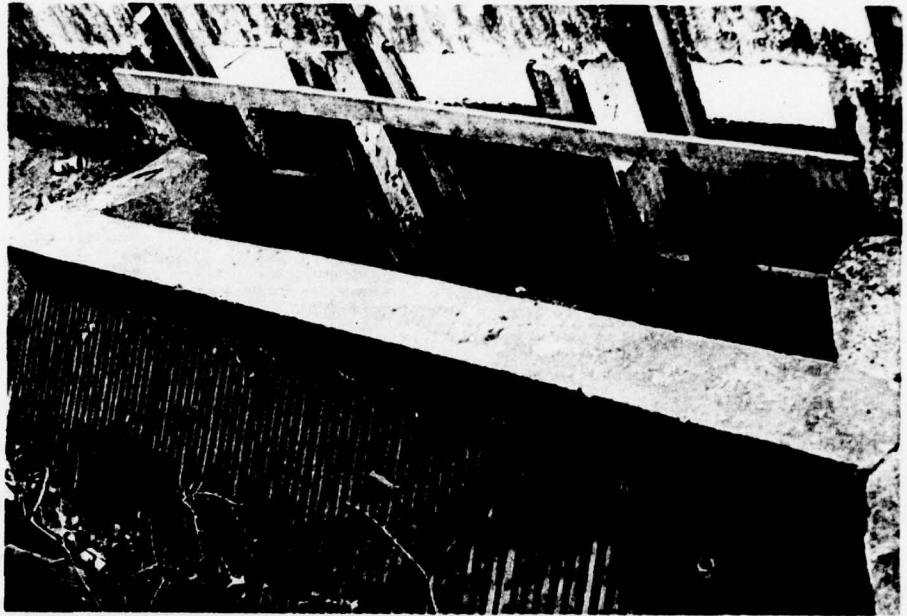
- . Large amounts of debris were noted in the trash rack structure located on the upstream side of the spillway and in the Mill Race itself. The trash rack, if left

PHOTO 7
Mill Race—Lift Stems & Trash Rack

d. The deteriorated trash control at the Mill Road spillway and the deteriorating trashrack at the mill raceway should be repaired or replaced within one year from the date of approval of this report.

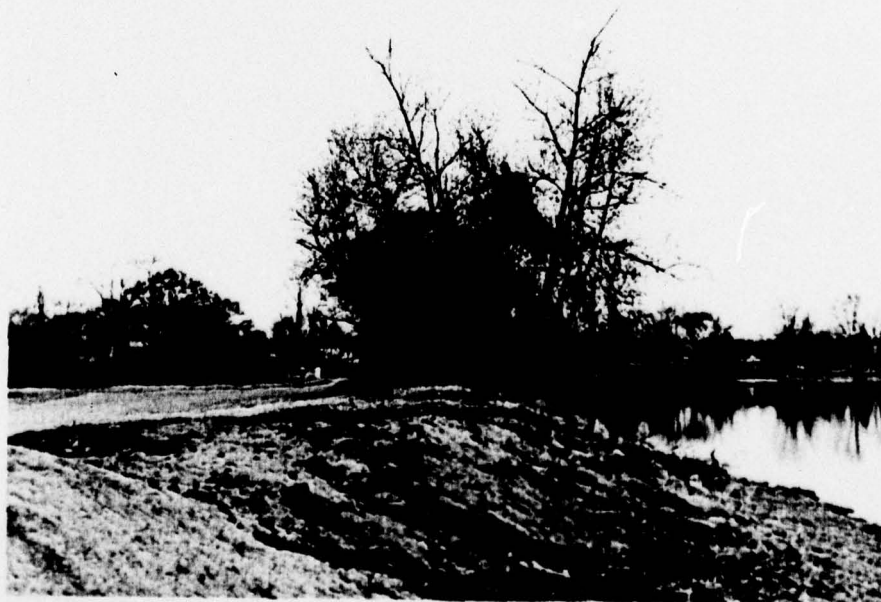
No visual evidence of leakage or seepage was observed at the time of inspection. At each side of the bridge abutment there is slight surface erosion occurring as a result of road surface run-off on the downstream side of each embankment. Several 10 to 18 inch diameter willow trees were growing on the upstream side of the embankment near the north end of the main spillway bridge structure.

PHOTO 14
Eroded Upstream Side Embankment

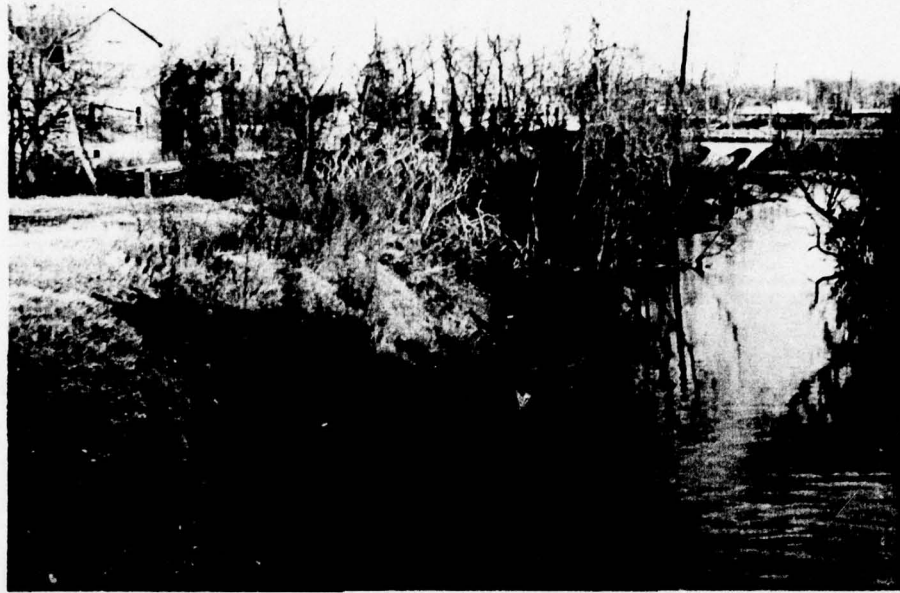
PHOTO 15
Downstream View of Eroded South-
Side - Mill Road Dam Channel

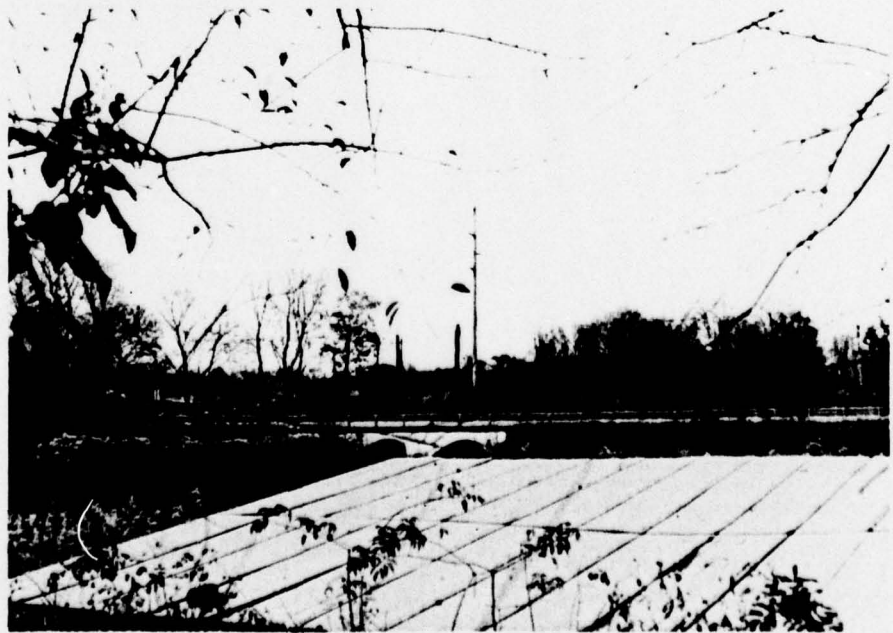
PHOTO 18
Overtop View-Route 195 and Penn.
Railroad From Mill Road

- Photo 18 - View from the center of the Mill Road showing the relative elevations of the Rt. 195 bridge and the Pennsylvania railroad line. Note that the railroad is at a considerably higher elevation than Rt. 195.
