PASSAIC RIVER BASIN
RAMSEY BROOK
BERGEN COUNTY
NEW JERSEY

**CRYSTAL SPRING
LAKE
NJ 00231**

**PHASE 1 INSPECTION REPORT
NATIONAL DAM SAFETY PROGRAM**

May, 1979

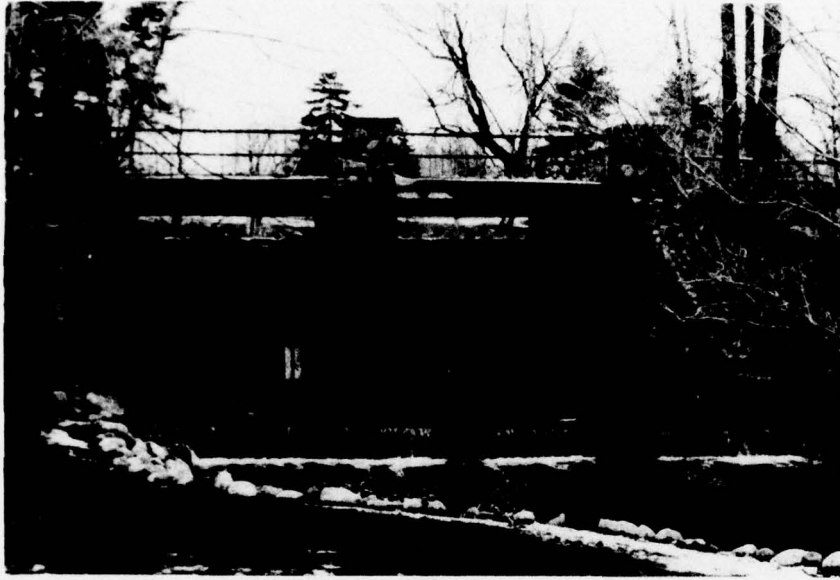
The spillway is a 2-bay overflow weir separated by a bridge deck support pier (Photo 4). Because of its rock masonry construction, discharge over the weir was rather uneven, but the crest and downstream face appeared to be in good condition, with no evidence of erosion or plucking of the masonry (Photo 5). The center bridge pier and masonry training walls have been repaired recently and are in good condition. A new toe wall has been installed at the base of the spillway apron (Photo 4), and the underside of the bridge was recently covered with wire mesh and gunite.

The spillway appears to be structurally sound, as is the lined channel downstream. The condition of the reservoir drain could not be determined.

Photo 4 - Downstream View of Spillway.
(November 30, 1978)

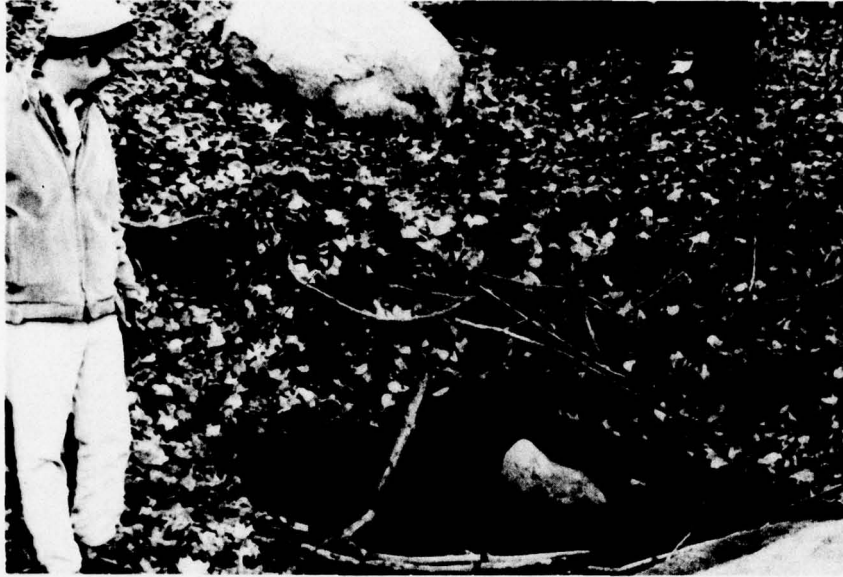
Little of the emergency drain could be observed. It is reported to consist of 2 10-inch pipes controlled by valves in a manhole on the crest of the dam. The manhole was observed to be filled with water to the level of the reservoir and the valves were submerged in 9 feet of water. The downstream outlet was obscured by debris. There was about 1/2 gpm seepage from the outlet area (Photo 6).

Photo 6 - Reservoir drain outlet obstructed
by debris. (November 30, 1978)

(3) Repair and clean out the outlet area of the emergency drain and regularly operate the valves to verify that they are in working order.
