# CRANDON LAKE DAM

## NJ 00267

### PHASE 1 INSPECTION REPORT NATIONAL DAM SAFETY PROGRAM

May, 1979

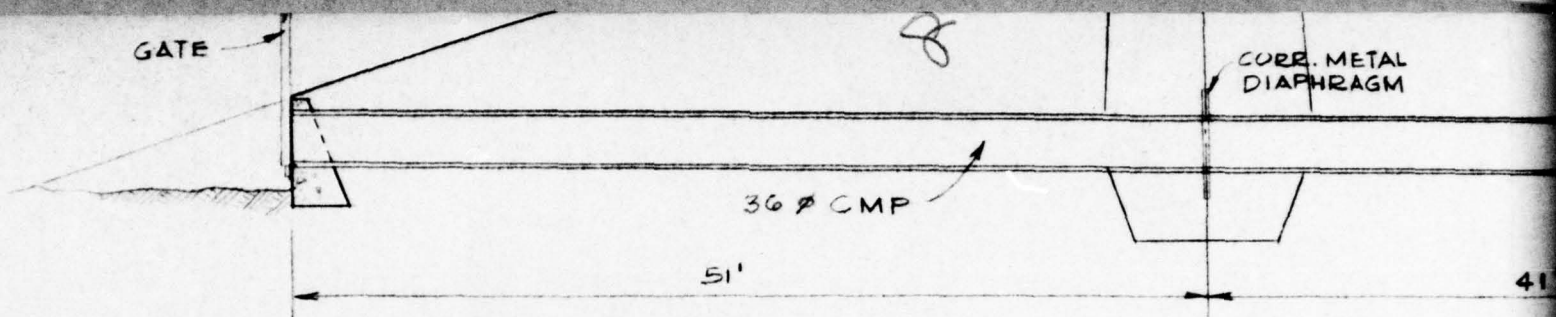
TYPICAL SECTION OF D  
THRU BLOW-OFF PIPE  
 SCALE 1"=10'

\* It is reported that the upstream slope of the embankment is 2H:1V  
 Visual inspection shows the upstream slope above lake level is about 5H:1V

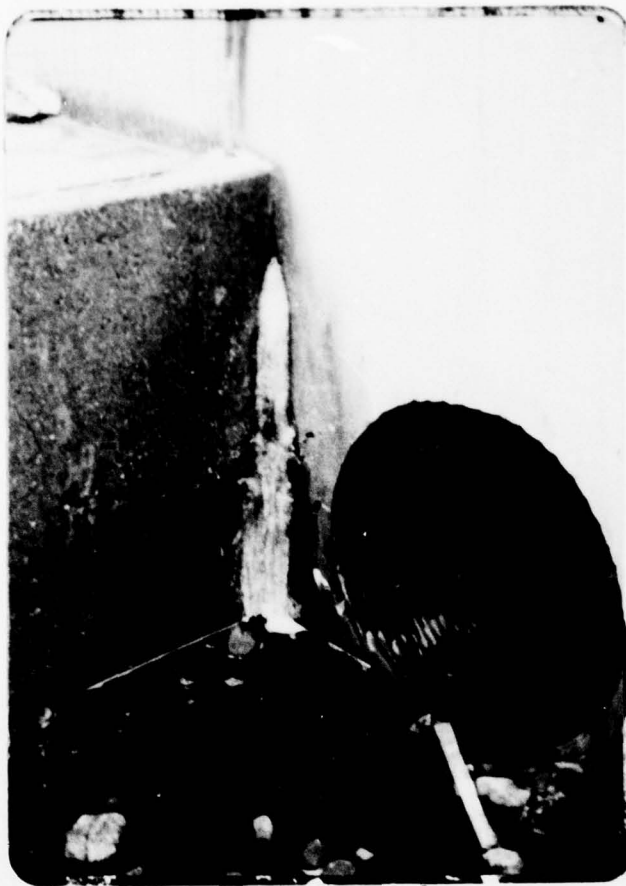
| VISUAL EXAMINATION OF | OBSERVATIONS | REMARKS OR RECOMMENDATIONS |
|---|---|---|
| INTAKE STRUCTURE | Numerous cracks observed on upstream face of concrete headwall of the 6-ft-dia conduit. Three cracks extend to the top and appear on exposed sides of the wall. At left junction of drop box/headwall, water seepage. | Cracks should be further investigated. Leakage at junction should be repaired. |

Water seeping at joint at left  
wall of drop box spillway.

5. Eroded areas of the dam should be suitably backfilled and measures taken to prevent future erosion. This should be done soon.
6. Repair leaks in the drop-box spillway. This should be done in the near future.
