PASSAIC RIVER BASIN
SHEPARD BROOK, PASSAIC COUNTY
NEW JERSEY

SKYLINE LAKE DAM NO. 2 NJ 00200

PHASE 1 INSPECTION REPORT NATIONAL DAM SAFETY PROGRAM

May, 1979

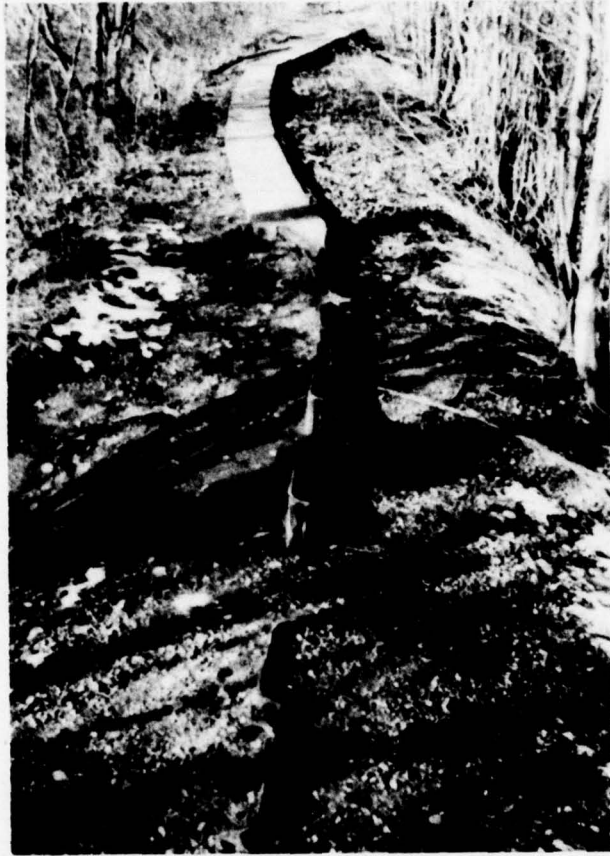
The steel sheet piling and concrete cap of the core wall were exposed along the longitudinal axis of the dam protruding approximately 6 inches above the earth fill (Photo 1). Some minor cracking of the concrete which caps the steel sheet piling was noted. The top of the embankment has been eroded up to a depth of about 2.5 feet adjacent to the right spillway wall. This erosion has presumably been aggravated by pedestrian traffic. The top and upstream and downstream faces of the dam are covered with a heavy growth of trees and brush extending down to the water line. The left abutment is also heavily wooded.

Photo 1
View of embankment
crest looking west
from spillway

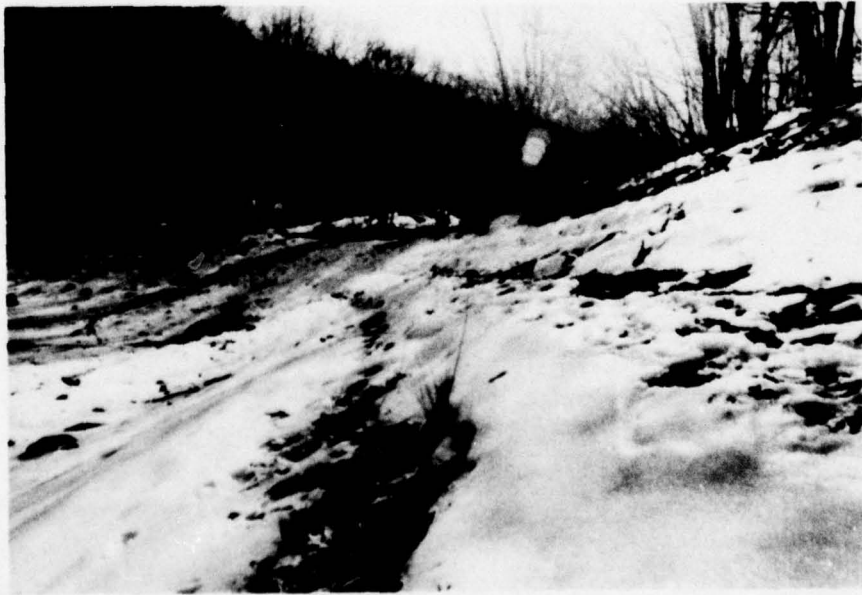
Two wavecut benches 1 to 2 feet deep were observed on the upstream face of the dam as shown in Photo 2. These benches were apparently caused by wave erosion when the reservoir was at approximately the same elevation as the benches. The majority of the visible surface of the upstream face of the dam consisted of a sandy clay soil with some gravel. No riprap was observed on the upstream face of the dam.

Photo 2 View of upstream face of dam looking east

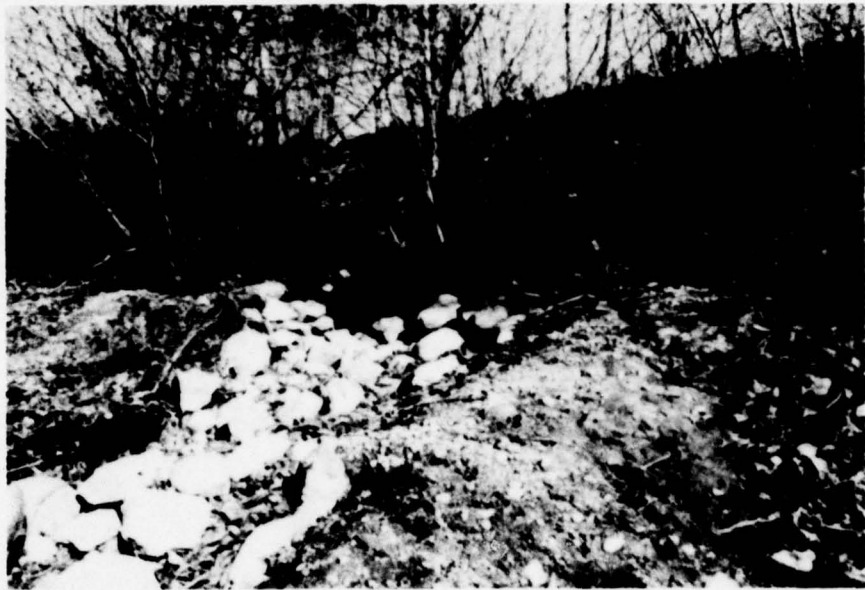
Two significant erosion gullies were observed on the downstream face of the embankment. One gully, located in the center of the embankment, begins at the high water level of the lower reservoir and extends down to the toe of the dam (Photo 3). This gully has been filled with

riprap; however, erosion appears to be continuing at the upper end. The erosion forming this scar may be the result of wave action from the lower reservoir or possibly seepage through the embankment. The local extent of the erosion indicates that seepage is the most probable cause. The second gully is located above the outlet works as shown in Photo 4.

Photo 3 View of stone filled gully in central section of the downstream face of embankment

- (3) Erosion scars on the downstream face of the embankment and the eroded section of embankment adjacent to the west wingwall should be filled and compacted with a suitable earthfill. If inspection of the embankment when the upper reservoir is full indicates that the erosion on the downstream face is caused by seepage, remedial measures to eliminate the seepage should be performed.

5. If inspection of the embankment when the upper reservoir is full indicates that the erosion on the downstream face is caused by seepage, remedial measures to eliminate the seepage should be performed.

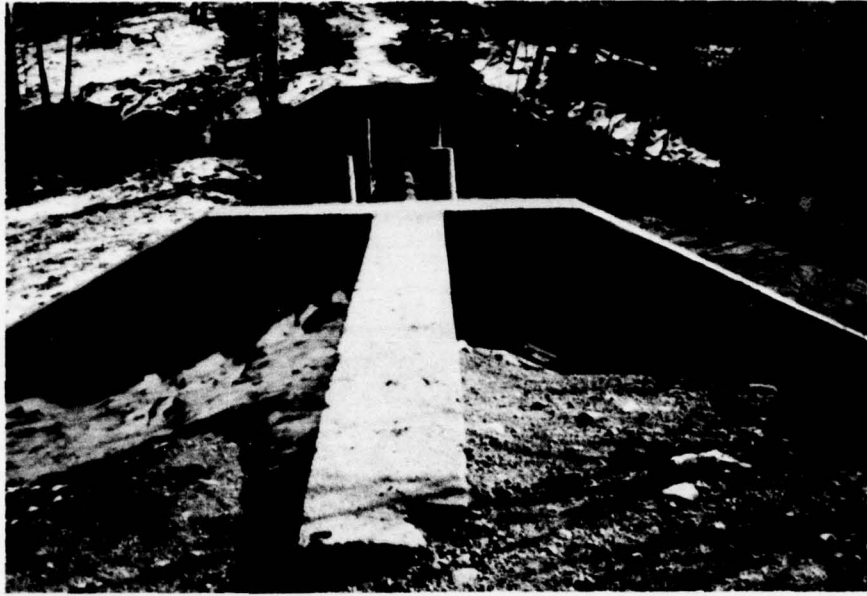
The spillway appears to have been constructed generally as shown on the design plans (Plate 4), with the exception of four concrete cylindrical piers 10 inches in diameter and 4.5 feet high located adjacent to the spillway crest (Photo 5). These piers reportedly supported a foot bridge across the spillway which was damaged and removed.

Photo 5 View of spillway looking east

- (5) Remove the bridge piers from the spillway.
- (6) The cracks and spalling in the spillway wingwall should be repaired.
- (7) A trash rack should be placed over the intake to the outlet conduit.

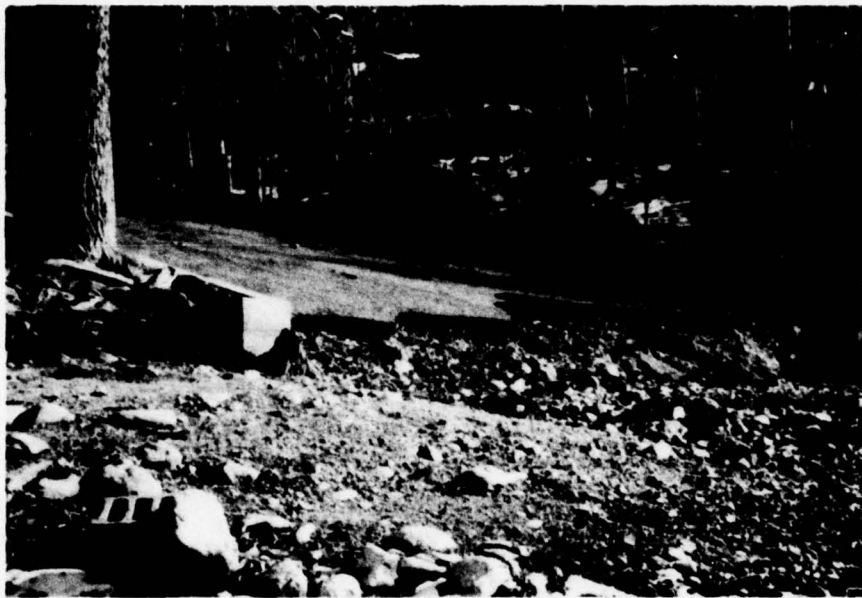
The downstream toe of the spillway apron has been severely eroded as shown in Photo 7. The abutment on which the apron is founded has been eroded up to a depth of about 4 to 5 feet just downstream of the apron toe. The present toe of the macadam surface is very irregular and has been eroded from 3 to 10 feet upstream from the downstream end of the training walls.

Photo 7 View of spillway apron

- (4) The eroded portion of the downstream toe of the spillway apron should be replaced and resurfaced in such a manner as to avoid further deterioration.

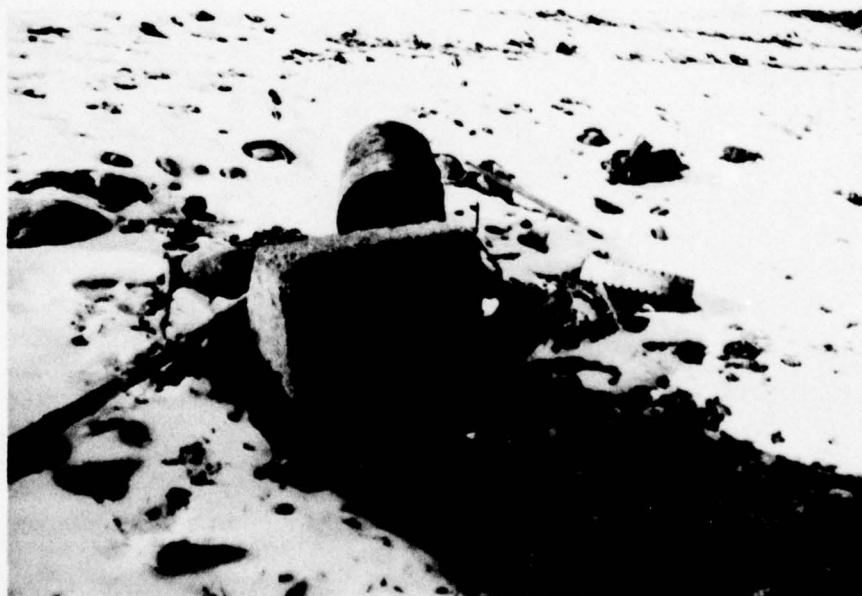
The upstream and downstream ends of the 20-inch diameter outlet pipe are surrounded by concrete collars and appear to be in satisfactory condition. The upstream reservoir level was below the intake to the outlet pipe at the time of the first inspection. There was miscellaneous debris around the intake to the outlet pipe (Photo 8) and there are no trashracks or similar guards over the intake.

Photo 8 View of intake to outlet pipe

A trash rack should be placed over the intake to the outlet conduit as soon as possible.

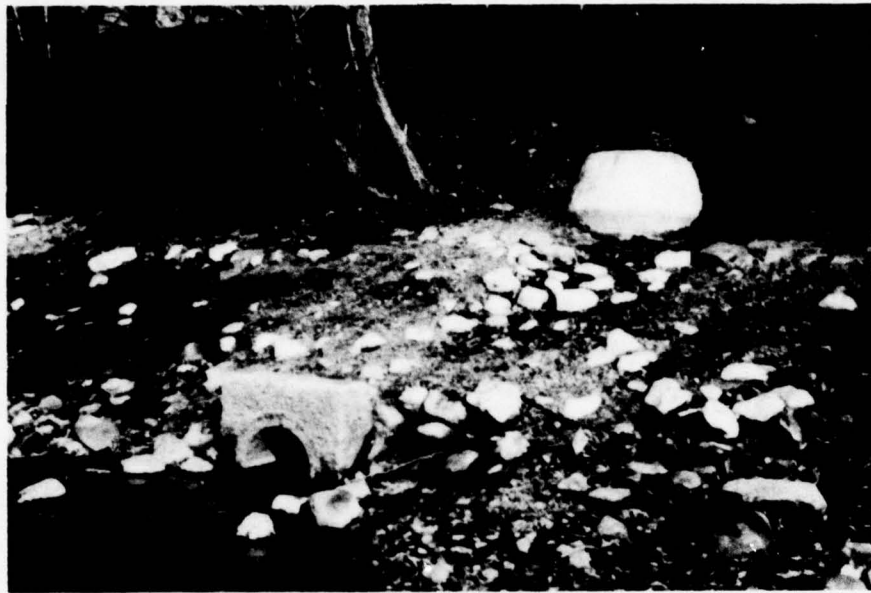
The water level of the lower reservoir was about 6 inches above the invert of the outlet pipe. The outlet pipe valve is housed in a concrete manhole (Photo 9). The steel manhole cover was locked at the time of the inspection; therefore, the valve could not be observed.

Photo 9 View of outlet pipe and valve chamber at
downstream toe of dam
