NEW JERSEY STATE DEPT OF ENVIRONMENTAL PROTECTION TRENTON F/G 13/2  
NATIONAL DAM SAFETY PROGRAM. WAGAMONS POND (DE00061), DELAWARE --ETC(U)  
MAR 79 T T MOORE

| REPORT DOCUMENTATION PAGE | | READ INSTRUCTIONS<br>BEFORE COMPLETING FORM |
|---|---|---|
| 4. TITLE (and Subtitle)<br>Phase I Inspection Report<br>National Dam Safety Program<br>Wagamons Pond Dam<br>Sussex County, N.J. | 5. TYPE OF REPORT & PERIOD COVERED<br><b>9</b> FINAL rept. | |

Inclosed is the Phase I Inspection Report for Wagamons Pond Dam in Sussex County, Delaware which has been prepared under authorization of the Dam Inspection Act, Public Law 92-367. A brief assessment of the dam's condition is given in the front of the report.

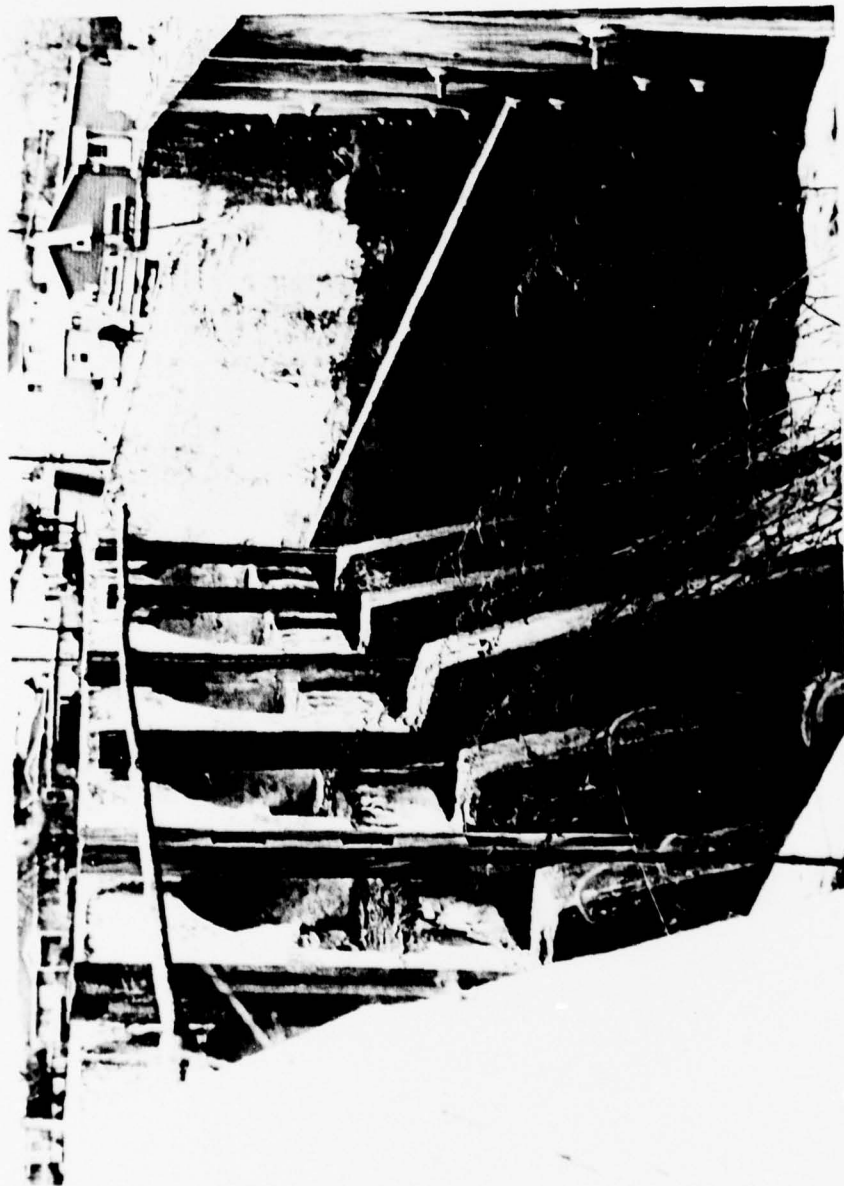
OVERALL VIEW  
OF  
DAM
