NARRATICON LAKE DAM

NJ00111

PHASE 1 INSPECTION REPORT NATIONAL DAM SAFETY PROGRAM

March, 1979

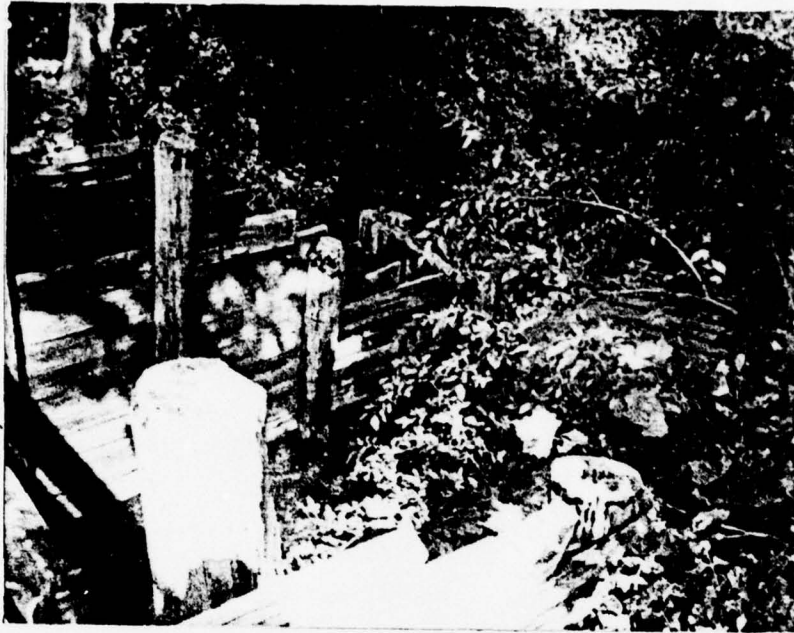
The timber bridge is in an advanced stage of decay and should be replaced. There is evidence of seepage in and around the entire substructure and the apron plank slab is rotted out with pieces missing and is undercut on the downstream end. The timber box spillway portion abutting the bridge is in an adequate condition to be preserved on a short-term basis but it is almost 25 years old and approaching the time for replacement for timber construction. The dam embankment is judged to be in a satisfactory and stable condition as only minor seepage was observed at the bottom of the backslopes. As previously stated, the major seepage is concentrated immediately behind the timber walls of the bridge.

Spillway outlet structure

As previously stated, it is recommended that the vehicular highway bridge be replaced in the near future.

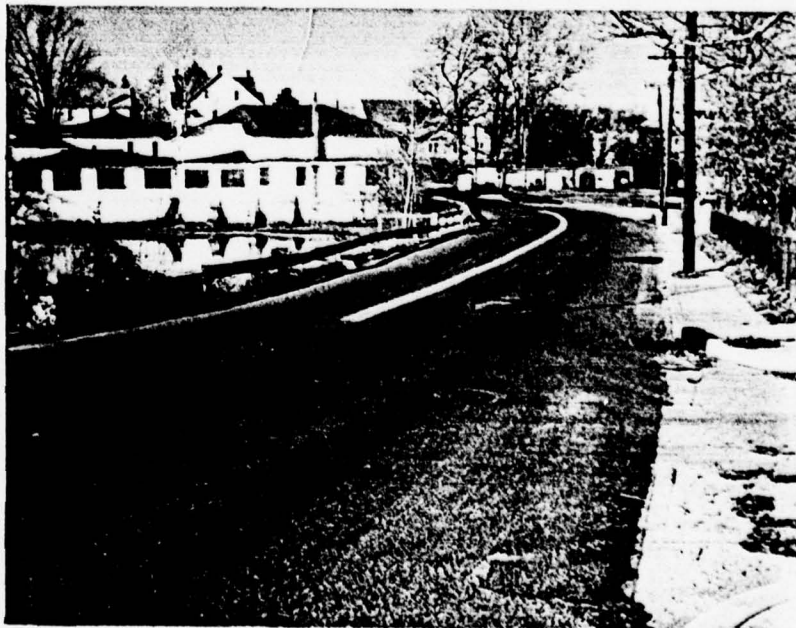
View West of Franklin St. across dam

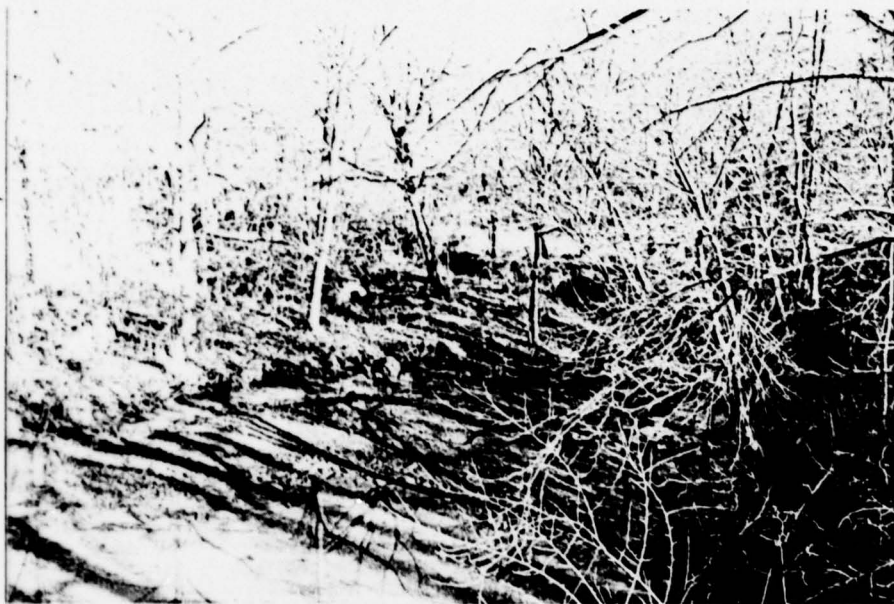
Downstream channel

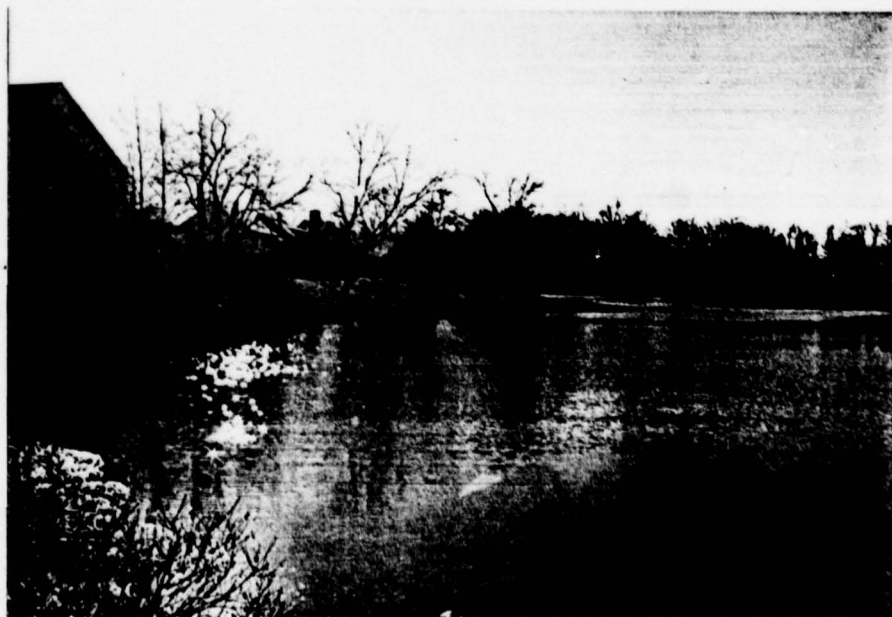
Lake Narraticon as seen from dam

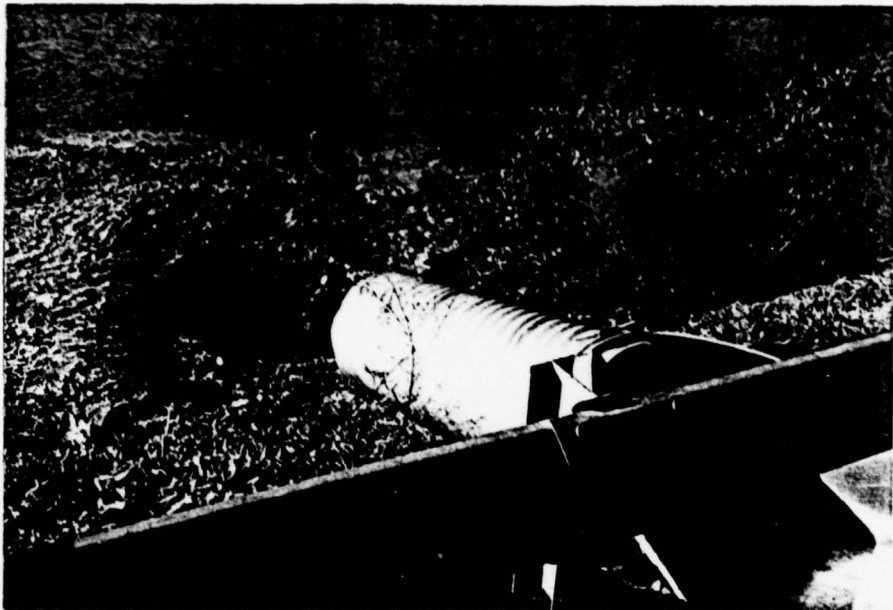
Roadway drain pipe

- The upstream slopes of the dam embankment should be regraded, compacted and protected, especially in the vicinity of the CMP curb drain.
- The trees should be removed from the dam slopes and the disturbed areas regraded, compacted and seeded.
- The deck planking on the walkway over the spillway should be replaced as it constitutes a potential danger to operating personnel.

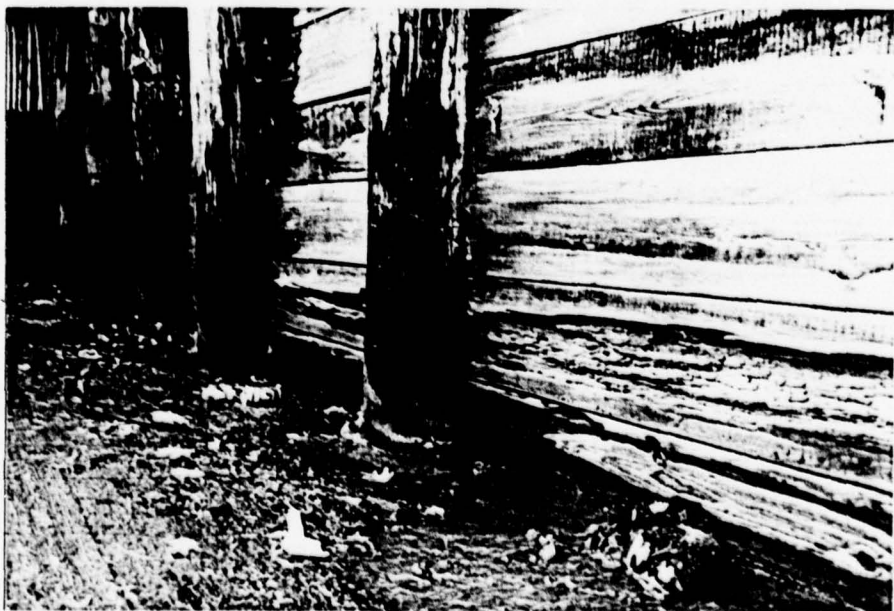
Rotted timber planking in spillway structure

(1) Replace the deteriorated timber planking of the walkway over the spillway.

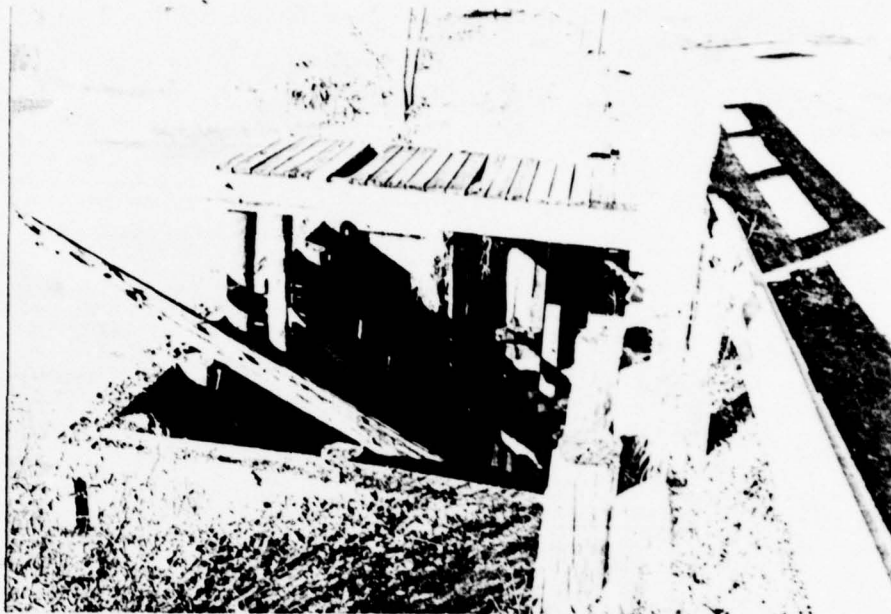
The timber bridge and spillway structure are in poor condition and exhibit advance stages of dry rot in numerous members. The superstructure carrying traffic over the ungated outlet opening has a span of 20 feet and is founded on timber piling. The 18 by 12 foot box inlet is framed and braced solidly and is in much better condition than the bridge structure. There was only minor evidence of leaking, rotting or splintering and the stoplogs in the 2'-3" removable section are equipped with lifting eyes and appear to be operable. A considerable amount of debris had collected in the drop inlet over the summer months but is of no concern to the inspection team. The downstream wingwalls and plank outfall apron beneath the bridge are in advanced stages of decay with the left bulkhead wall tilted inward several inches. The auxiliary culvert pipe near the right abutment is set at an elevation slightly below the main spillway and although functioning satisfactory, is completely deteriorated on the inlet end and has severe cracks in its concrete headwall. This culvert outlets into an ill-defined auxiliary power raceway which extends to an old abandoned mill site about 200 feet downstream.

Timber box spillway

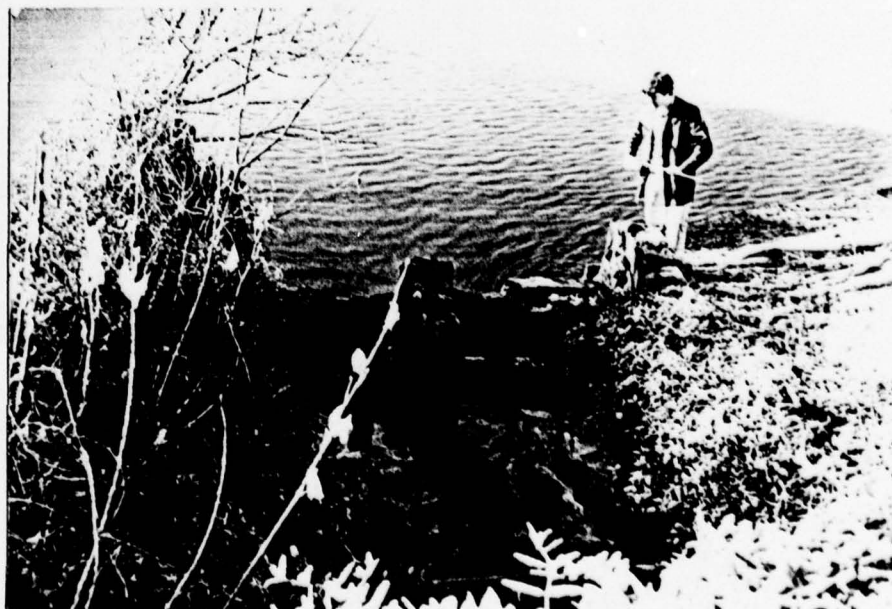
Auxillary spillway to old mill race
