ATLANTIC COAST BASIN  
FOUR MILE BRANCH MILL CREEK  
OCEAN COUNTY  
NEW JERSEY

# HOLIDAY LAKE DAM NJ 00061

## PHASE 1 INSPECTION REPORT NATIONAL DAM SAFETY PROGRAM

Philadelphia District  
Corps of Engineers  
Philadelphia, Pennsylvania

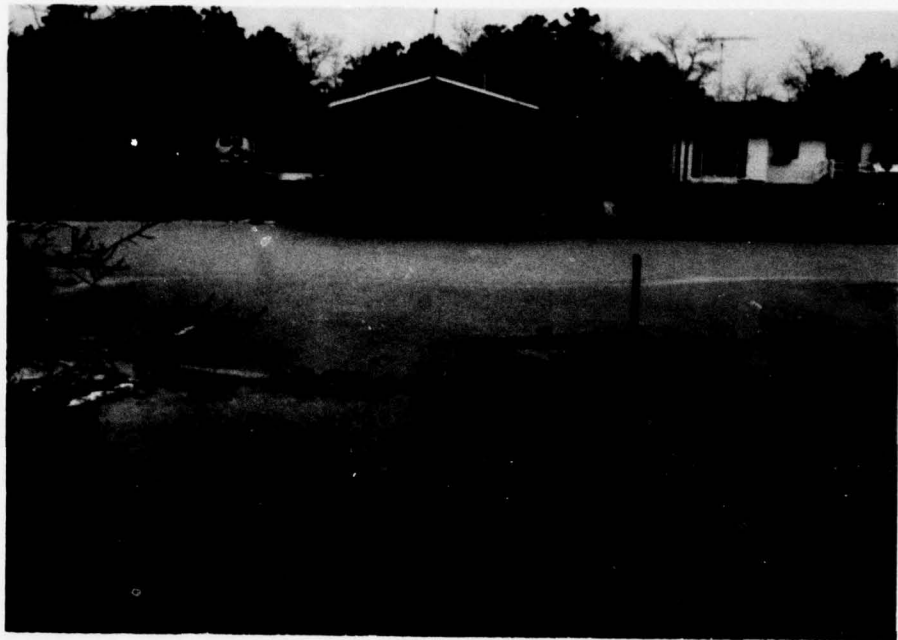
Most of the corrugated metal drop inlet spillway was covered, submerged or buried at the time of inspection and, therefore, could not be observed. The corrugated metal trash rack and anti-vortex cover appeared to be in good condition. However, much of the asphalt coating had peeled off of the surface and the metal had become somewhat rusted. The flared end section at the spillway discharge culvert outlet contains some rust but otherwise is in good condition.

PHOTO 1  
SPILLWAY STRUCTURE

2. The asphalt coating on the anti-vortex assembly should be renewed after rust is removed.
3. Erosion on the downstream embankment slope should be filled, compacted and sodded.
4. A suitable stand of grass should be established on the bare sections of the embankment.
5. Access to the dam by motor vehicles should be prevented by constructing barriers at each end of the embankment.
6. Riprap on the upstream face of the embankment should be renovated by the placement of additional stones.

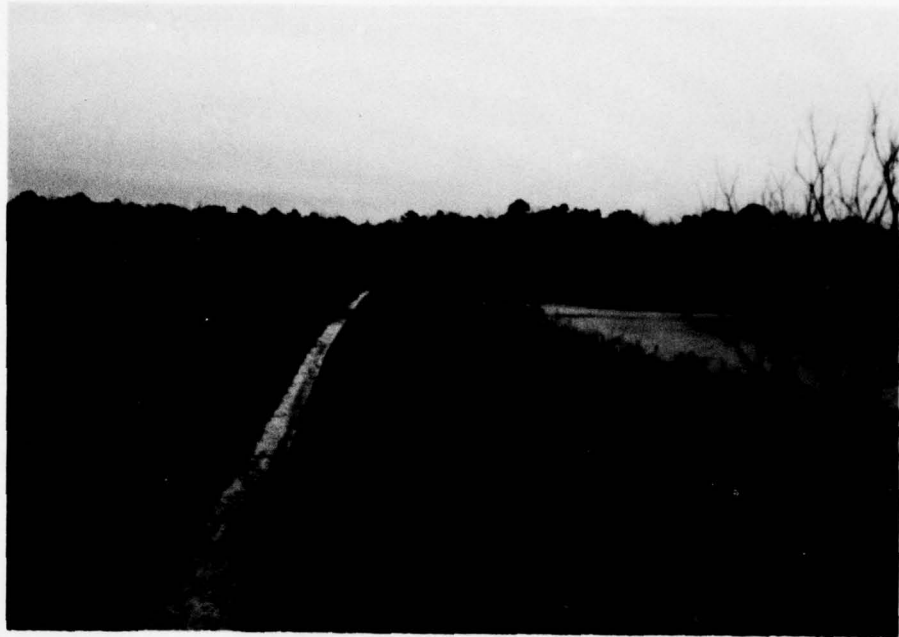
The dam embankment appeared to be uniformly aligned both vertically and horizontally with a good stand of grass covering most surfaces. A path located along the dam crest as well as some sections of the downstream slope lack grass cover. A few small trees were observed on the embankment. No evidence of cracking or settling was noted nor were any animal holes observed.

PHOTO 3  
CREST OF DAM.

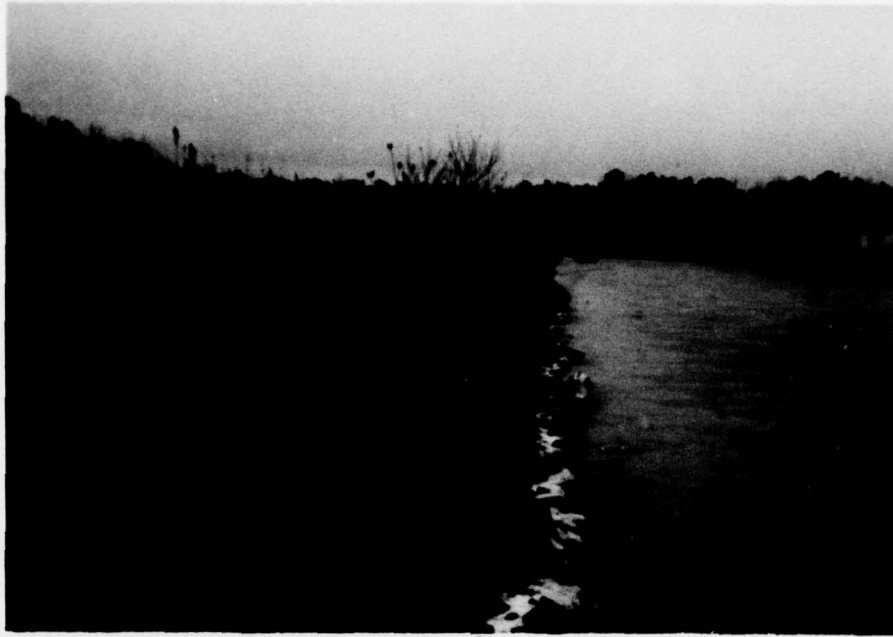
PHOTO 5

Riprap was noted along the entire length of the upstream face of embankment and around the concrete slab used as crest for the emergency spillway. The riprap appeared to be insufficient in quantity to provide adequate slope protection.

UPSTREAM FACE OF EMBANKMENT
