**SURVEYS OF GROOVES IN
19 BITUMINOUS RUNWAYS**

**Richard Melone
Naval Air Engineering Center
Lakehurst, N. J. 08733**

March 1979

Final Report

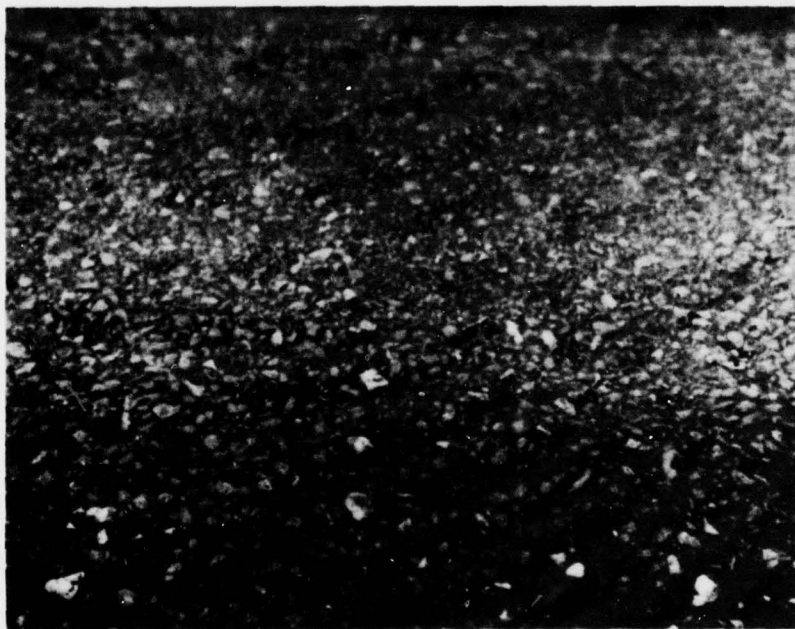
A. WEAR -- Groove depth measuring 1/8 inch or less (all were supposed to be 1/4 inch). (See Figure 1)

Figure 1 - Wear (Groove Depth of 1/8 Inch or Less) Identified During Runway Survey

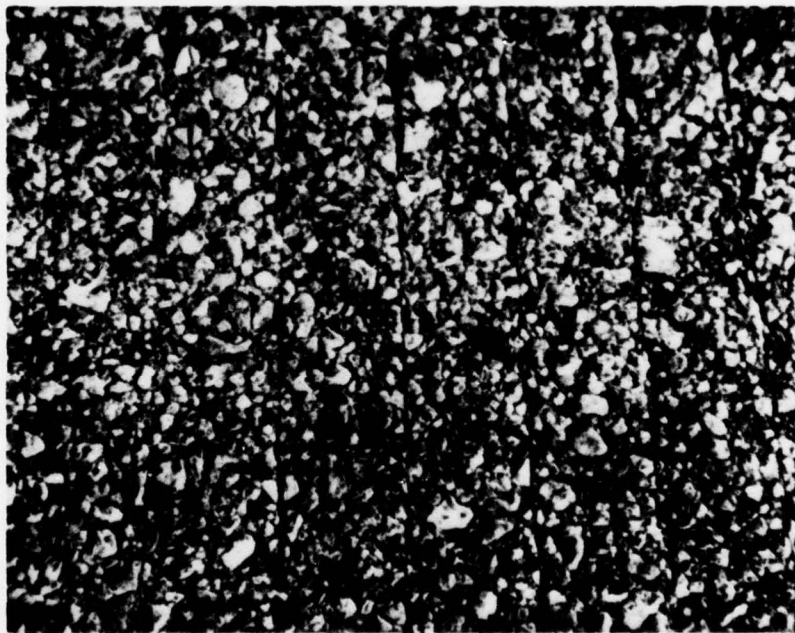
Figure 2 - Closing (Groove Width of 3/16 Inch or Less) Identified During Runway Survey

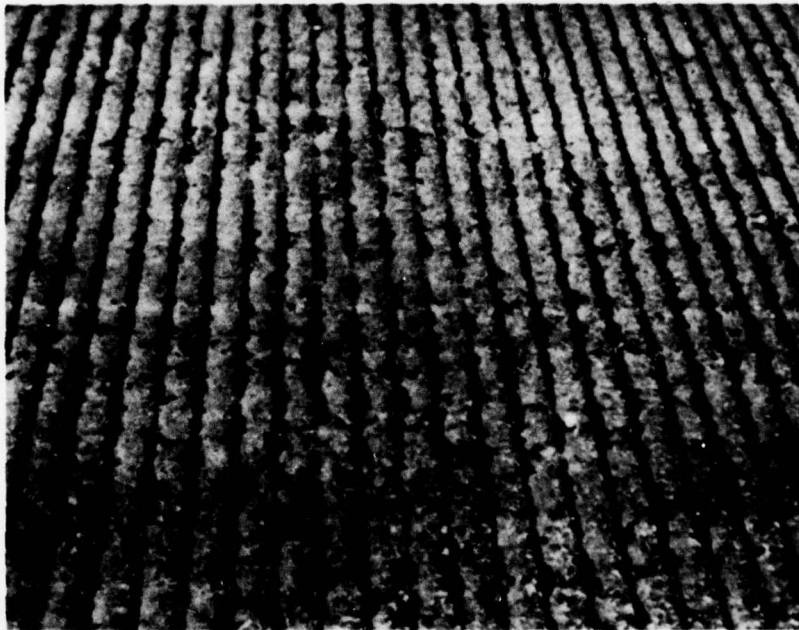
Figure 3 - Rubber Found in Grooves of Runway During Survey

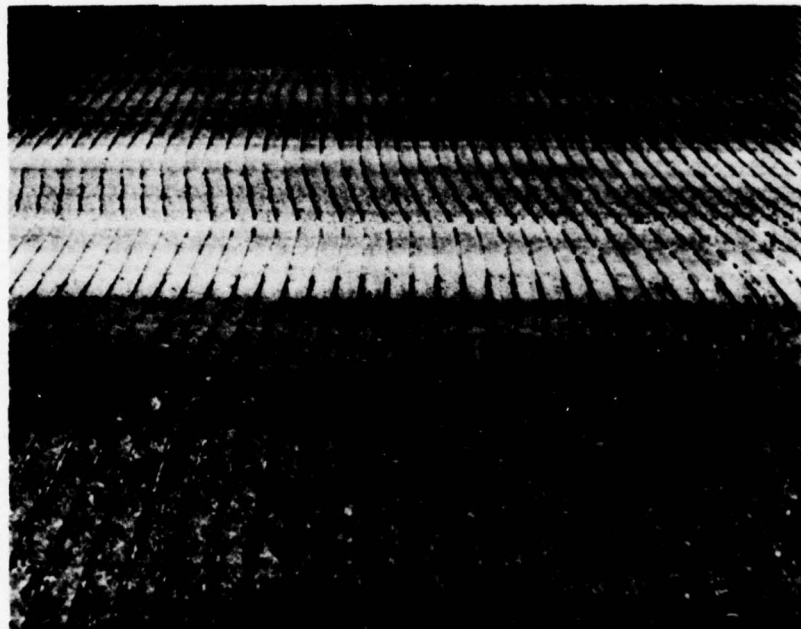
Figure 5 - Migrating Identified During Runway Survey

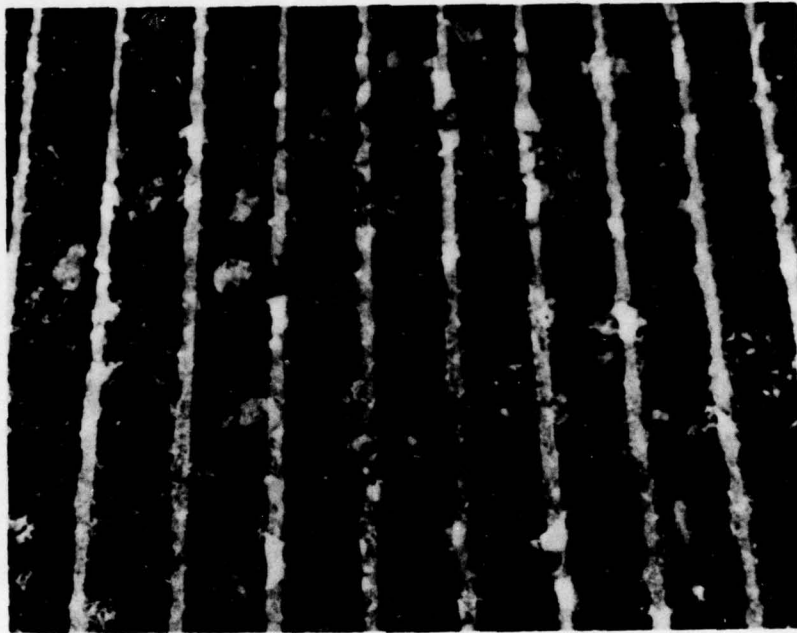
H. SPALLING -- Disintegration, breaking up of asphalt surface.
(See Figure 8)

Figure 8 - Spalling Identified During Runway Survey

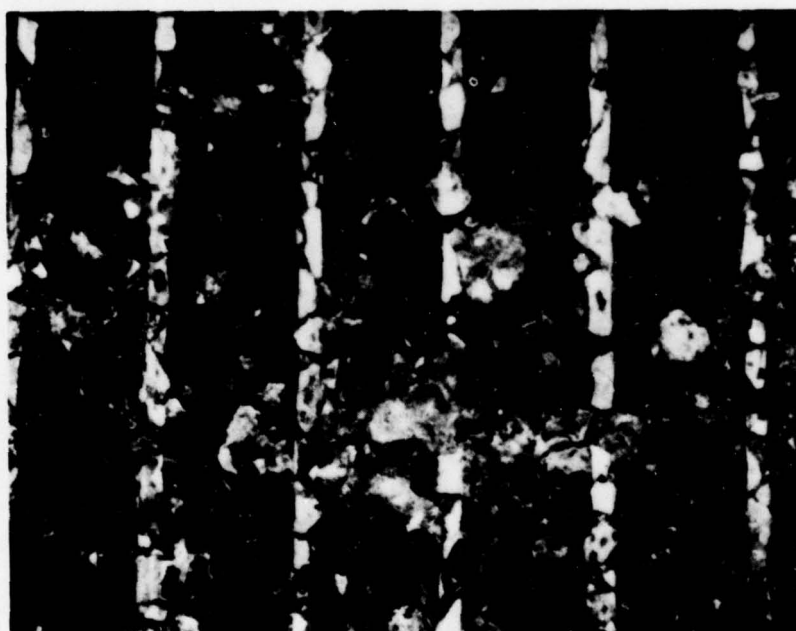
Figure 10 - Erosion Discovered on Runway During Survey

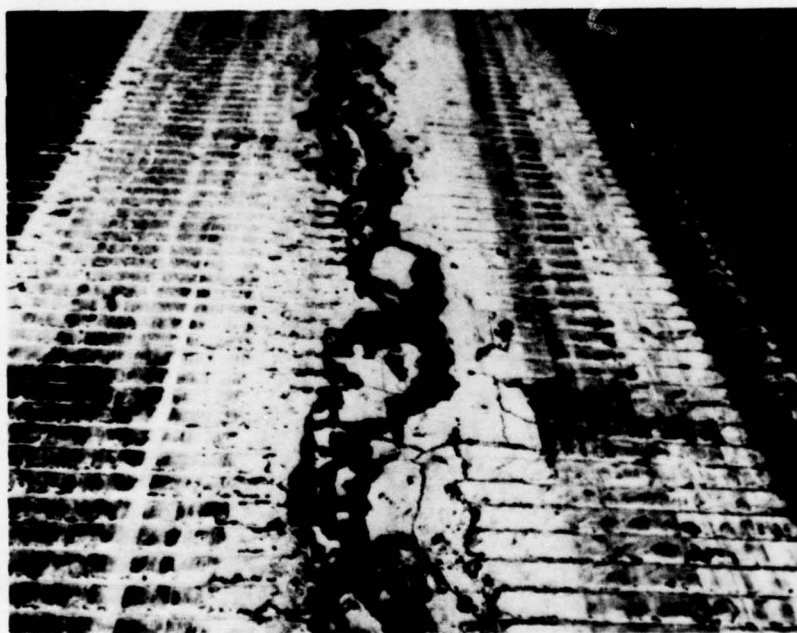
At several of the runways surveyed, extensive cracking along cold seams and/or along the centerline light wiring trough necessitated repairing the damaged areas with cold patch (see Figures 11 & 12). The patches were typically 10 to 20 feet from the centerline and ran parallel to the centerline for hundreds of feet. No regrooving was attempted where these patches were made. The portion of the existing grooves between the centerline and the patched areas cannot effectively drain. Some effort should be made to regroove these patched areas to match the existing pattern as closely as possible.

Figure 11 - Cold Seam Cracking Discovered During Runway Survey

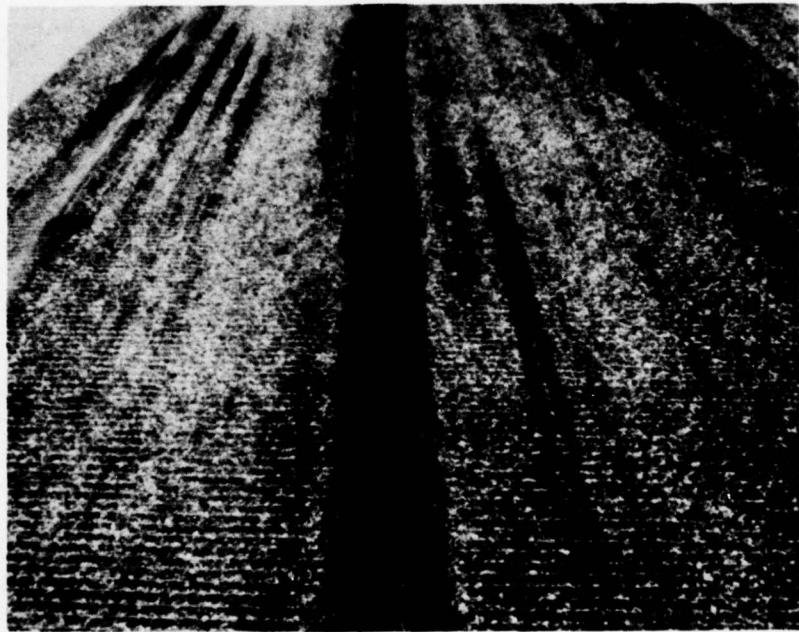
Figure 12 - Ungrooved Patch Discovered During Runway Survey
