**BASS LAKE DAM**

**NJ 00271**

**PHASE 1 INSPECTION REPORT  
NATIONAL DAM SAFETY PROGRAM**

May, 1979

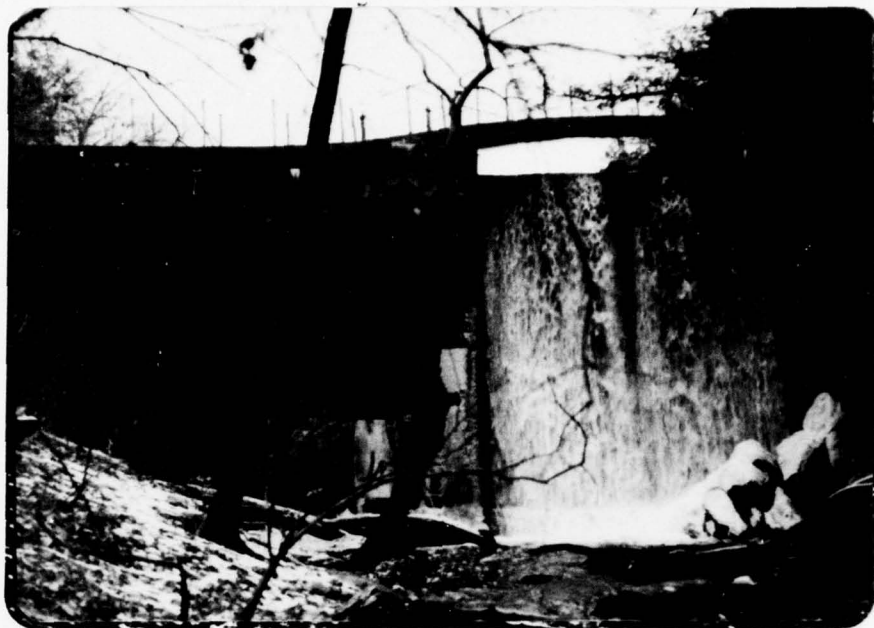
Downstream right face of  
dam and spillway. Looking  
upstream.

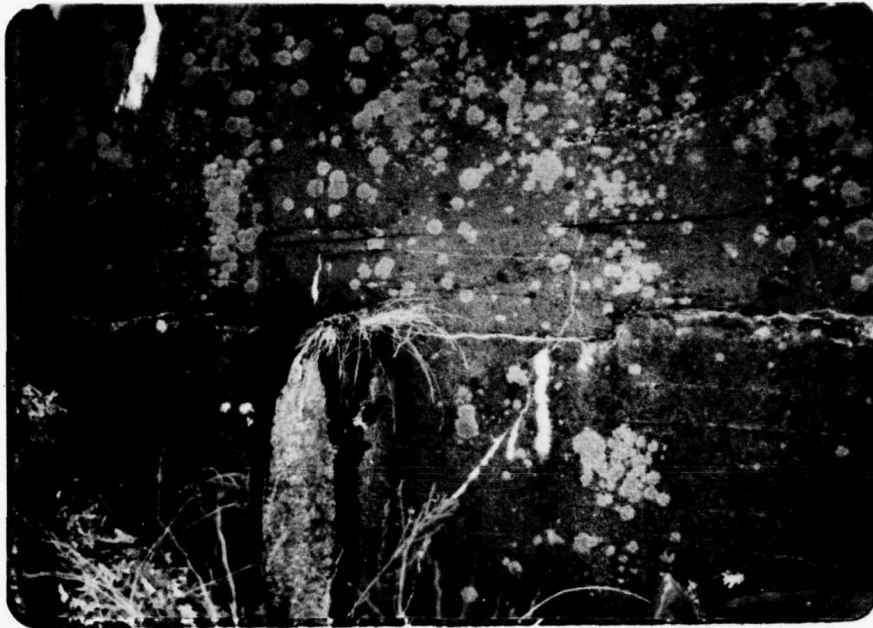
Water leaking through face  
of dam at right side of  
spillway.

1. Determine by means of borings and tests the engineering properties of the dam and foundation materials. This information should be used to determine the stability of the dam under different loading conditions and develop, if required, measures necessary to strengthen the dam. This should be done very soon.
2. Make sluice gate for 18 inch low level outlet functional. This should be done soon.
3. Repair spalled and deteriorated concrete and completely plug leaks through the dam. This should be done soon.

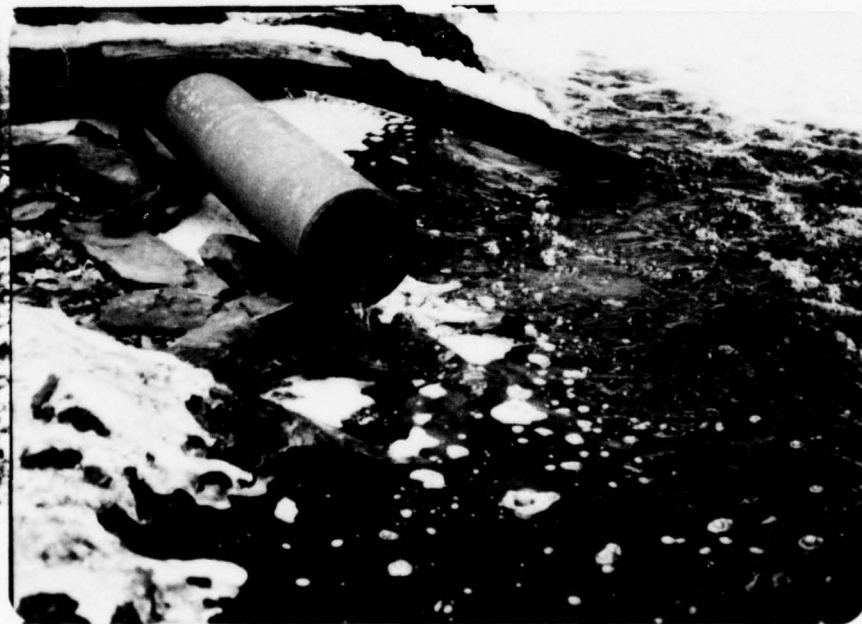
12-in-dia outlet pipe.  
Outlet pipe is below tail  
water.

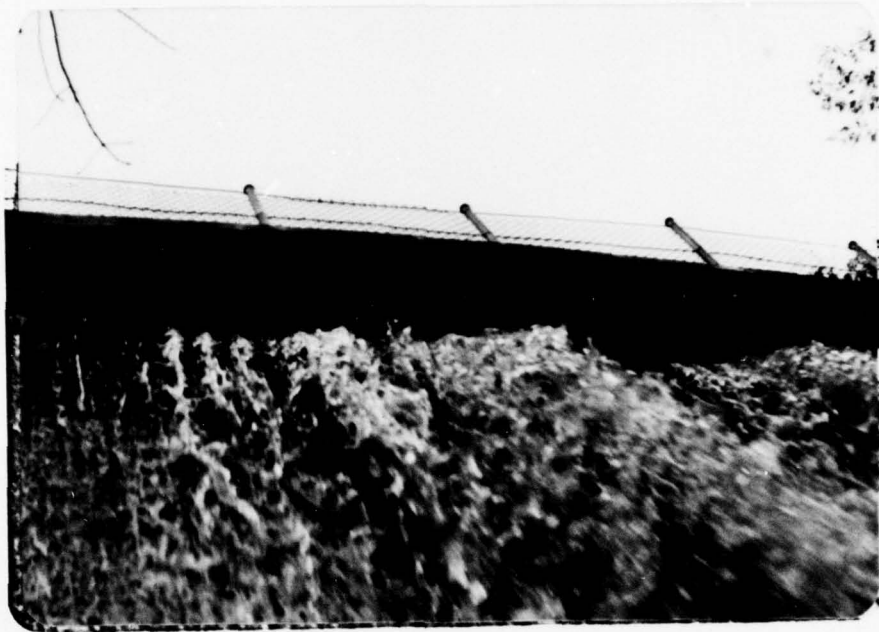
Spillway crest below foot  
bridge.

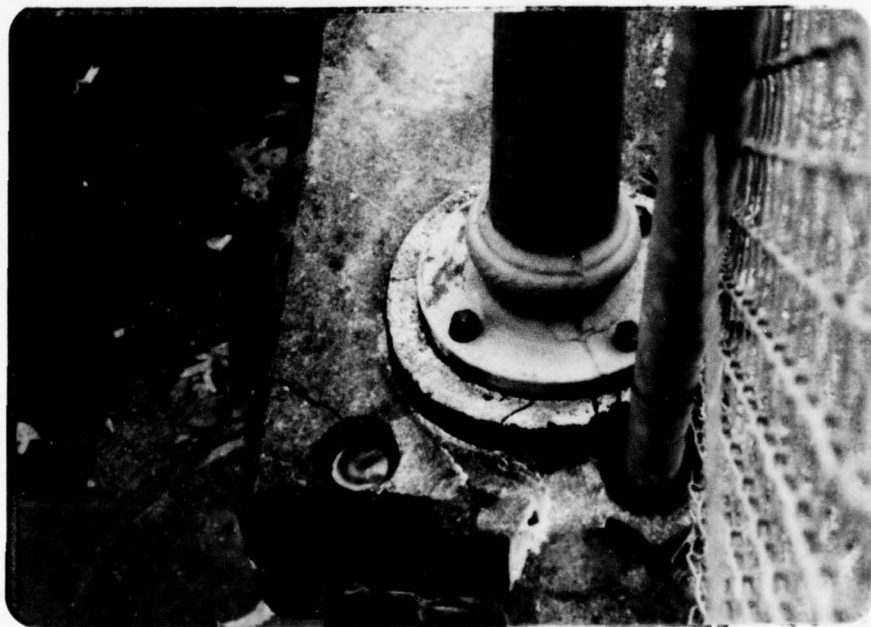
The gates for the 12-inch and 18-inch outlet pipes, which are located at the base of the upstream side of the dam, are operated by two control stems which extend up to the top of the dam. All gates were known to be closed at the time of our inspection. Yet, a small quantity of water was observed discharging from the 12-inch-dia pipe. The superintendent did not know whether or not the gates could be closed once they were opened, consequently, they were not operated. The concrete headwall for the two outlet pipes has deteriorated badly. Concrete support for the gate operators has cracked.

Concrete cracked under  
gate valve operator.

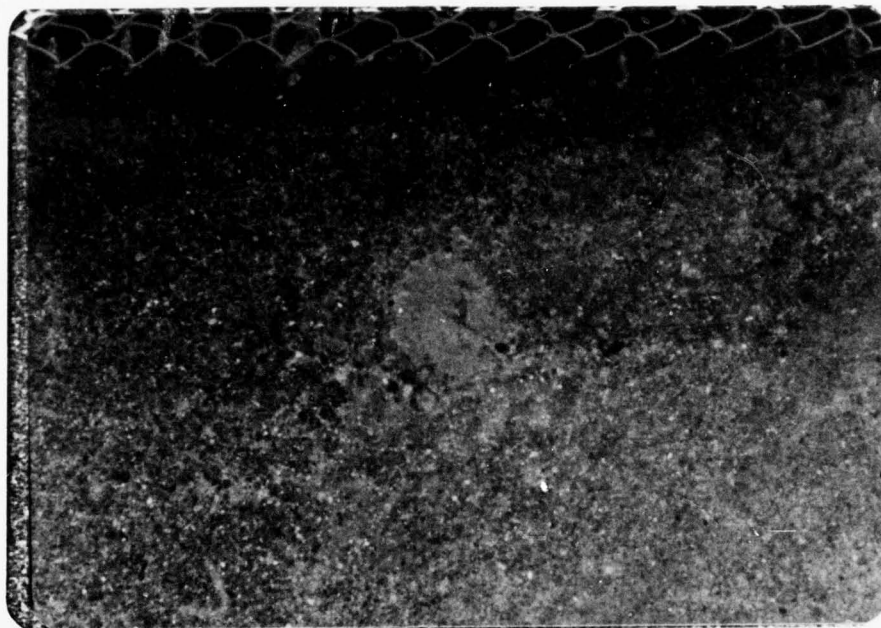
Patched grout hole at top  
of dam.

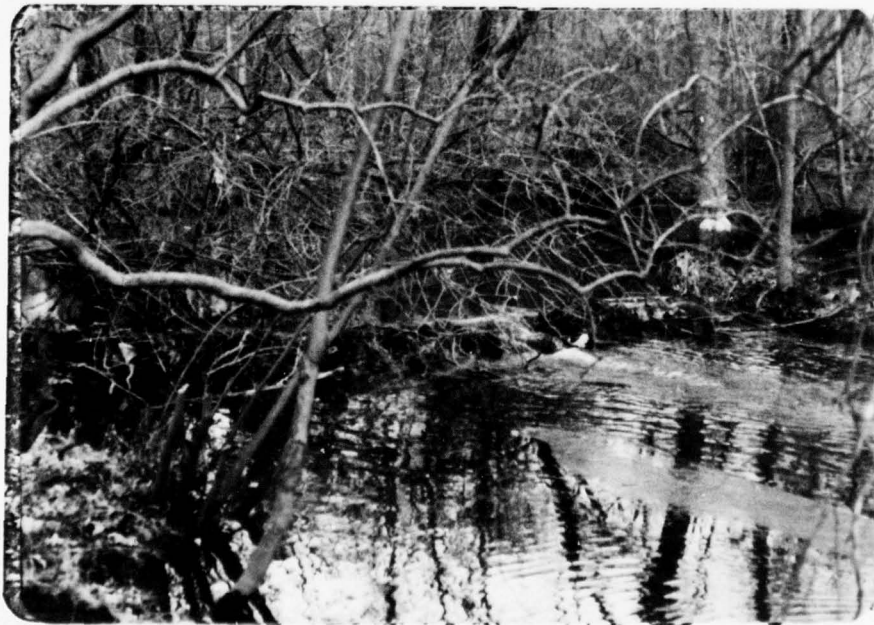
Beaver dams upstream of  
inlet stream to Lake.

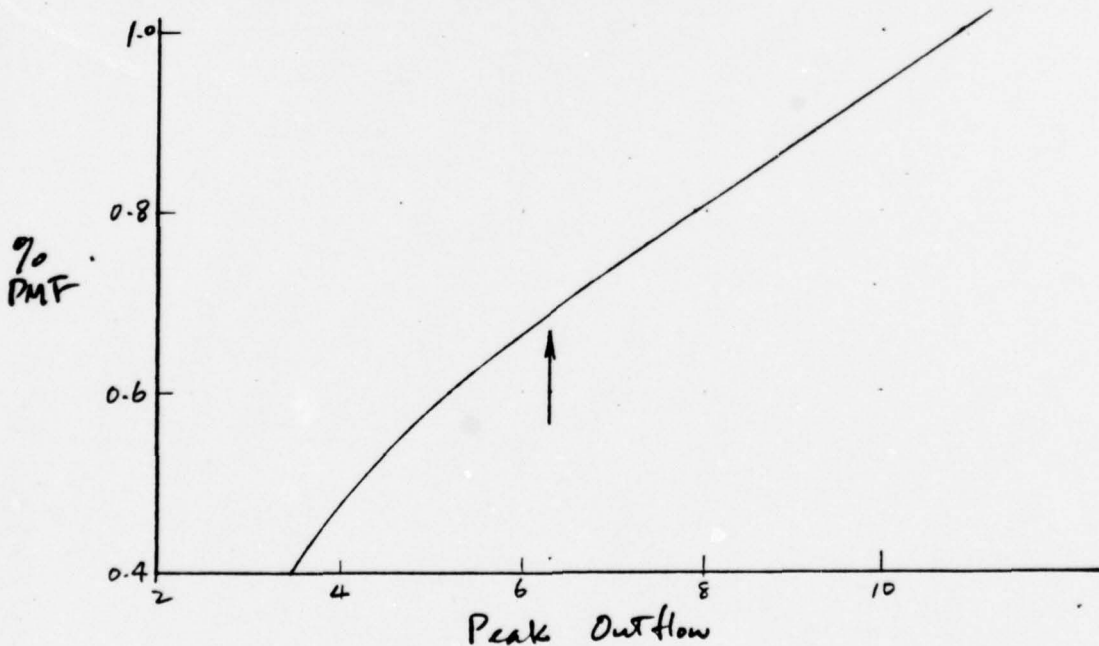
3. Dam overtops at approx. El. 101.1 with  $Q = 63$  cfs  
 $\therefore$  dam can pass approx. 0.7 % of PMF.
