**WESTON MILLS
POND DAM
NJ 00164**

**PHASE 1 INSPECTION REPORT
NATIONAL DAM SAFETY PROGRAM**

PHASE I REPORT
NATIONAL DAM INSPECTION PROGRAM

Name of Dam Westons Mills Pond Dam Fed ID# NJ 00164,
NJ ID# 25-3

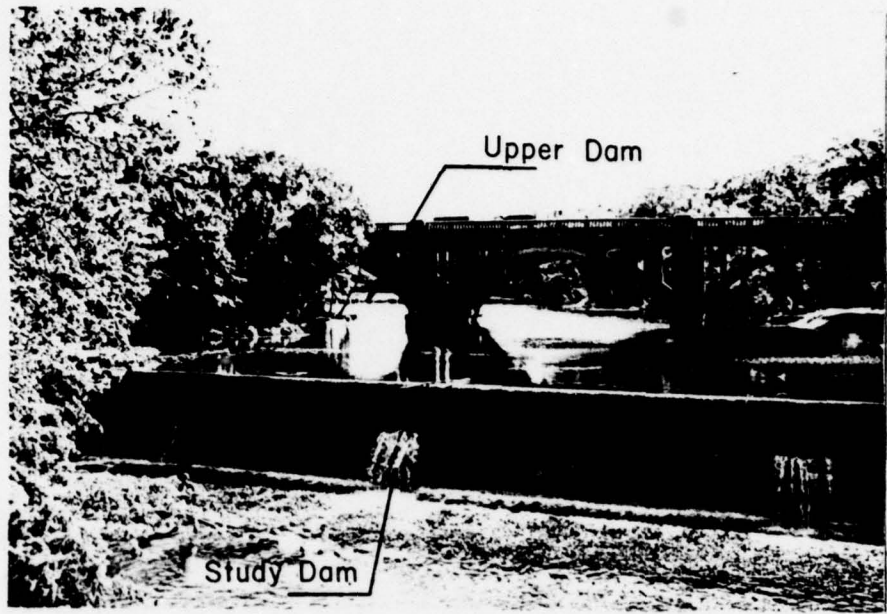
Downstream view of dam

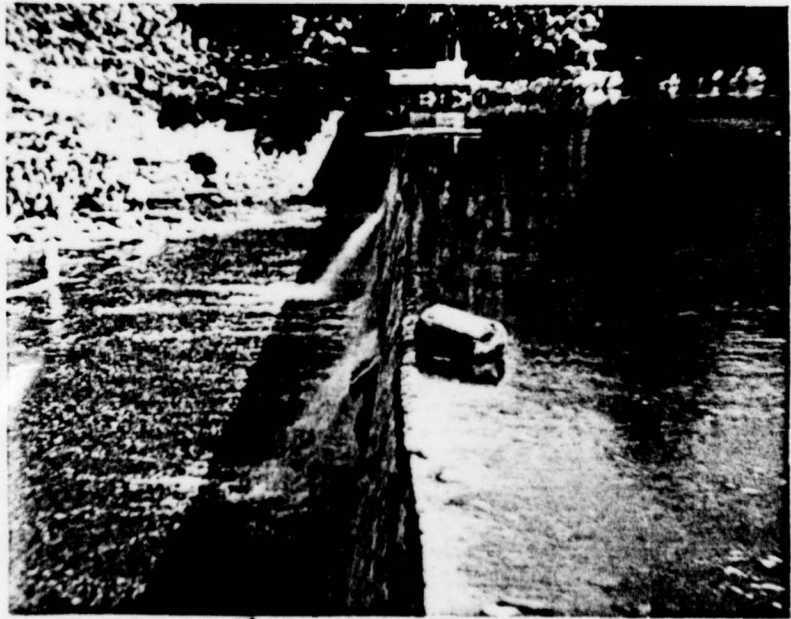
View of dam crest from west abutment

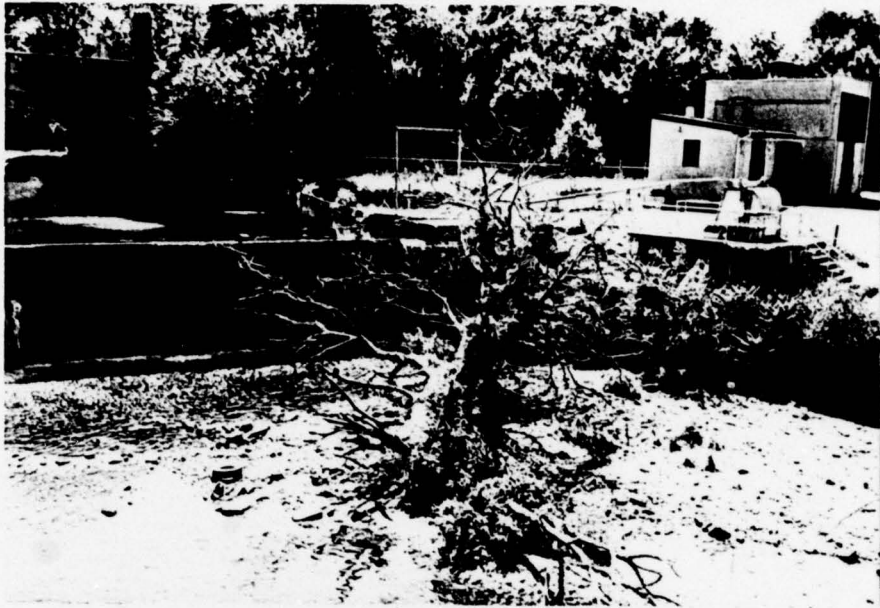
Downstream view of west abutment

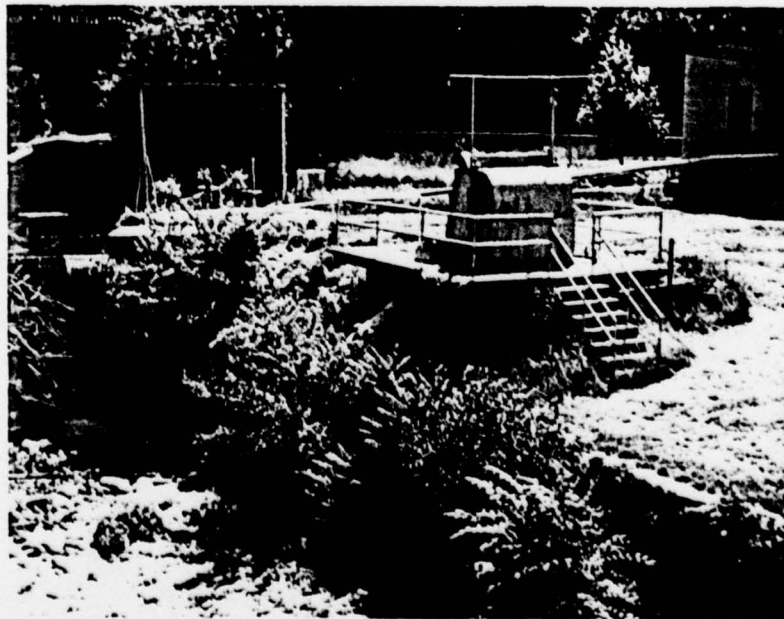
View of intake structure

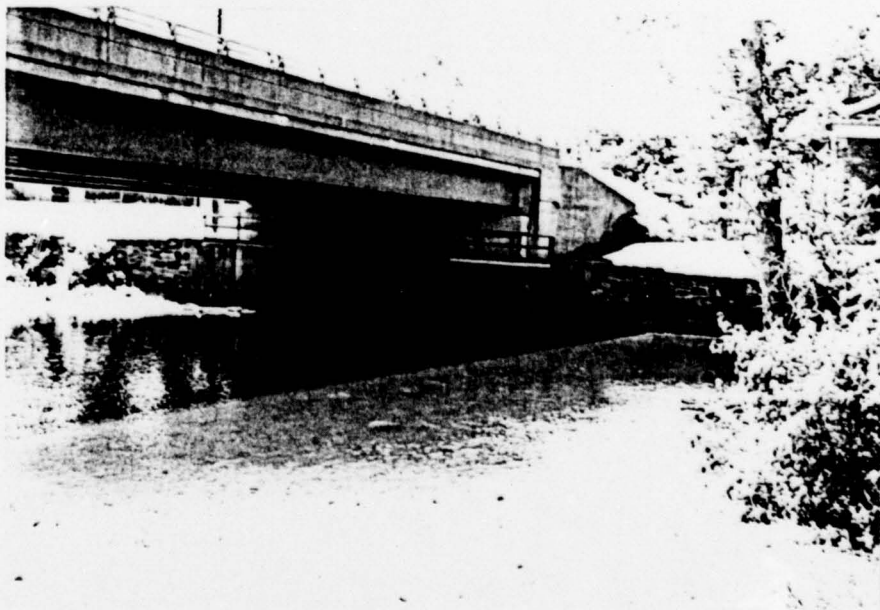
The downstream channel immediately below the dam is somewhat restricted by the Burnet Street bridge when periods of heavy rain coincide with maximum high tide. This bridge is approximately 104 feet downstream, has a span of 102 feet, a clear headroom in excess of 15 feet

Burnet Street bridge 104' downstream from dam
