**CLEMENTON LAKE**

**NJ 00410**

**PHASE 1 INSPECTION REPORT  
NATIONAL DAM SAFETY PROGRAM**

May, 1979

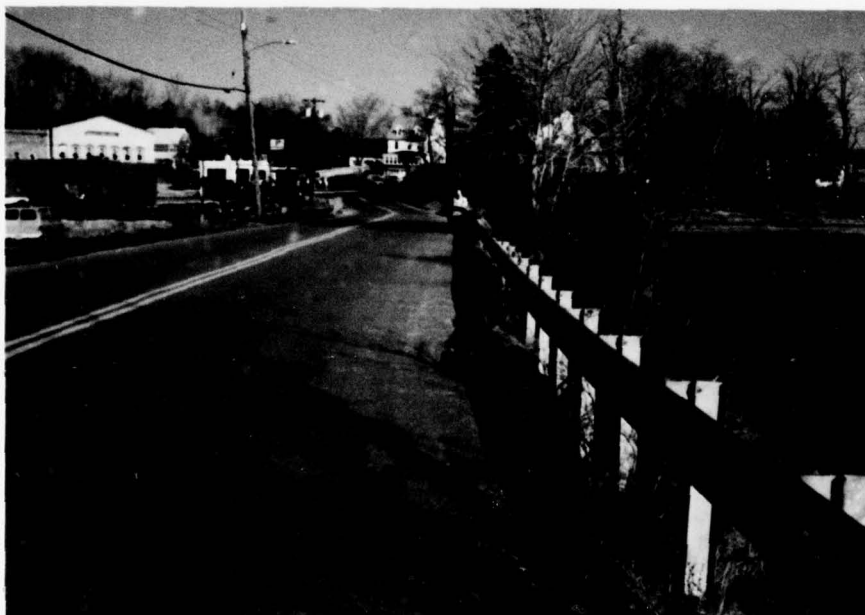
PHOTO 8

upstream slope of the embankment. The sheets had apparently rusted through at the normal water level. There was no evidence of riprap protection along the upstream slope as had been recommended in the 1974 dam inspection report and the slope was still in need of stabilization. Longitudinal cracks were noted in the bituminous roadway pavement on the upstream edge of the dam crest. Areas were observed where pavement had been undermined and broken away at the upstream edge. This damage was apparently due to poor road drainage and perhaps wave action.

PAVED ROAD ON CREST OF DAM

(2) Repair eroded areas and the broken and cracked roadway pavement on the upstream slope of the dam. Riprap should be placed along this slope to protect it against wave attack and drainage induced erosion.
