PASSAIC RIVER BASIN
WANAQUE RIVER, PASSAIC COUNTY
NEW JERSEY

LAKE INEZ DAM
NJ 00228

PHASE 1 INSPECTION REPORT
NATIONAL DAM SAFETY PROGRAM

May, 1979

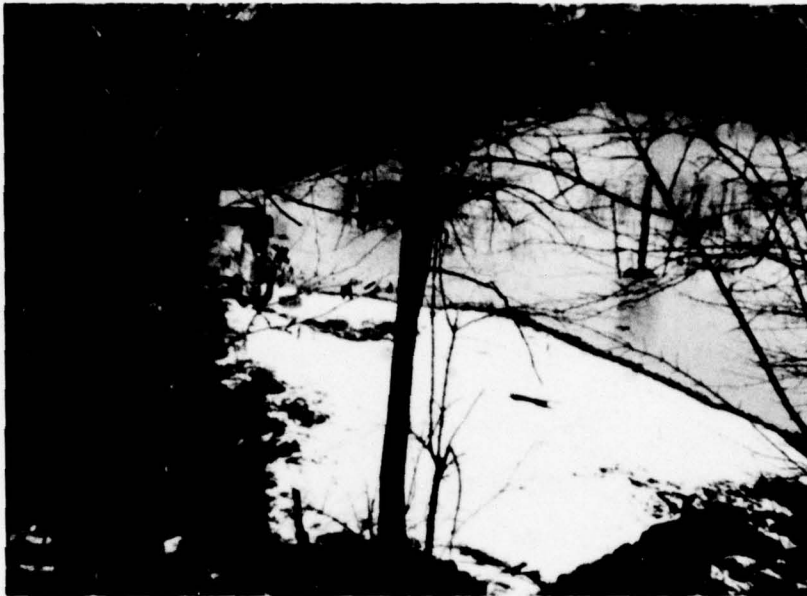
The left side of the dam is founded on rock and a deposit of soil has formed a beach on the upstream side at the left abutment. (Photo 1)

Photo 1
View of left abutment of dam looking west

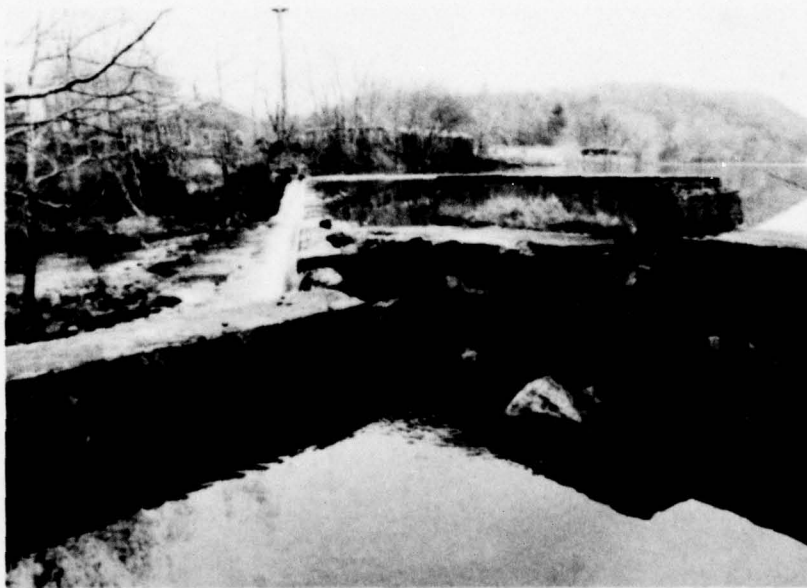
Severe cracking and separation between the concrete cap and masonry were observed at the junction of the left side of the spillway and the dam (Photo 2). Water from the reservoir is leaking through these cracks at an estimated rate of 5 gpm, forming a pond 6 to 12 inches deep. (Plate 2). There is a notch in the left side of the dam approximately 2 feet deep and 6 feet long which may have been associated with the penstock which appears to pass beneath the dam at this location.

Photo 2
View of left spillway abutment looking west

(3) The cracks adjacent to the left spillway abutment should be repaired to eliminate the leakage.

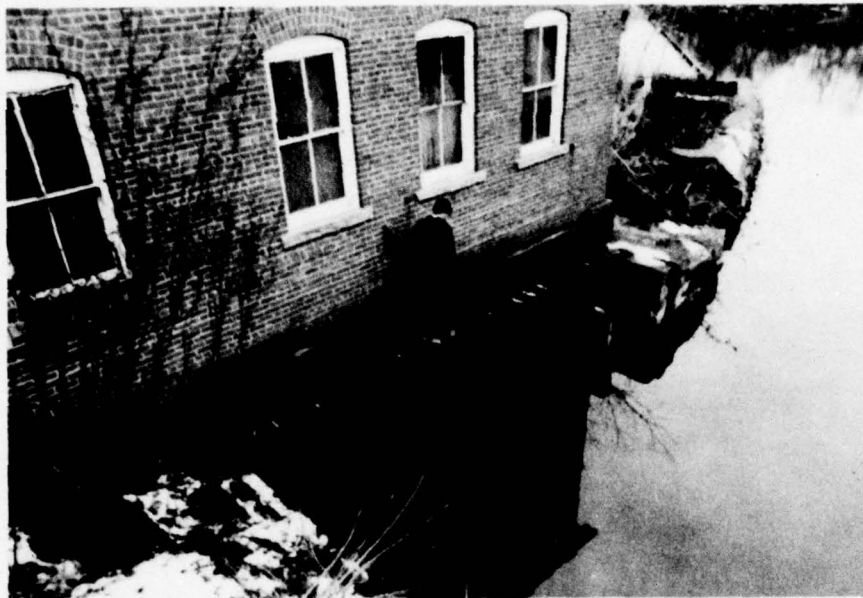
At the right abutment, the foundation of a mill building acts as part of the dam (Photo 3). A raceway which originally passed through the mill has been sealed with concrete bricks. The rubble masonry foundation of this building on the downstream side has been severely eroded (Photo 4). The erosion is most severe on the east side adjacent to the sluiceway and particularly at the downstream corner of the building. A minor amount of seepage through the foundation of this building was also observed.

Photo 3
View of mill at right
abutment of dam looking east

(2) The foundation of the mill should be repaired and seepage through the foundation should be sealed off.

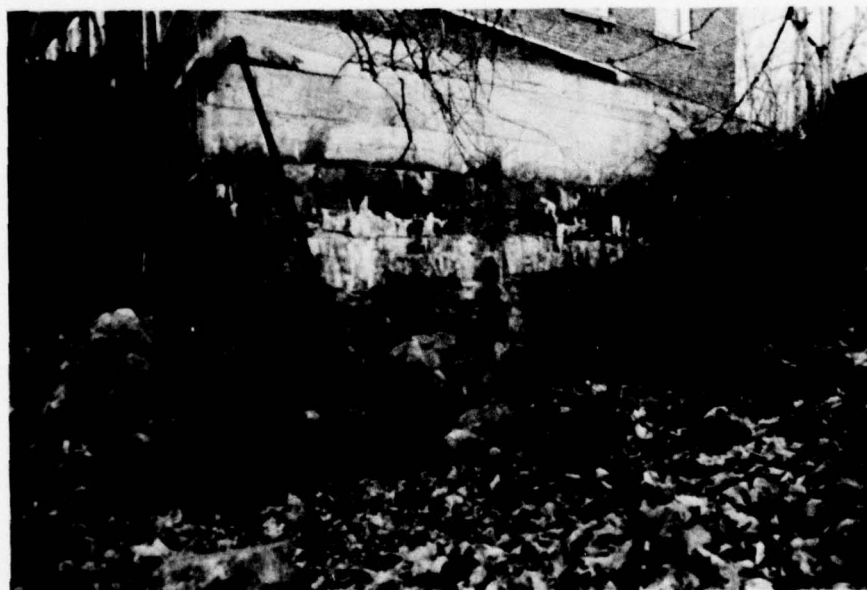
Photo 4
View of mill foundation
looking west with sluiceway in foreground

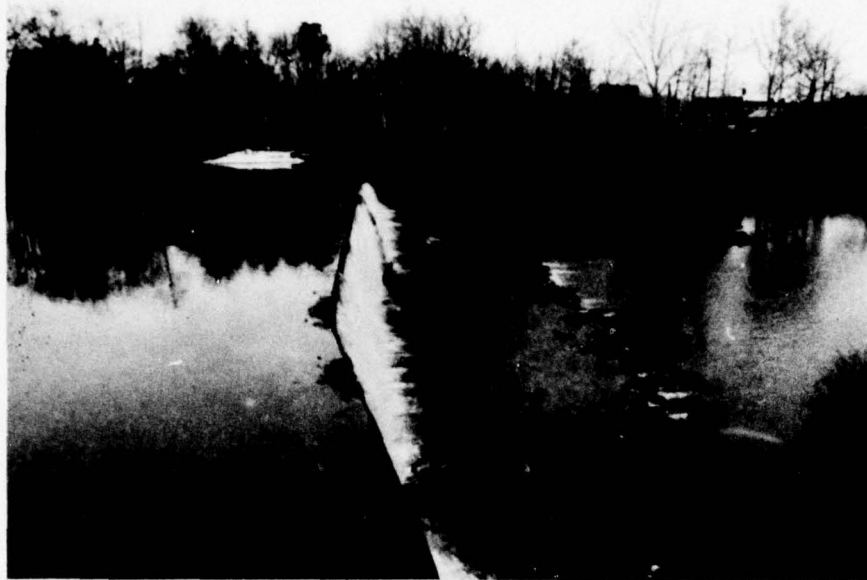
The ashlar masonry spillway structure has a concrete cap approximately 5 feet wide. This cap is generally set upstream of the masonry face except along a section approximately 25 feet long adjacent to the left abutment. This offset in the position of the spillway crest is shown in Photo 6 and is made most obvious by the different characteristics of flow over the spillway. Water flowing over the spillway obscured this structure so that the offset in the spillway crest and the face of the spillway could not be closely observed.

Photo 5
View along spillway crest
looking towards left abutment

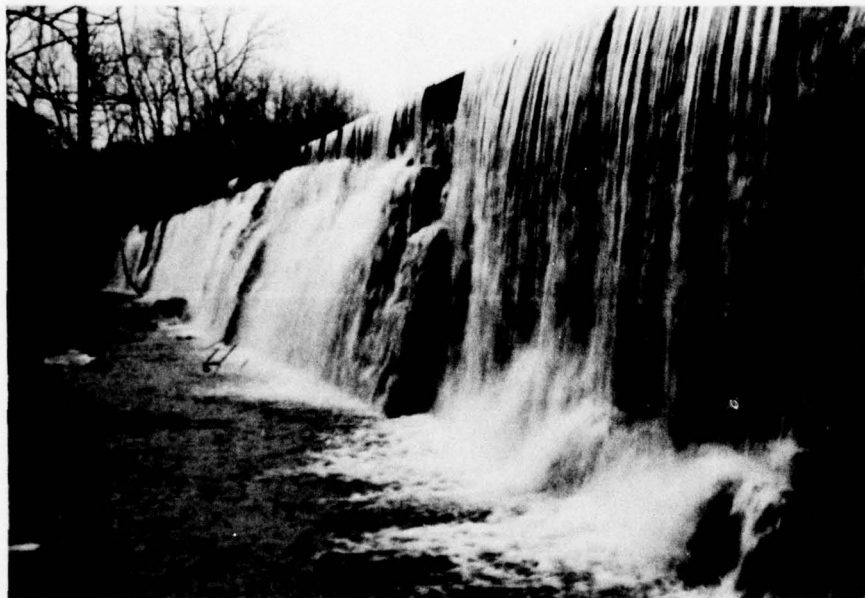
A concrete apron extends 10 to 15 feet downstream from the dam. (Photos 5 through 7) The foundation of the spillway and apron were submerged and therefore could not be observed.

Photo 6
View of spillway face
looking west from left abutment

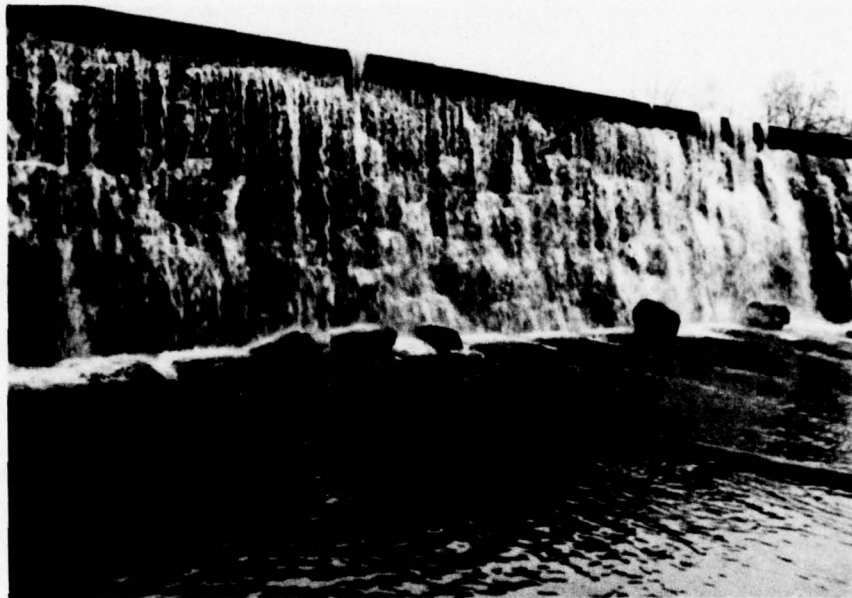
Five loose stones, similar to those that comprise the downstream face of the spillway structure, are lying on the spillway apron (Photo 7). However, due to the flow of water over the spillway, it could not be determined if these stones were dislodged from the spillway.

Photo 7
View of spillway face
showing loose stones on apron

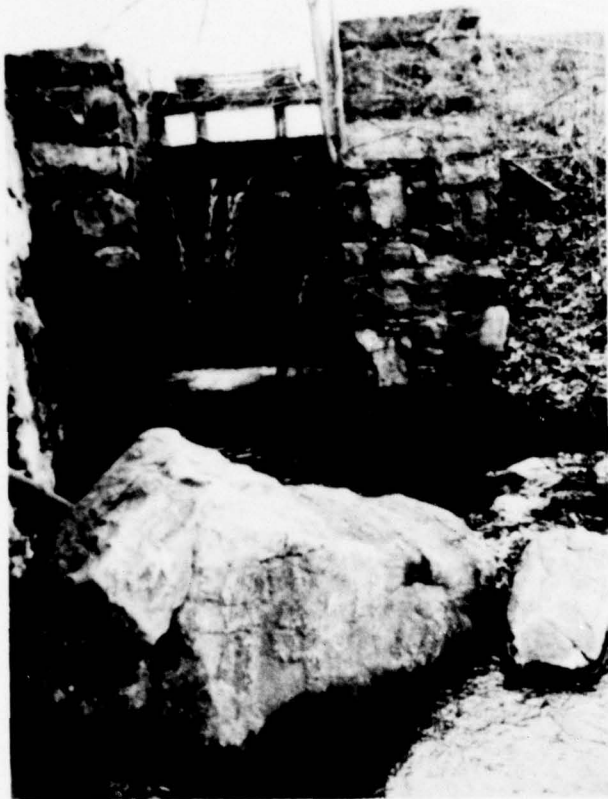
A 9.4-foot wide sluice gate consisting of 4-inch by 8-inch boards is located to the left of the mill at the right side of the dam. The gate controls are inoperable and there is serious leakage between the boards (Photo 9). A small tree growing in the masonry wall adjacent to the sluice is shown in Photo 9. The discharge from the sluice flows adjacent to the old mill and joins the main channel downstream as shown in Plate 2.

Photo 9
View of sluice gate
looking upstream

(1) The present wooden sluice gate should be replaced by a suitable means of control which can be operated from the dam crest.

(6) The trees adjacent to the sluice gate should be removed and the area restored in order to prevent root damage.

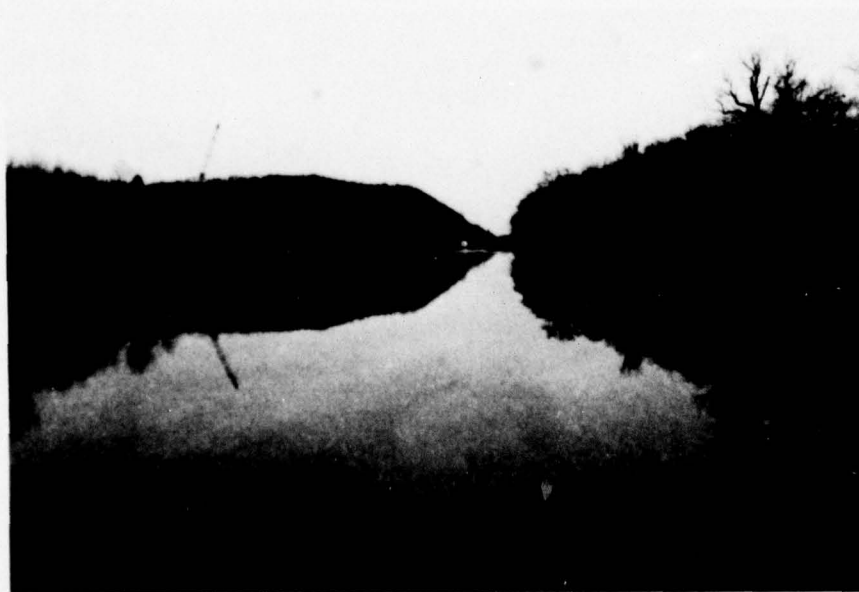
Photo 10
View of reservoir looking upstream from dam

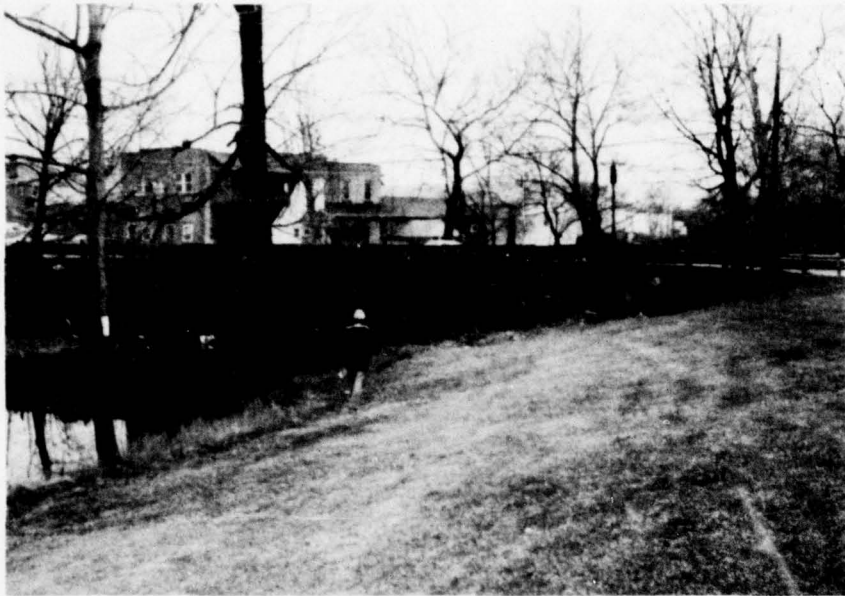
Photo 11
View of road bridge and
Borough of Pompton Lakes downstream from dam

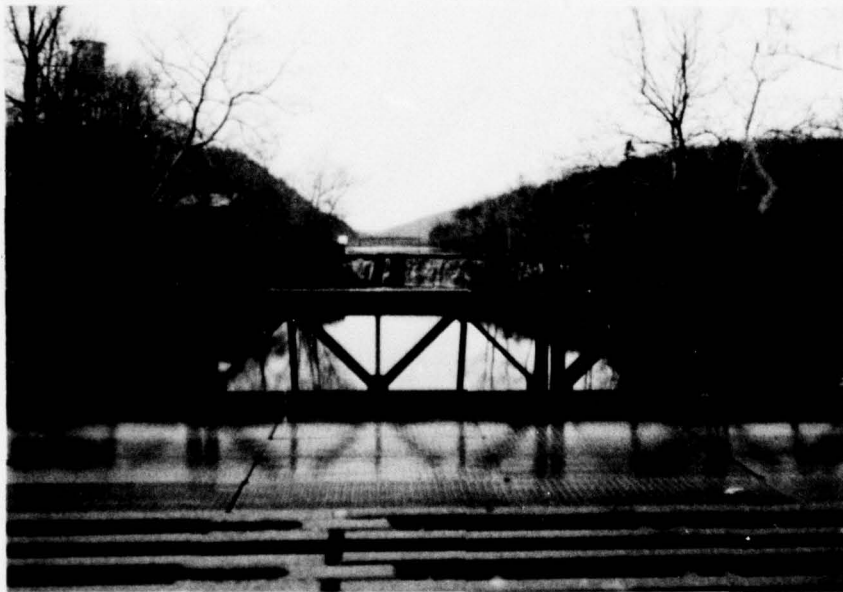
Photo 12
View of dam looking
upstream from bridge shown in Photo 11
