RARITAN RIVER BASIN
RAHWAY RIVER, UNION COUNTY
NEW JERSEY

BLOODGOODS POND DAM NJ 00370

PHASE 1 INSPECTION REPORT NATIONAL DAM SAFETY PROGRAM

March, 1979

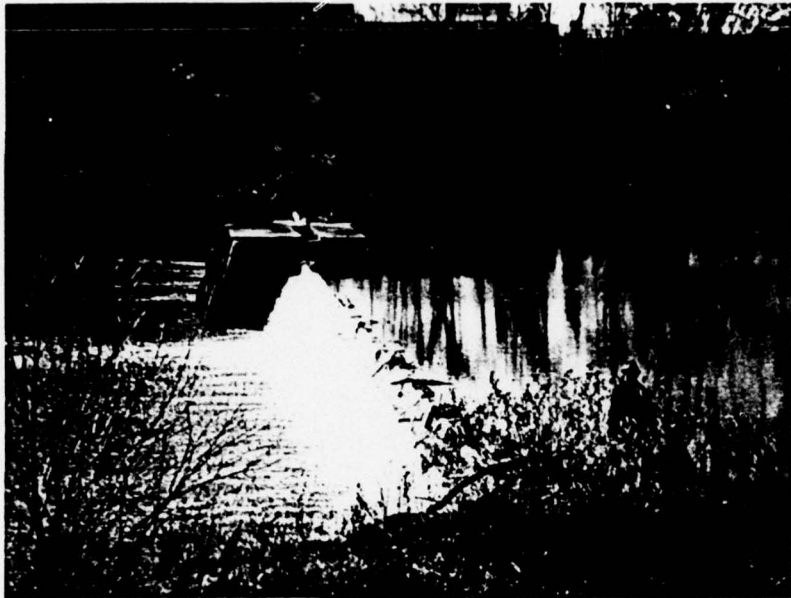
View of crest from east abutment

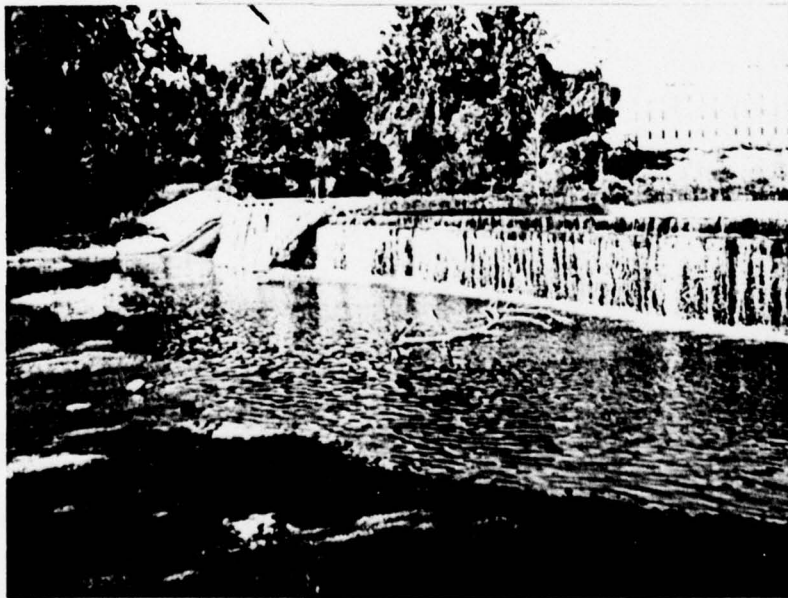
Downstream view of dam

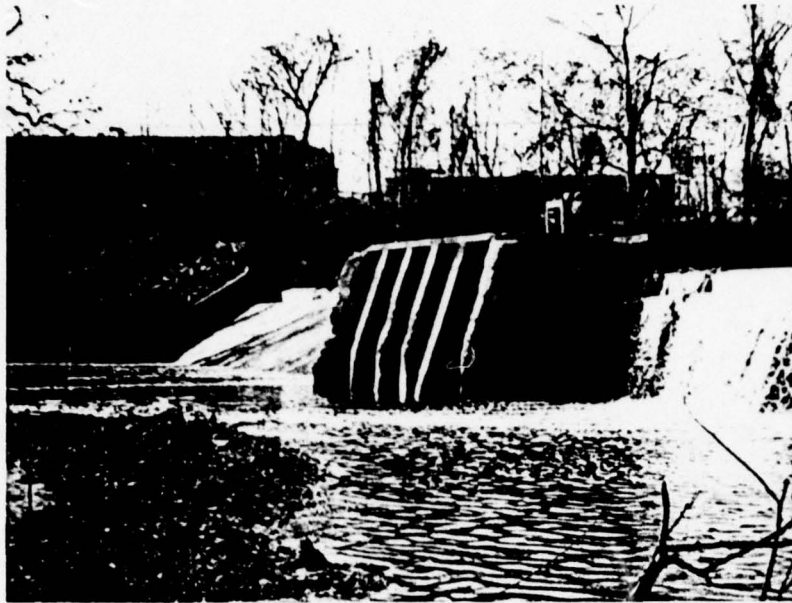
The only operable facility at Bloodgoods Pond Dam is the five-celled flood-gate structure whose inner walls, sluice gate, timber stop logs, and guides were all refurbished in 1972. However, the sluice gate is reportedly inoperable at the present time. The flashboards on both spillways were replaced in 1972 and appear in good condition although they are sealed in and it is doubtful that they could be removed.

View of floodgate structure

All disintegrated concrete at the left wingwall, flood-gate structure, and along the slab and buttress spillway should be repaired and/or replaced where deemed necessary. Further, a rapid and safe method of gaining access to the flood-gate structure should be provided, preferably by means of a catwalk. The inoperable 30" \emptyset sluice gate should be repaired or replaced.

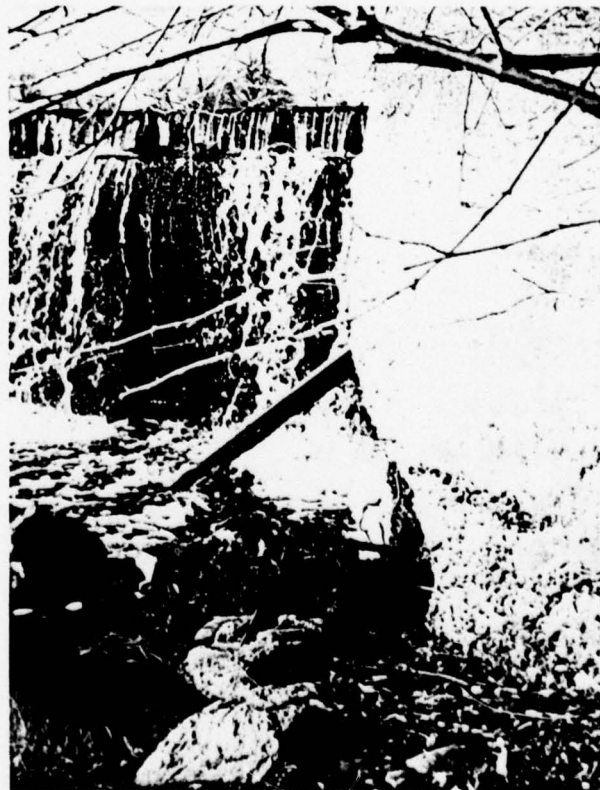
The original 158 foot section of concrete spillway and the left abutting wingwall also exhibited signs of advanced deterioration and cracking. The wingwall concrete is extensively eroded at the base and the reinforcement is exposed and corroded (see photos). The downstream edges of the top apron slab and the buttress wall are cracked and spalled. A close inspection of this area was prevented by the continuous discharge over the spillway.

View of east wingwall

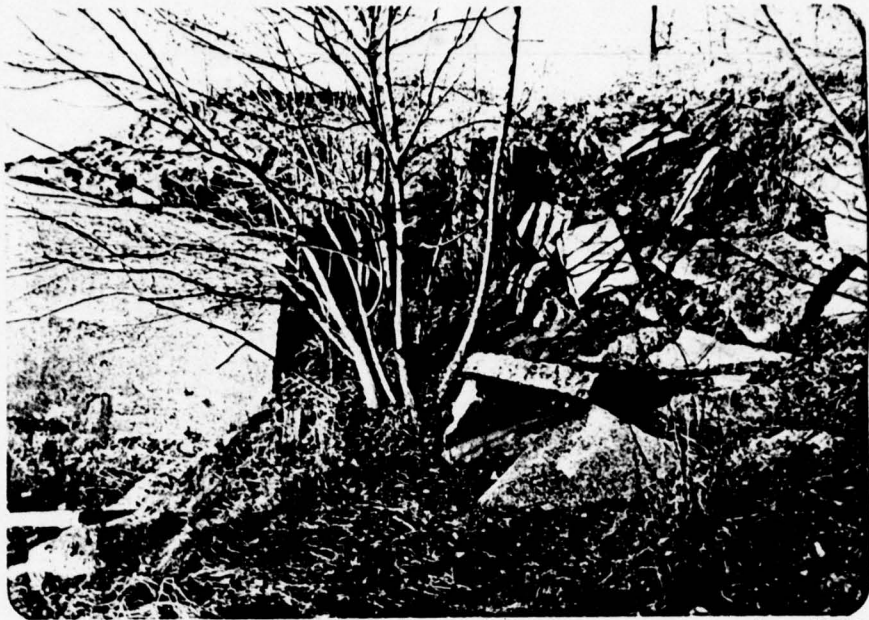
View of left embankment

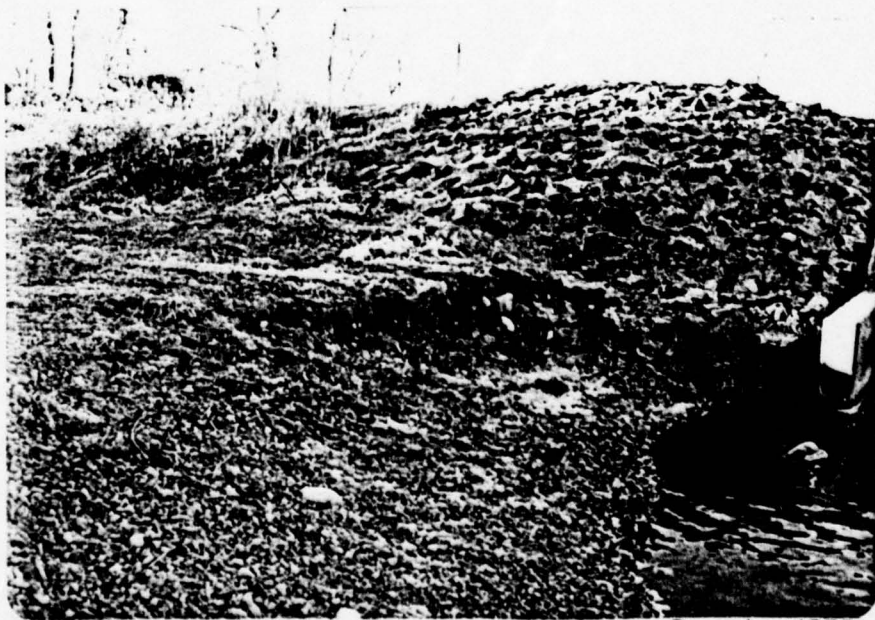
View of right embankment
