**SKYLINE LAKE**

**DAM NO. 1**

**NJ00203**

**PHASE 1 INSPECTION REPORT  
NATIONAL DAM SAFETY PROGRAM**

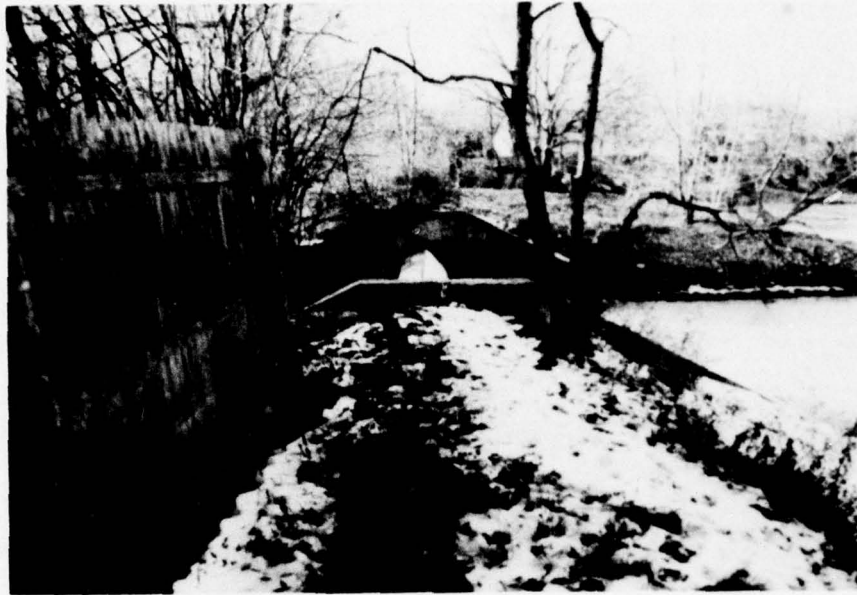
The embankment is partly covered with grass, brush and a few trees up to 1-foot in diameter. A residential property fence extends over part of the east embankment and snow was partly obscuring the upstream face of the dam at the time of the inspection (Photo 1). No riprap was observed on the upstream face of the dam.

Photo 1 View along dam crest looking west

All brush and small trees should be removed from the embankment soon in order to facilitate inspection of the embankment, permit embankment restoration, and prevent root damage and possible piping problems. Clearing of the downstream face should continue as standard maintenance procedure.

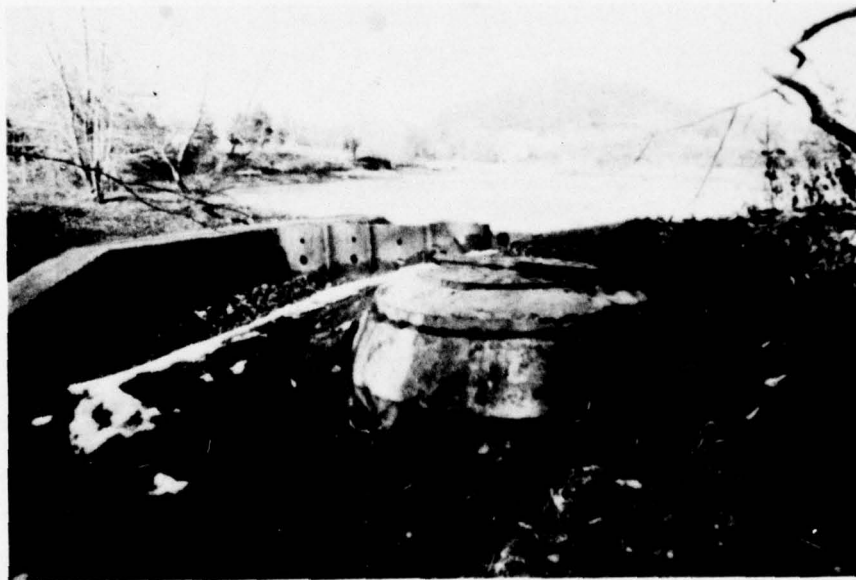
Erosion of the embankment, to a maximum depth of 1 foot, adjacent to the spillway walls was observed. The steel sheet pile core wall was partly exposed due to this erosion (Photo 2). An erosion scar approximately 2 feet deep and 4 feet wide was noted at the downstream side of the east embankment abutment (right hand side of Photo 3).

Photo 2 View of left (east) spillway abutment looking upstream

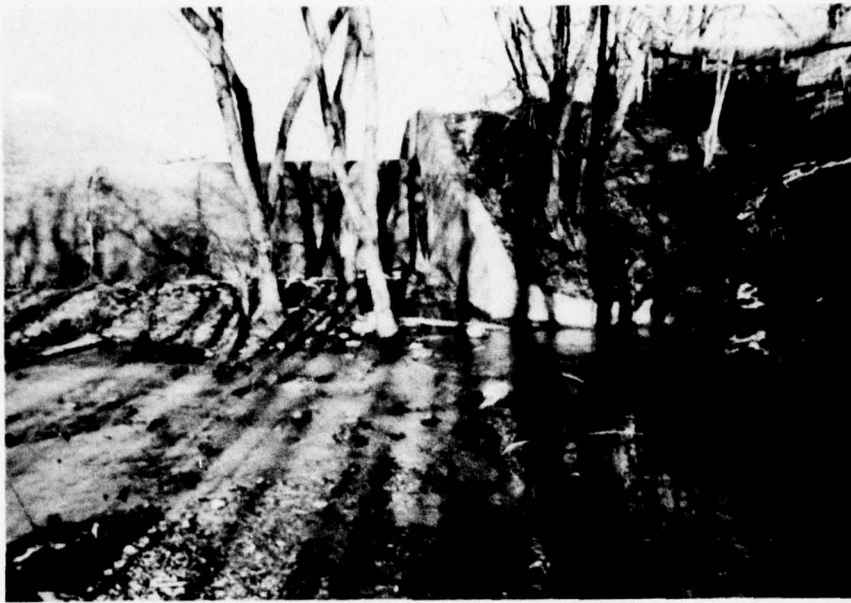
The intake to the outlet pipe was submerged during the inspections and therefore could not be observed. During the December 1, 1978 inspection the water level downstream of the dam was about 1 foot above the invert of the outlet pipe and water was discharging from the outlet pipe at an estimated rate of 100 to 150 gpm during the inspection (Photo 3).

Photo 3 View of left abutment looking upstream

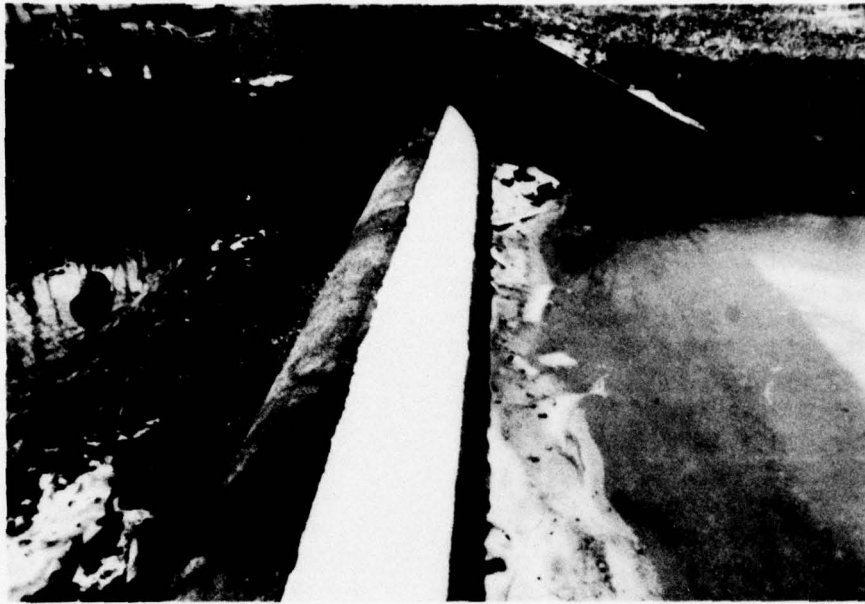
Photo 5 View of spillway crest looking west

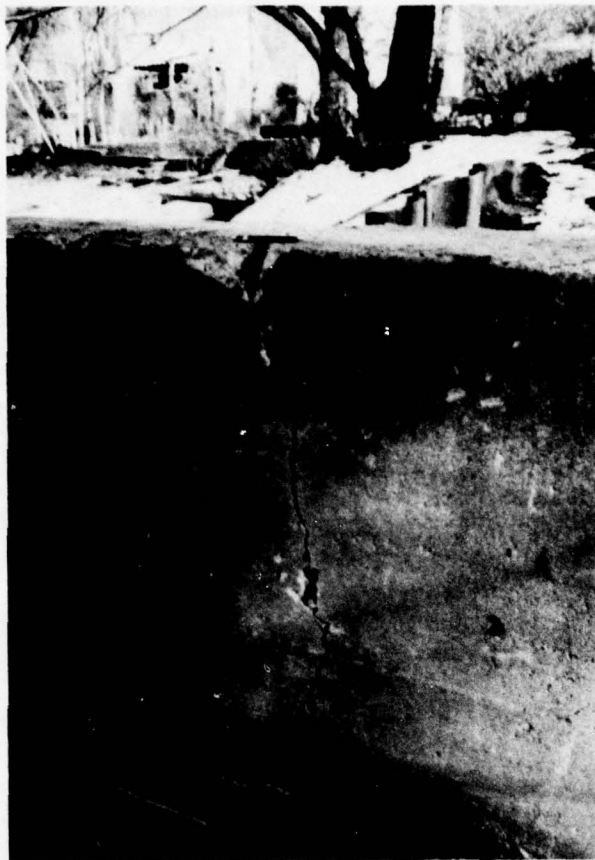
There are vertical cracks in the centers of both concrete wingwalls extending from the top of the walls to the top of the spillway crest (Photo 7). Both cracks are open approximately 1/4 inch and spalling has occurred along the crack in the left (east) wingwall.

Photo 7 View showing  
crack in left (east) wing  
wall

1. The hole at the right downstream toe of the spillway should be filled to avoid further erosion.
2. The cracks and spalling in the spillway and concrete wing walls should be repaired.
