SWEET ARROW LAKE DAM

NDI NO. PA-00680

**PHASE I INSPECTION REPORT
NATIONAL DAM INSPECTION PROGRAM**

BY
Berger Associates, Inc.
Harrisburg, Pennsylvania

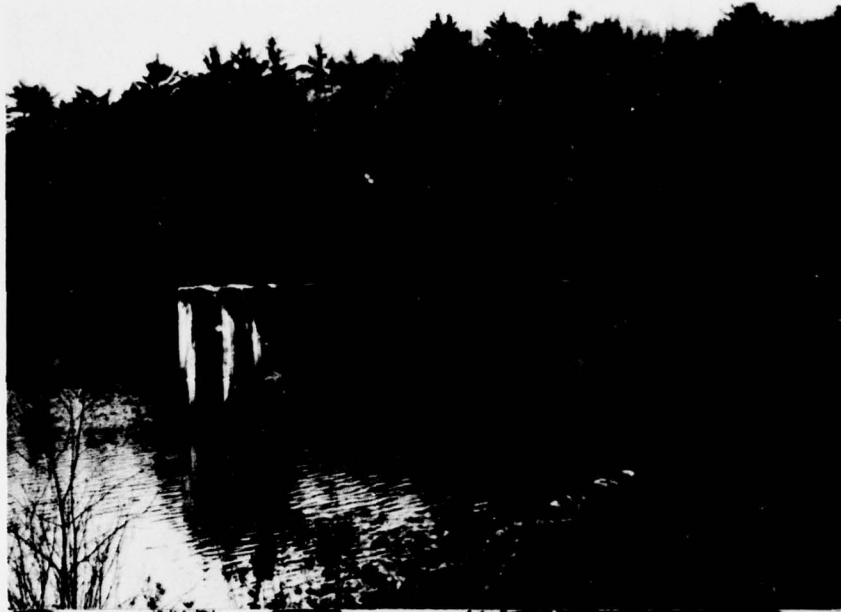
The intake tower is located about half way between the abutments of the dam and is accessible by a footbridge. Most of the planking on the steel truss bridge has disappeared and the inspector had to climb along the truss chord to check the intake tower. The manhole cover on the tower was missing and the owners representatives stated that the valves had not been operated since 1961. In 1974 an effort was made to operate the valves, but no movement was obtained. The valves are on 18-inch pipes and if operable, could be used to draw down the reservoir to an elevation of 531.0.

OBSERVATIONS AND REMARKS
A. INTAKE STRUCTURE	Circular concrete tower on upstream side. Concrete top deteriorating. Manhole cover missing.
B. OUTLET STRUCTURE	Concrete conduit outlet underwater in a pool formed by roadway.
C. OUTLET CHANNEL	Blocked by roadway without a pipe. Wide valley available for discharge.
D. GATES	Three operator stands on top of tower. None operated since 1961.
E. EMERGENCY GATE	Not operable - 18" valve.
F. OPERATION & CONTROL	None.
G. BRIDGE (ACCESS)	Truss footbridge from top of dam. Most planking has disappeared. Hazardous to cross.

Intake Tower
& Footbridge

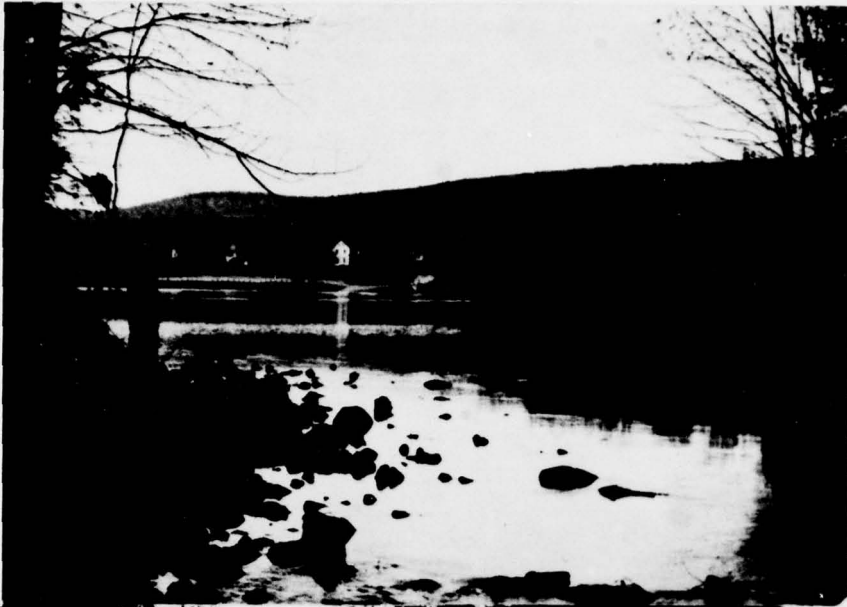
OBSERVATIONS AND REMARKS
A. APPROACH CHANNEL	Cut in rock. Some brush growing near left abutment.
B. WEIR: Crest Condition Cracks Deterioration Foundation Abutments	None - rock cut.
C. DISCHARGE CHANNEL: Lining Cracks Stilling Basin	Cut in rock. Good condition. Drop of at least 15 feet at end in natural stream.
D. BRIDGE & PIERS	None.
E. GATES & OPERATION EQUIPMENT	None.
F. CONTROL & HISTORY	None. Maximum water surface estimated at 5.7 feet during Agnes (1972) above spillway (1 foot above road).

Entrance to
Spillway

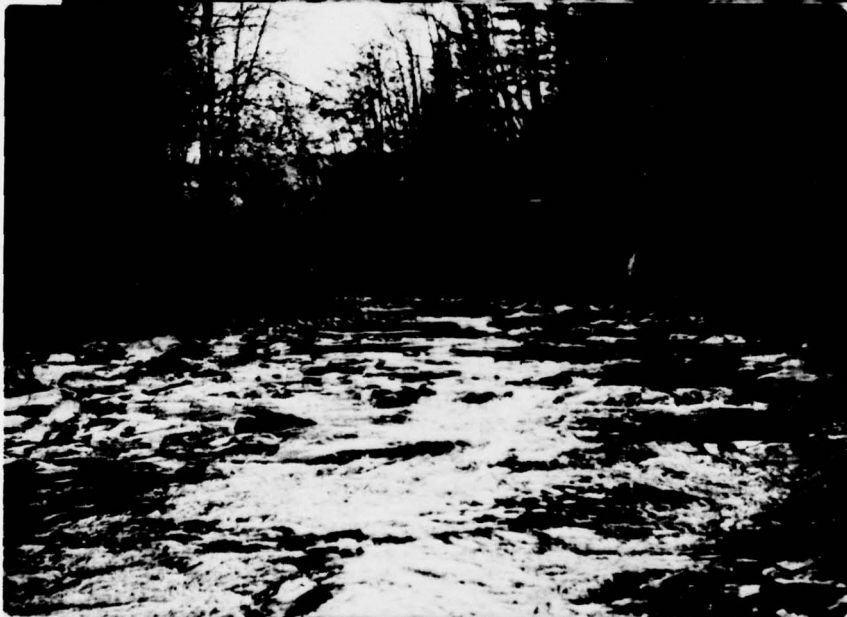
Spillway Over
First 200 Feet

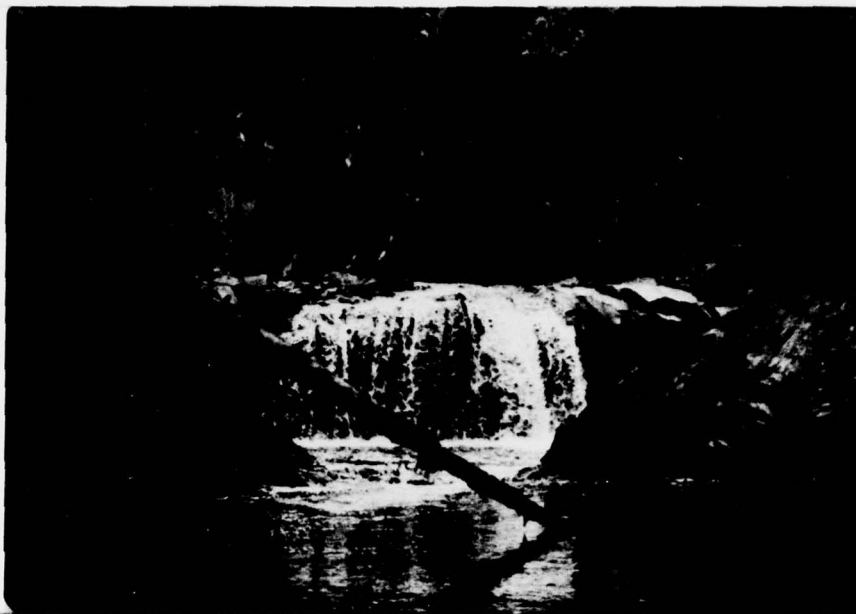
The spillway is in good condition and the rock cut does not appear to have an erosion problem. The discharge is at a considerable distance from the embankment and no damage could occur. Although deterioration of the concrete intake tower has occurred, the tower is considered to be in acceptable structural condition at the present. The gate valves are not operable at present and it is recommended that blowoff facilities should be made operable for emergencies.

Spillway

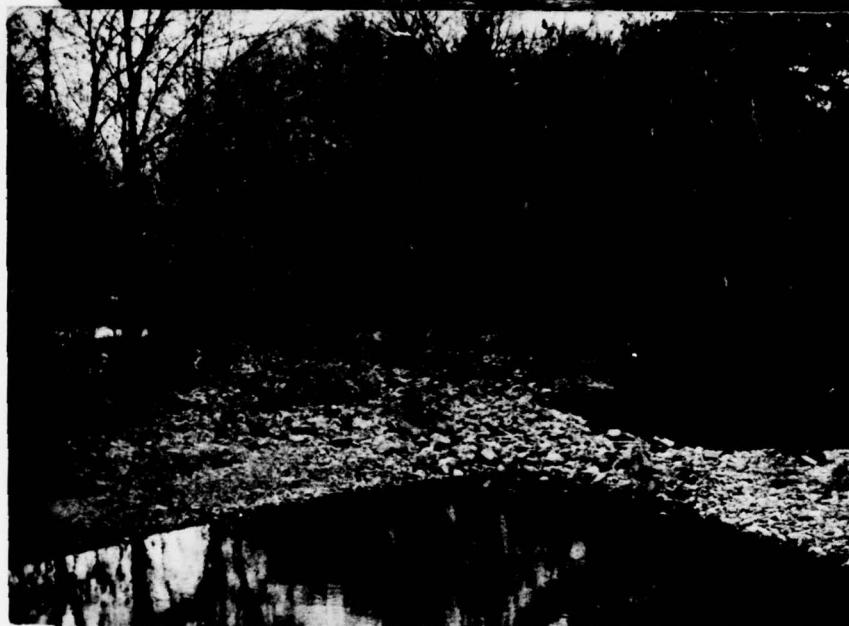
Conduit Outlet
With Creek in
Background

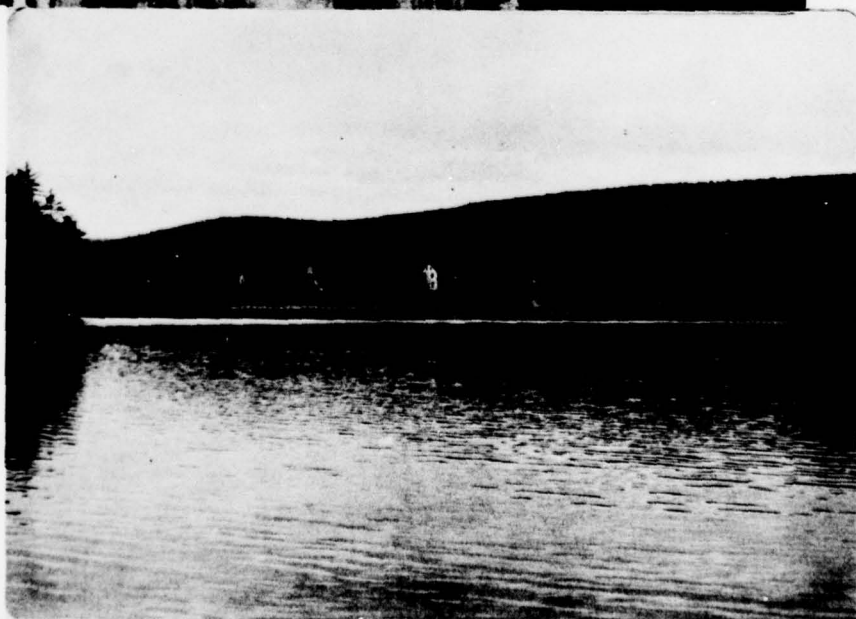
Reservoir
