LOWER HEREFORD MANOR DAM

NDI I.D. NO: PA-261

PHASE I INSPECTION REPORT

NATIONAL DAM INSPECTION PROGRAM

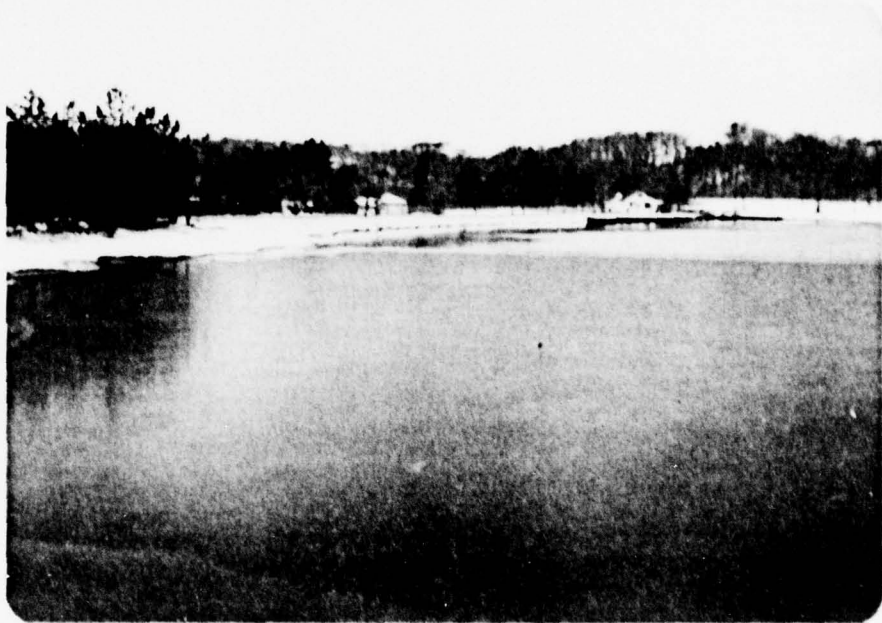
Upstream Face

While a portion of the upstream slope is protected by a masonry wall against erosion, the remaining portion of the upstream slope has no riprap. At certain sections, the upstream slope is steep (approximately one horizontal to one vertical).

| VISUAL EXAMINATION OF | OBSERVATIONS | REMARKS OR RECOMMENDATIONS |
|---|---|---|
| RIPPAP FAILURES | Poor, or nonexistent. | New riprap should be installed. |

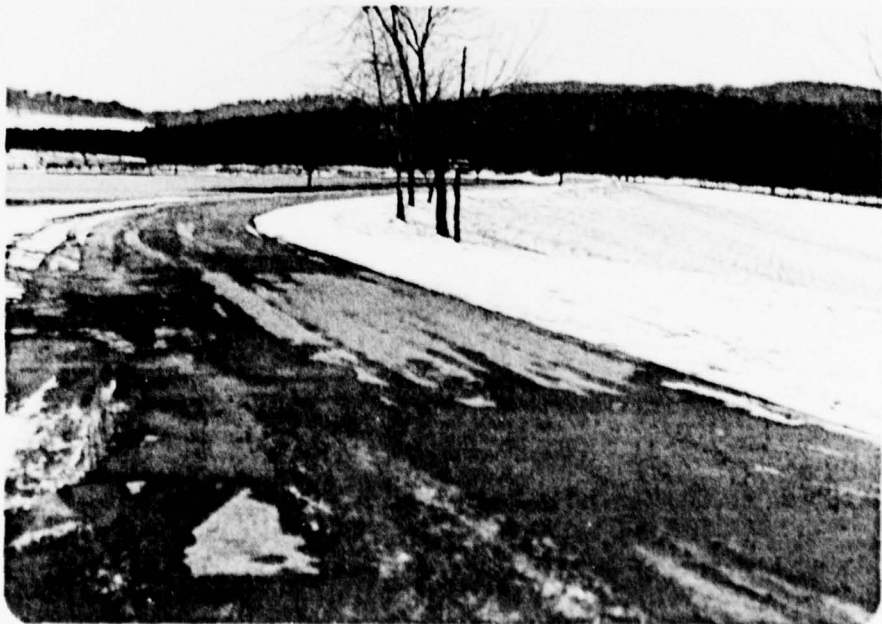
Downstream Face

In general, the condition of the embankment is considered to be fair. One wet area and a seepage point were found on the downstream face of the dam. The wet area was located near the left abutment approximately midheight of the downstream slope. No seepage flow appeared to be associated with this wet area. Seepage was found in a ditch on the downstream slope of the dam. The flow was estimated to be on the order of four to five gallons per minute.

5. The crest of the dam should be surveyed and low spots filled to design elevation.
6. The seepage on the downstream face of the dam should be periodically observed and remedial action taken if conditions deteriorate.

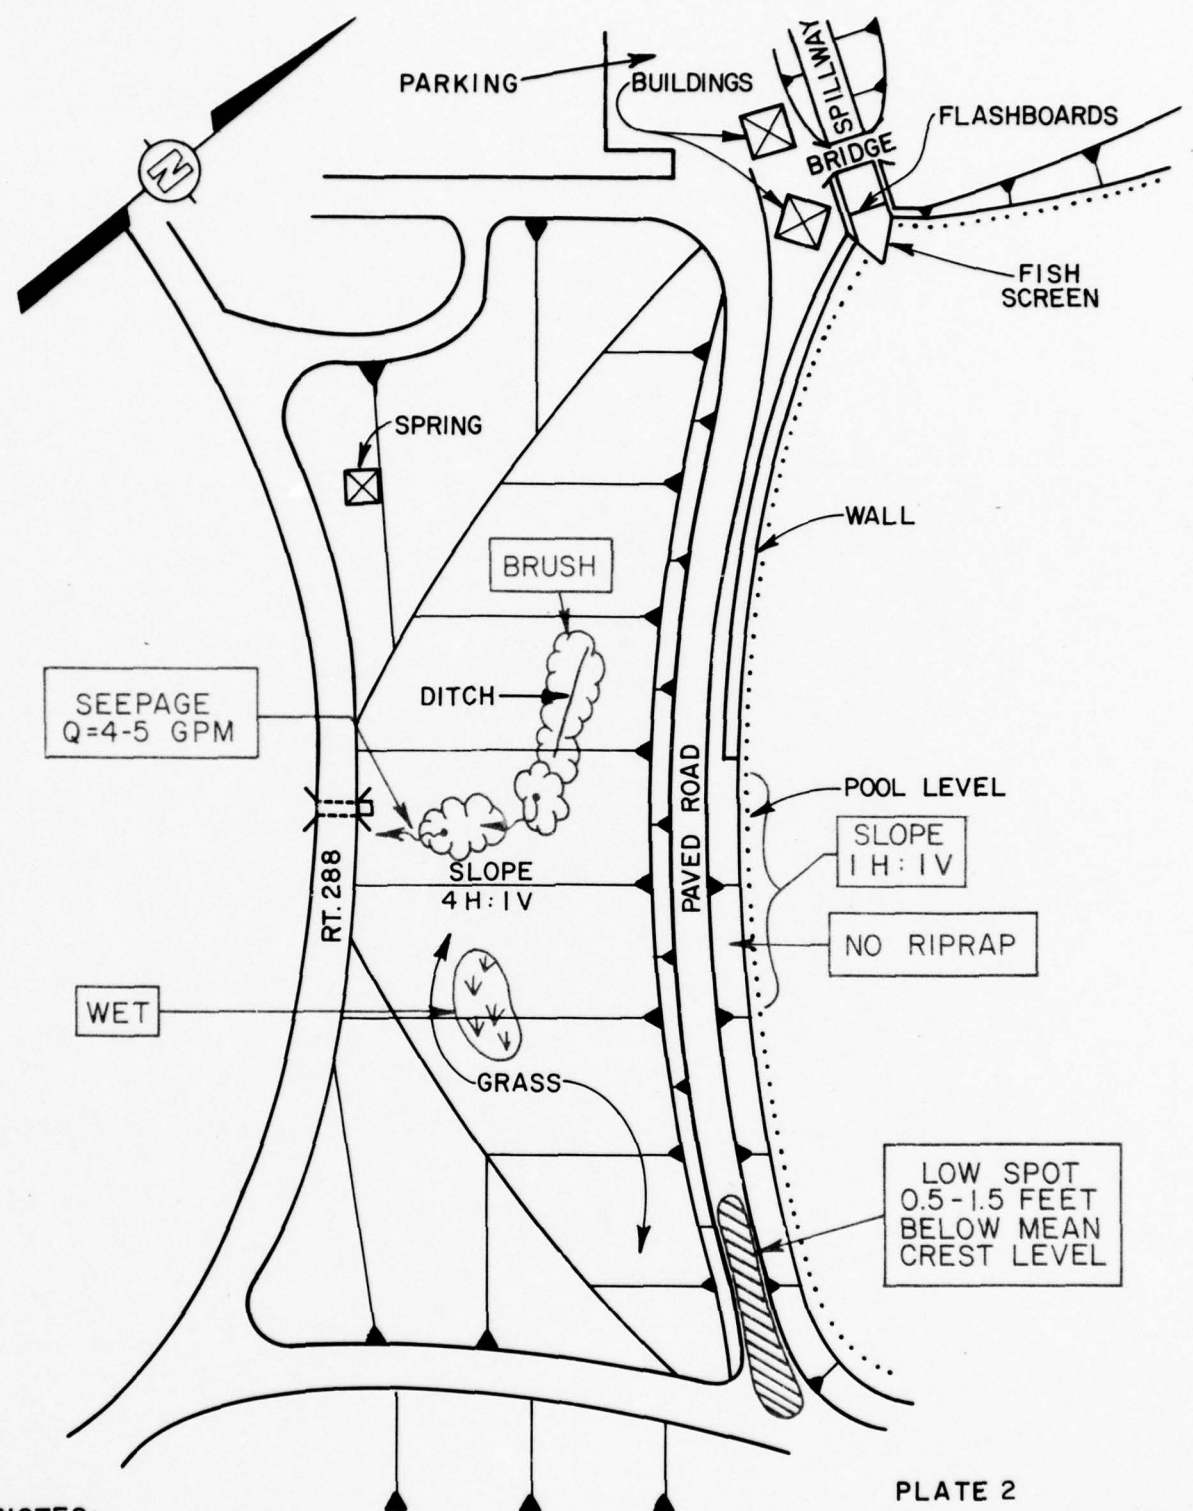
1. SPILLWAY FREEBOARD (MEASURED FROM LOW SPOT ON CREST TO TOP OF FLASHBOARDS = 2 FT.
2. POOL LEVEL DATE OF INSPECTION: 1.3 FT. BELOW LOW SPOT IN CREST.

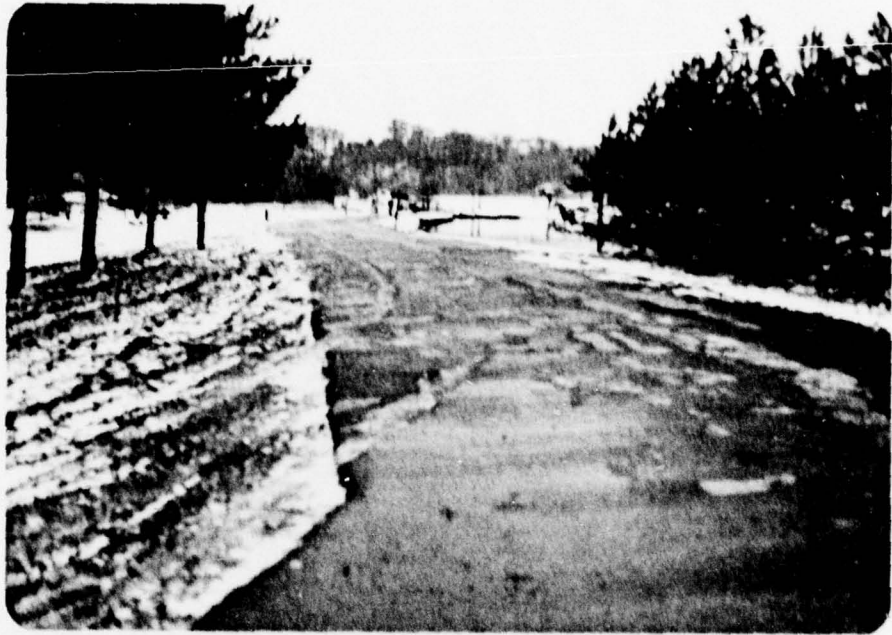
Photograph No. 1
Crest (looking west).

The top of the embankment was surveyed relative to the spillway flashboard crest elevation (934.7). A 150-foot-long section of the crest near the left abutment was found to be 0.5 to 1.5 feet below the mean crest elevation. The lowest point was about two feet above the spillway flashboard crest level.

A 150-foot-long section of the crest adjacent to the left abutment is about 0.5 to 1.5 feet below the mean crest elevation, and the lowest point is about 2 feet above the spillway flashboards.

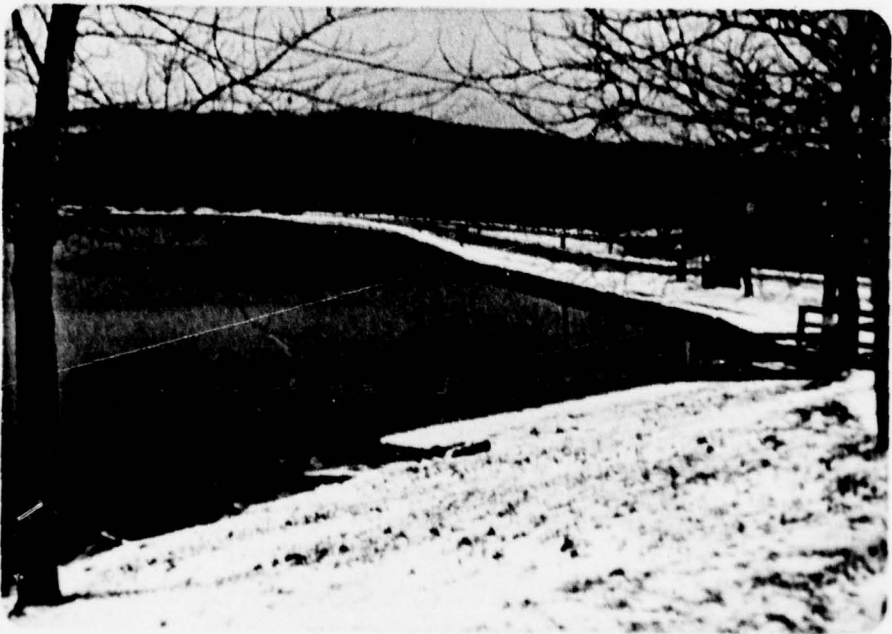
Photograph No. 2
Spillway approach. Spillway crest behind wood fence.

c. Appurtenant Structures. The only appurtenant structure of the dam, the spillway, was examined for deterioration or other signs of distress or obstructions that would limit flow. The fish screen, located immediately upstream of the flashboards, was found to be partially clogged by debris. The pool level of the upstream side of the fish screen was approximately eight inches higher than the water level on the downstream side of the fish screen. This condition clearly demonstrates the potential for obstruction of flow through the spillway by debris accumulating on the fish screen.

The fish screen across the only spillway of the reservoir poses a potential for blockage of the spillway.
