EATON DAM (BULL RESERVOIR)  
ERIE COUNTY, COMMONWEALTH OF PENNSYLVANIA  
NDI No. PA 00016  
PennDER No. 25-34

PHASE I INSPECTION REPORT  
NATIONAL DAM INSPECTION PROGRAM

(11) May 30 1979

Eaton Dam (Bull Reservoir), Erie County, Pennsylvania  
NDI No. PA 00016, PennDER No. 25-34  
Tributary to French Creek  
Inspected 16 November 1978

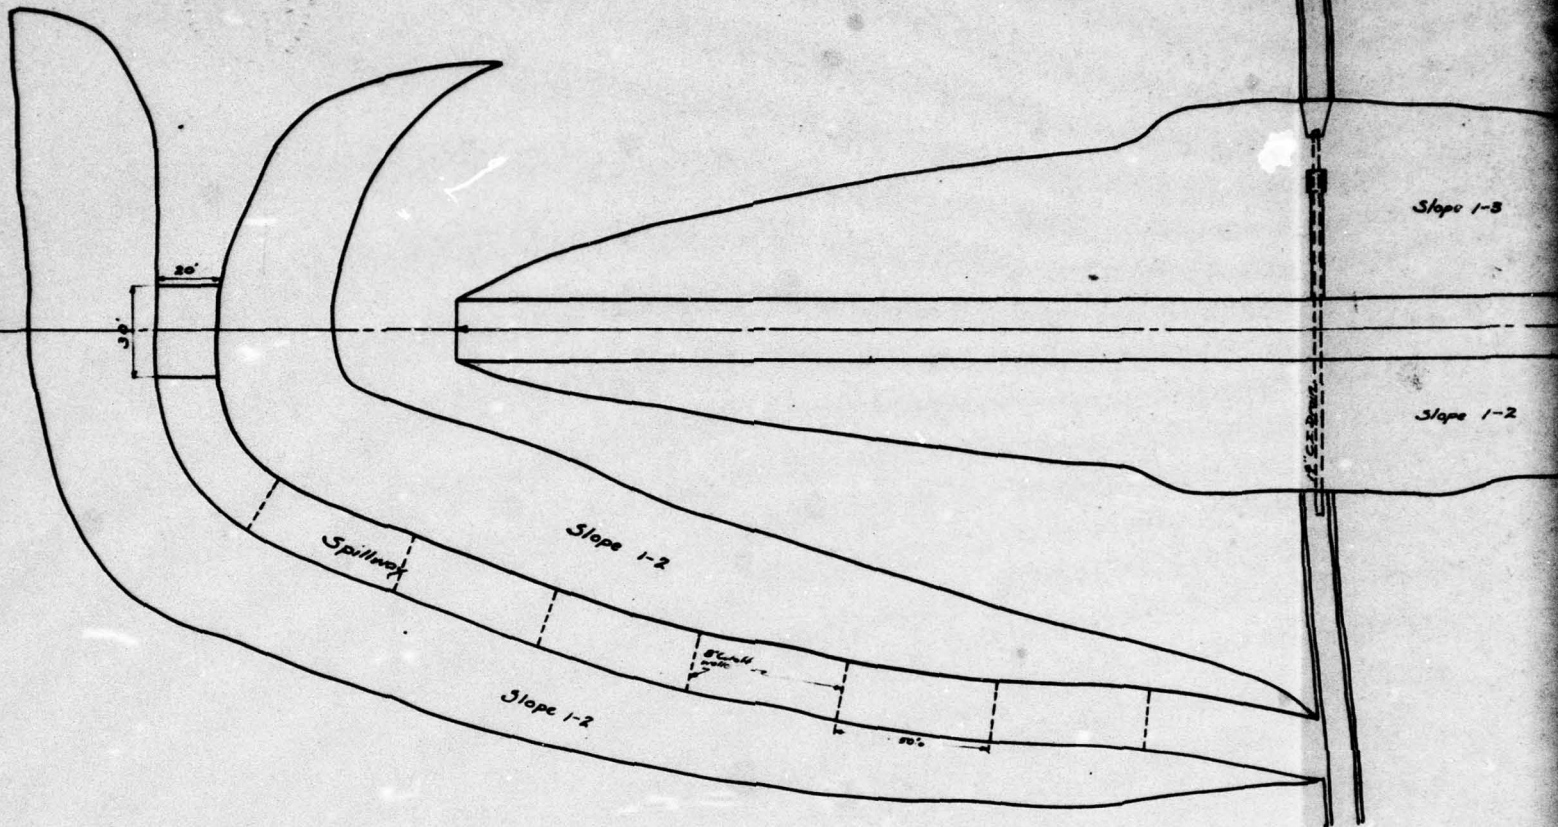
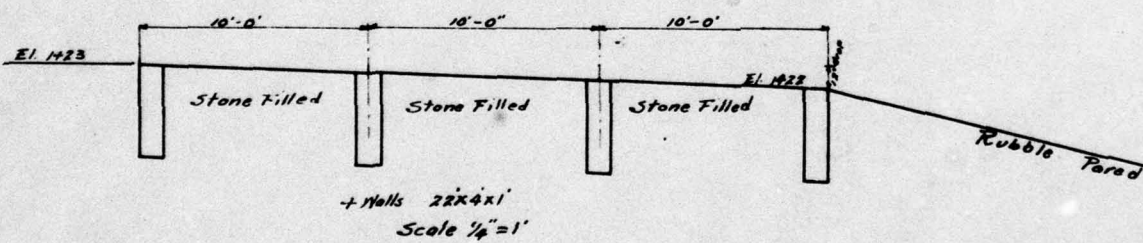
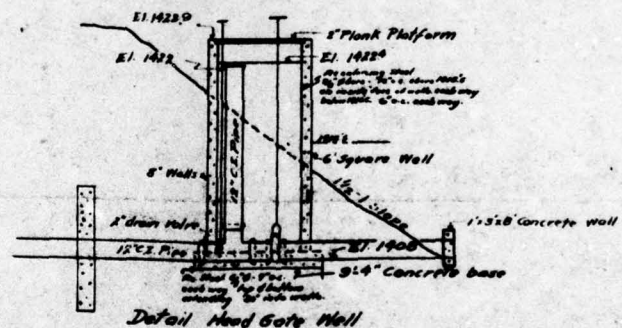
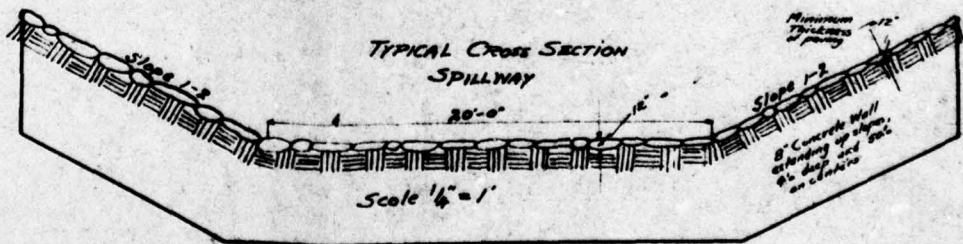
PLATE 4

**NOTE:** This Design Drawing of the Auxiliary Spillway Is Not Representative of the "As Built" Conditions. See the Text of This Report and Photos 5, 6, and 7 For "As Built" Condition.

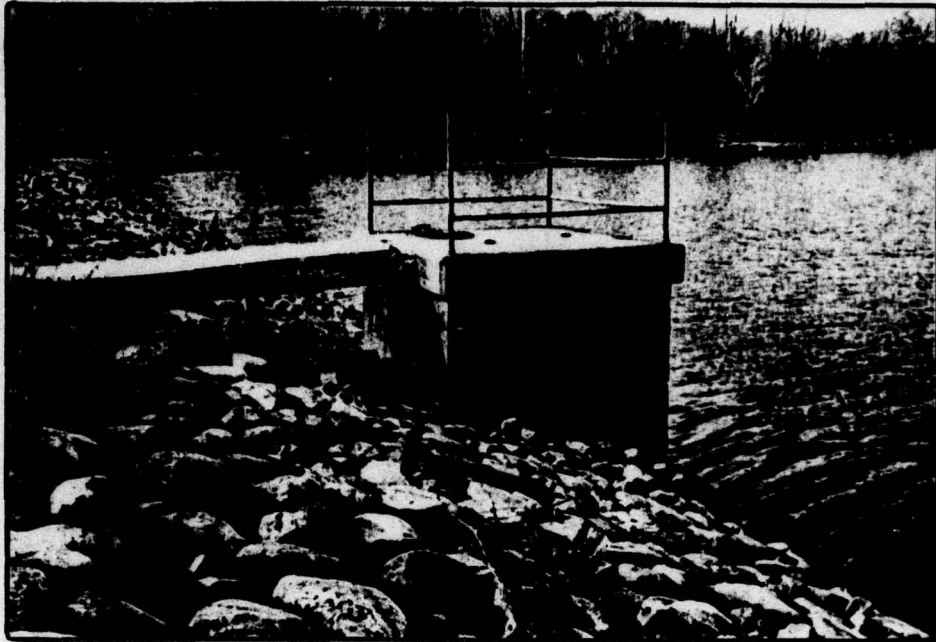
- c. Appurtenant Structures - The intake structure in the upstream embankment is cracked and spalled; consequently, reinforcing bars are exposed in some areas. The concrete in the auxiliary spillway also has signs of deterioration.

1. Reinforcing bars are exposed along the walkway to the intake structure.
2. The concrete is cracked and spalled on the walkway and the intake structure.

**PHOTO 1. Gate Valve Chamber in Upstream Embankment  
(Note Spalling of Concrete and Exposed Reinforcing Bar)**

1. The concrete should be repaired as necessary.

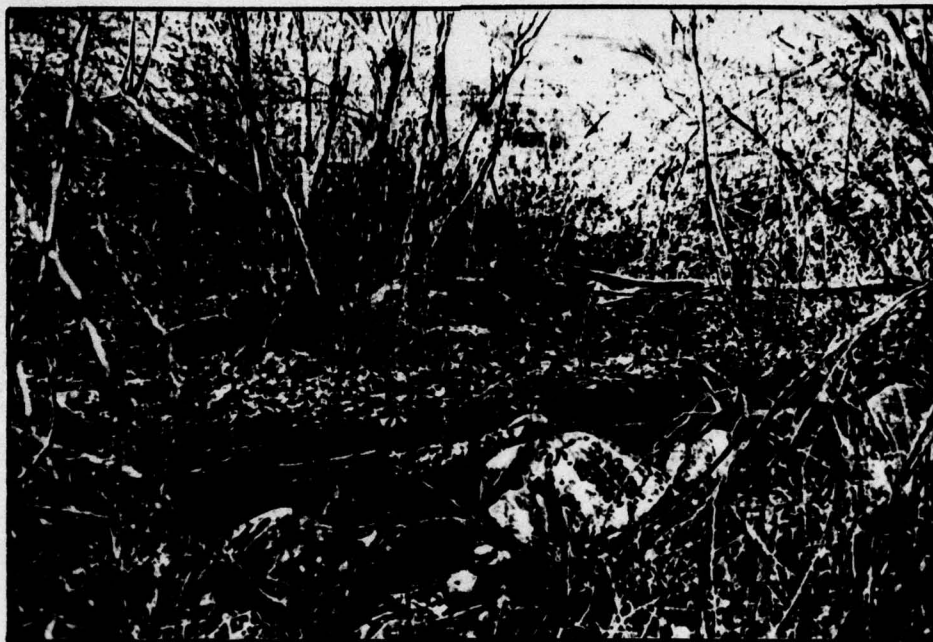
**PHOTO 7. View from Auxillary Spillway Channel Looking Back toward Weir  
(Note Brush and Debris in Channel)**
