**UPPER OWL CREEK DAM**

**NDS No. PA-00673**

**PHASE I INSPECTION REPORT  
NATIONAL DAM INSPECTION PROGRAM**

Name of Dam: UPPER OWL CREEK DAM, NDS NO. PA-00673  
State & State No. PENNSYLVANIA, 54-96  
County: SCHUYLKILL  
Stream: OWL CREEK  
Date of Inspection: October 26, 1978

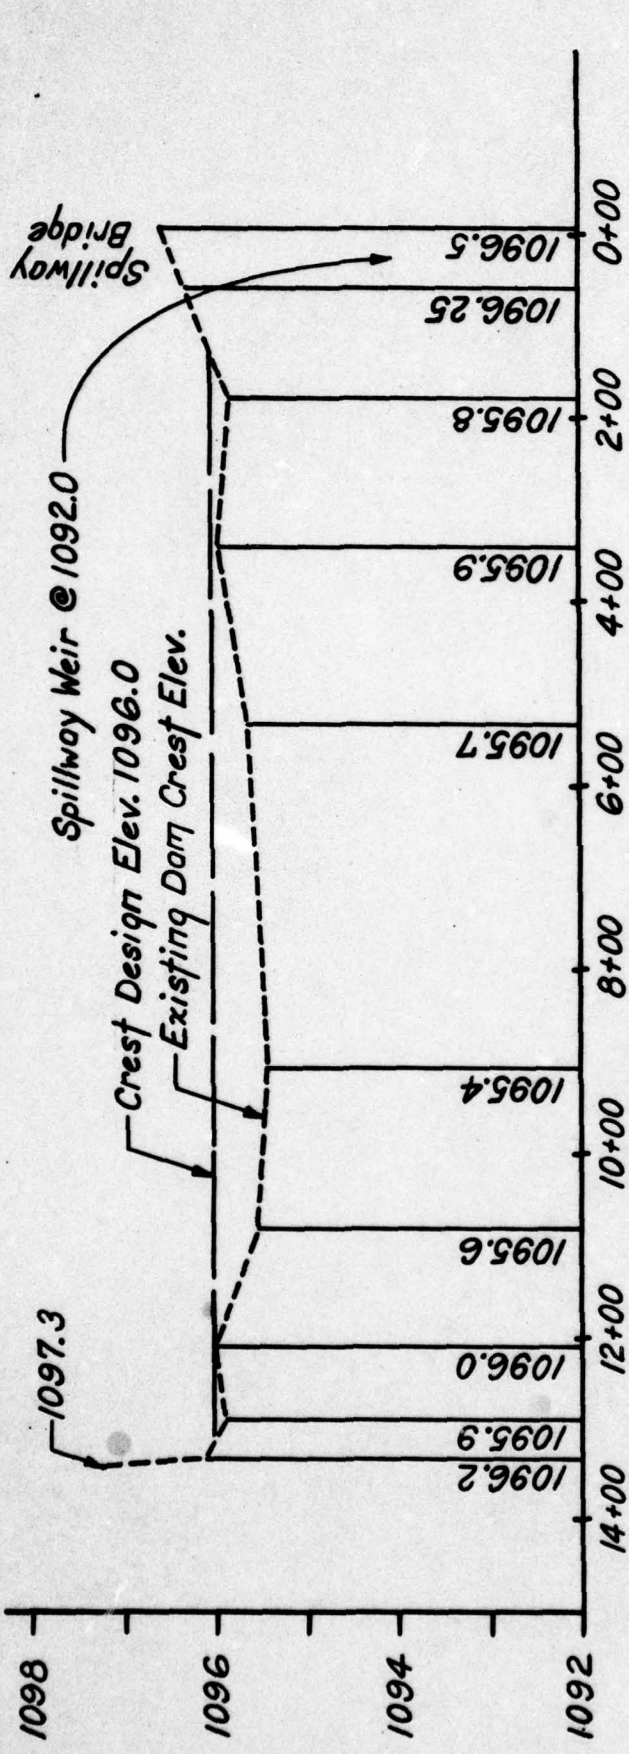
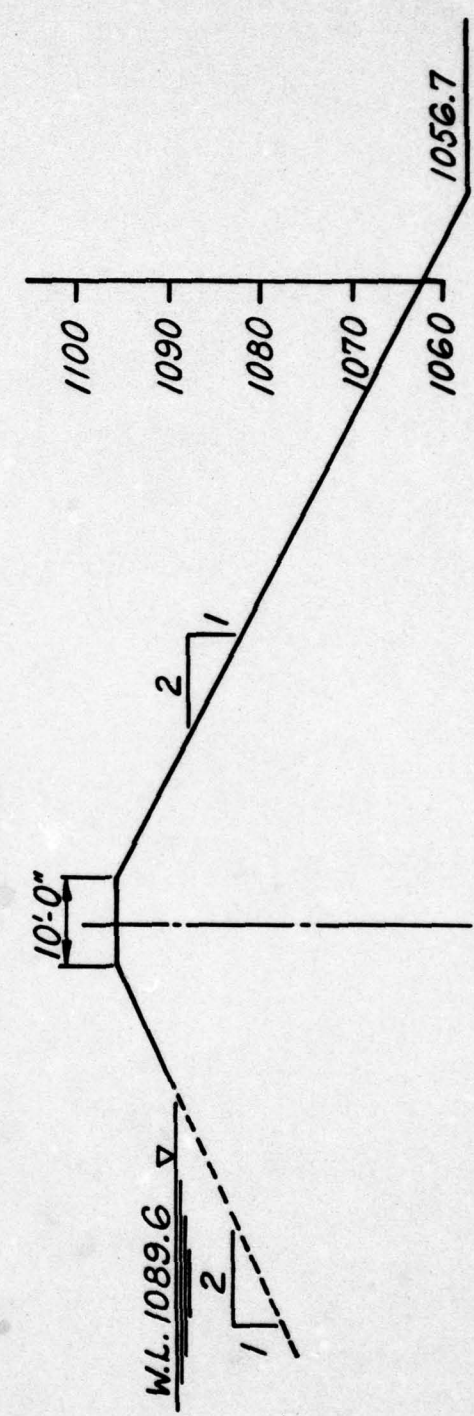
PLATE A-I

The inspection survey shows an uneven profile of the embankment crest. Refer to Plate A-I in Appendix A. While this condition does not affect the stability of the embankment, providing an uniform elevation at the design crest level will improve the overall capacity of the facility.

1. The top of the dam should be raised uniformly to its intended design height.
2. Access into the intake tower should be provided.
3. The condition of the upstream drawdown gate should be closely examined by a qualified professional engineer.
4. The seepage condition beyond the toe of the embankment should be evaluated by a qualified professional engineer. If remedial measures are necessary, they should be carried out by the owner.
5. The downstream embankment slope and the spillway discharge channel should be cleared of brush and trees.

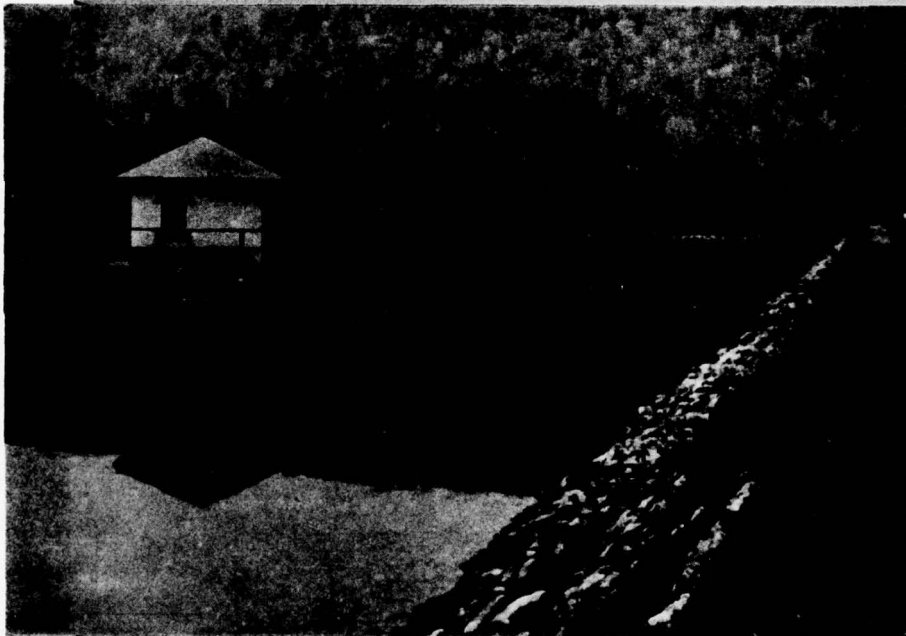
The intake structure is a circular concrete tower, accessible by a footbridge from the breast of the dam. Some spalling of the concrete at the waterline had occurred due to normal weathering and ice action. The door leading to the inside was locked and no keys were available.

Upstream Embankment  
and  
Intake Structure

The recent cutting of weeds, brush and trees indicate that the owners are aware of good maintenance procedures of the embankment. It is strongly recommended that access to the tower be obtained and that the lower gate be operated at least twice a year to insure an operable condition in case of an emergency. Keys to open the lock should be kept in a safe and easily accessible location. A formal surveillance and downstream warning system should be a part of the operational procedures.

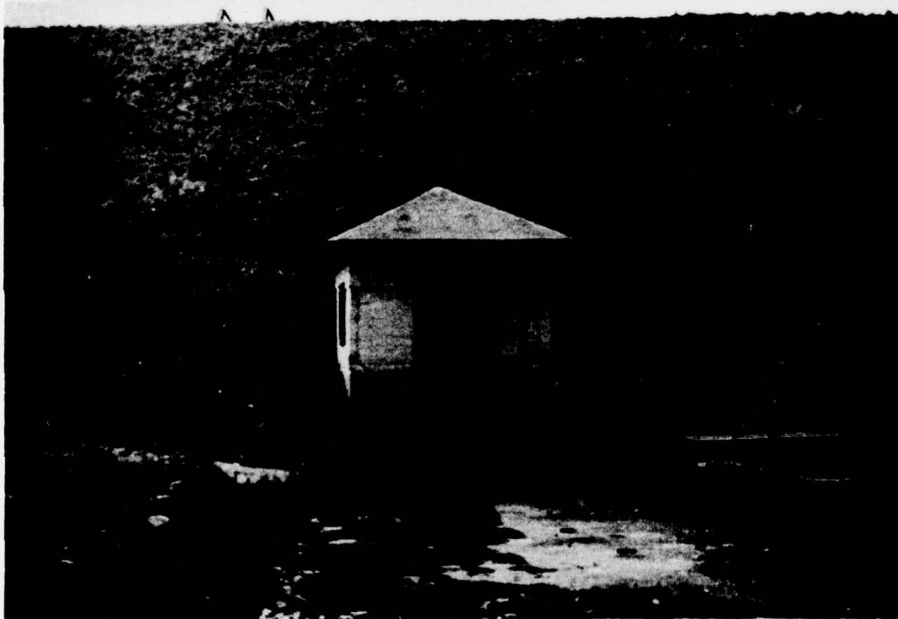
Valve House and  
Aeration Pipes

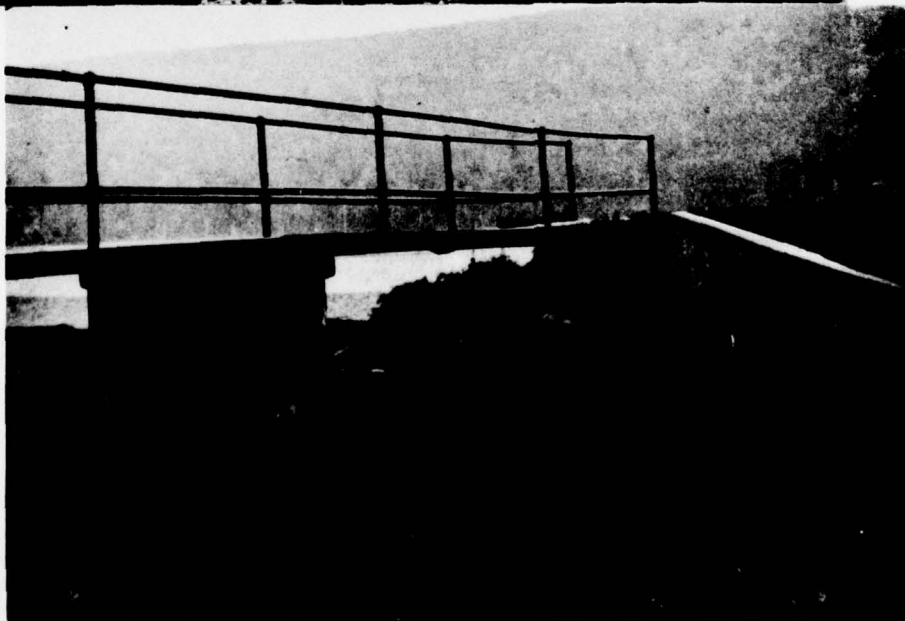
Spillway Weir &  
Footbridge

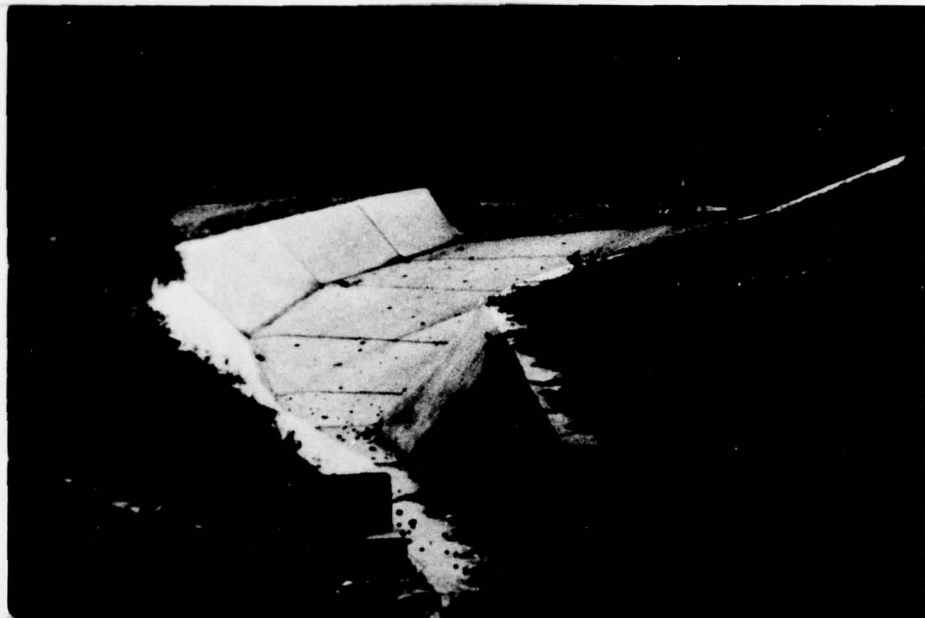
Spillway Chute
