CAMPBELLS LEDGE DAM

NDI ID NO. PA-00649

PHASE I INSPECTION REPORT
NATIONAL DAM INSPECTION PROGRAM

JANUARY 1979

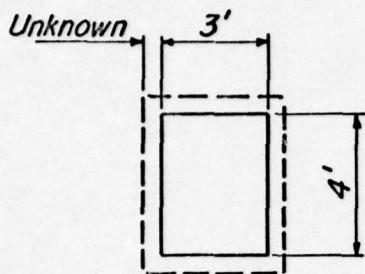
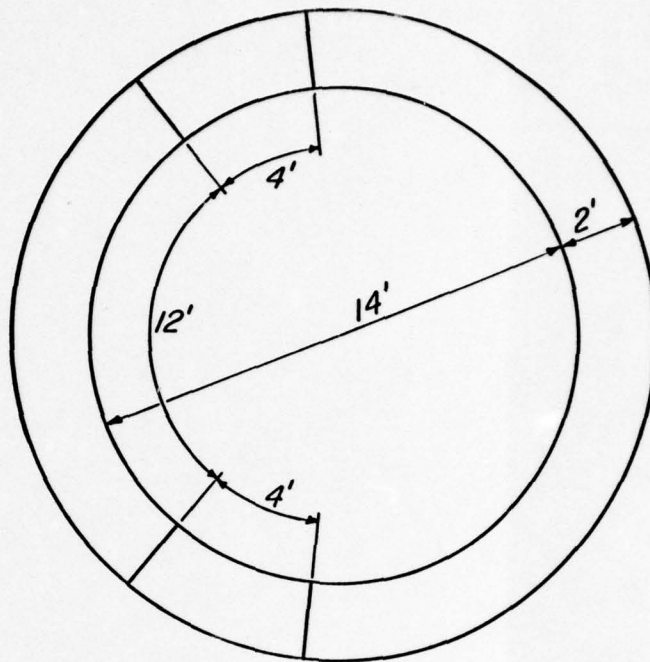
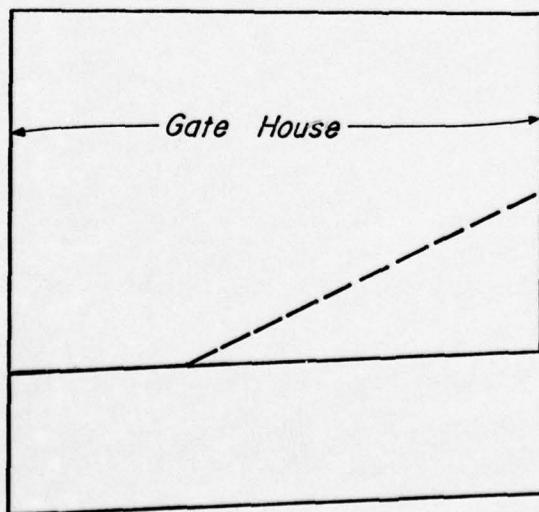
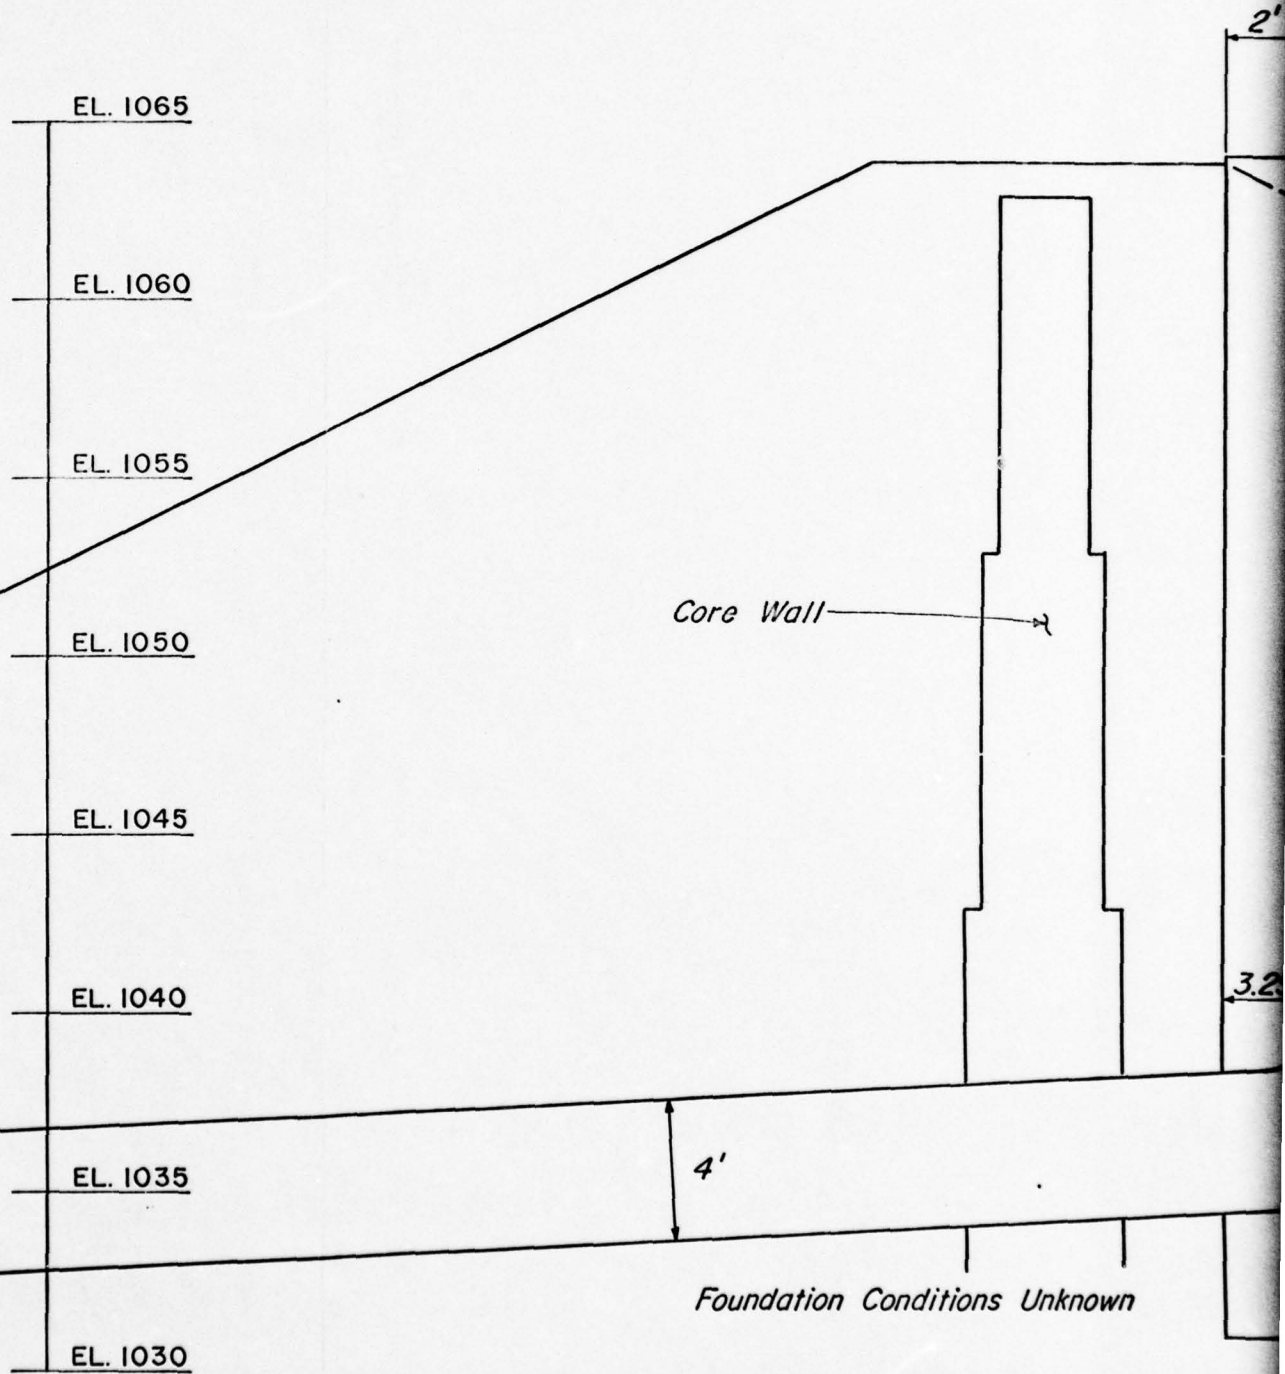
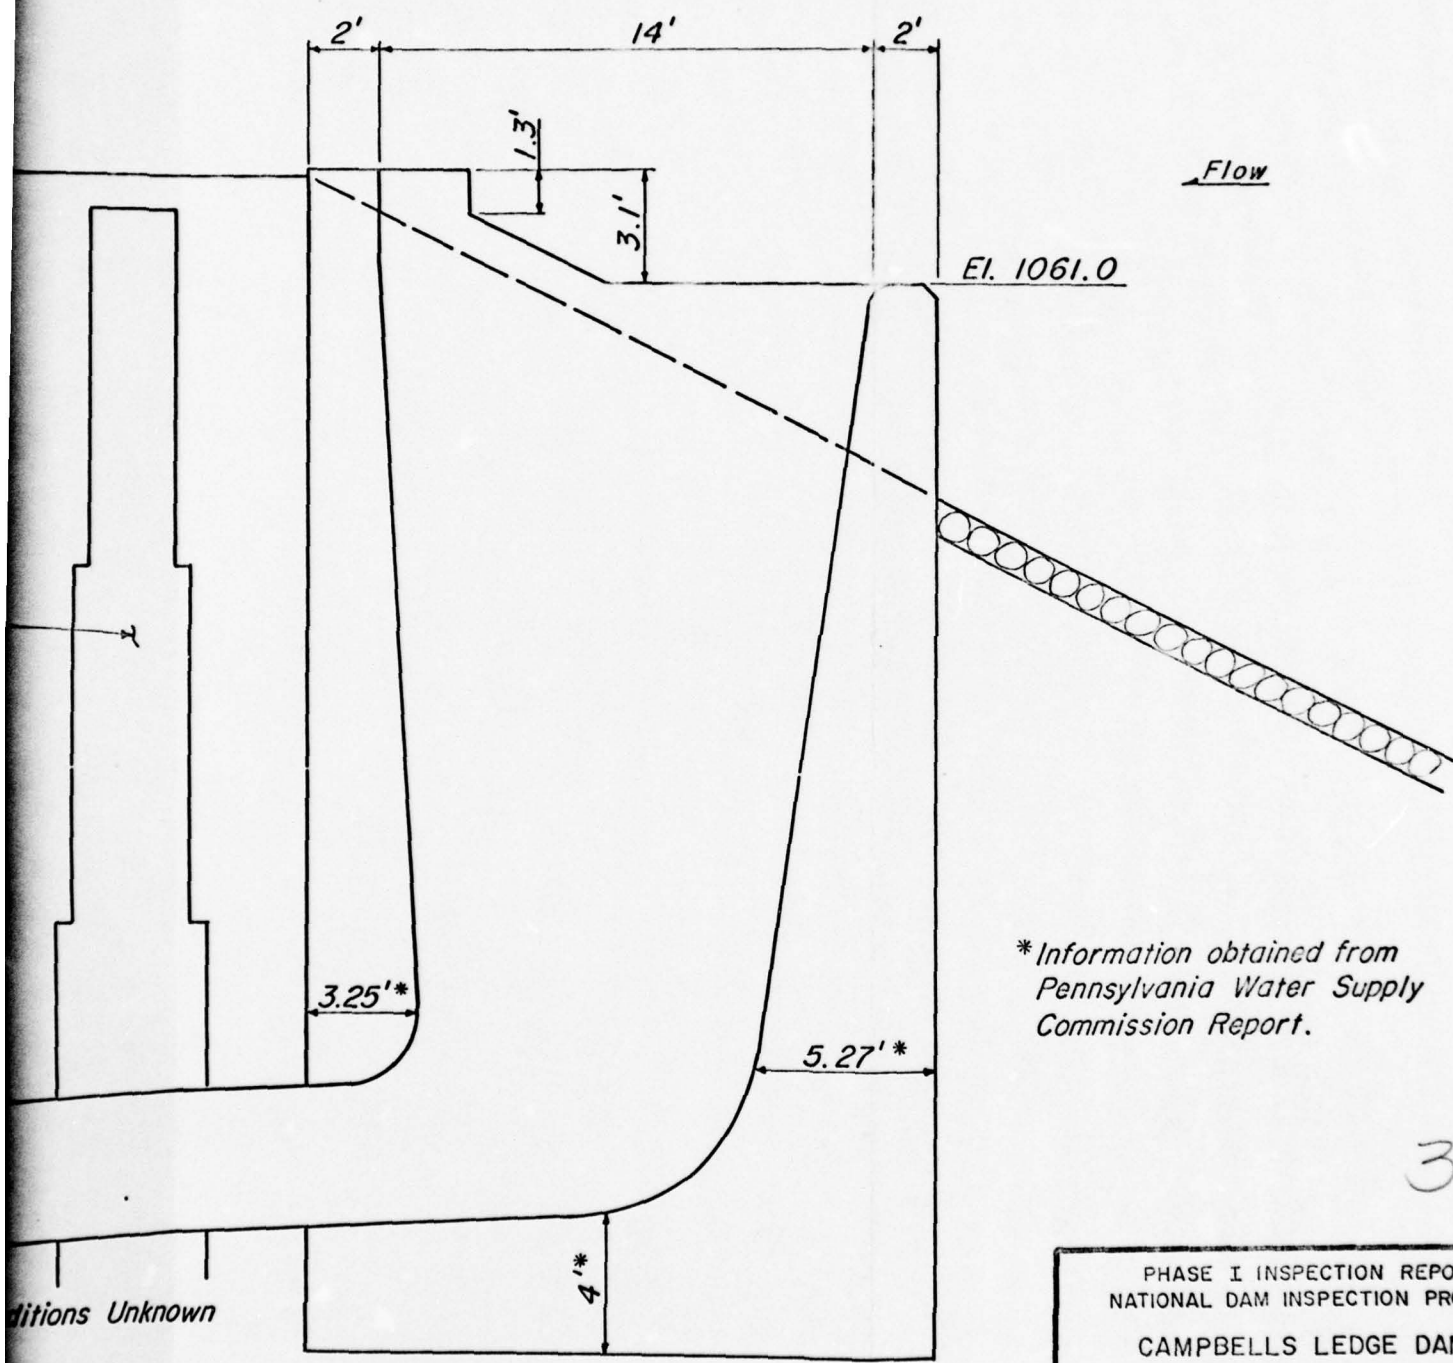
(3) Appurtenant Structures. The conditions at the spillway are of concern. Plate 4 shows the structural dimensions of the spillway, as determined from the field inspection and from the 1914 Pennsylvania Water Supply Commission Report. The spalling is sufficiently severe in the vertical shaft that the integrity of the structure may be threatened if spalling continues. The embankment exerts earth pressure around the entire vertical shaft. There is also full hydrostatic loading. The seepage observed indicates that a piping potential may exist, although no evidence of piping was observed.

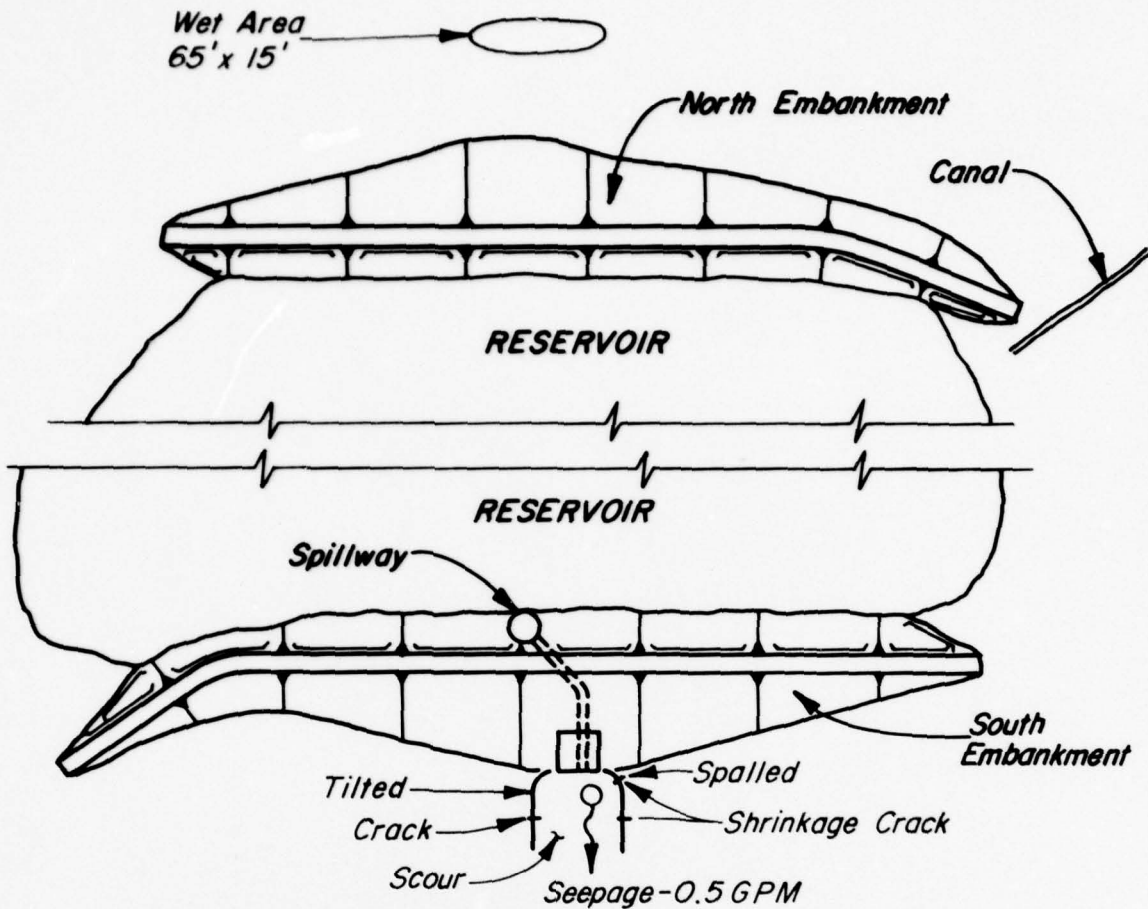
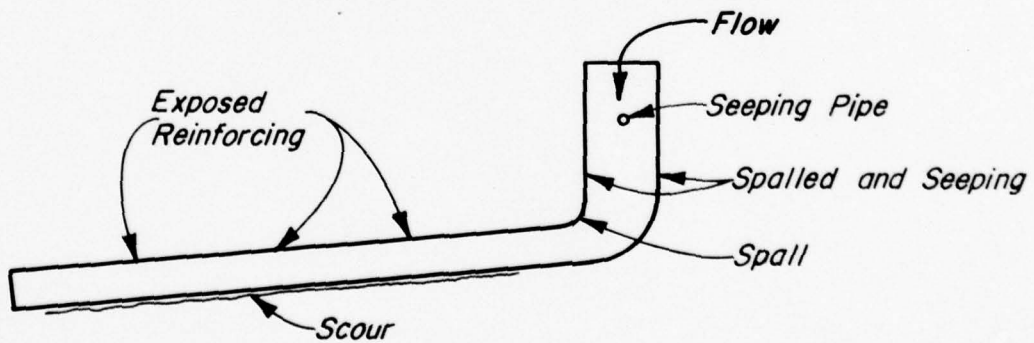
PHASE I INSPECTION REPORT
NATIONAL DAM INSPECTION PROGRAM
CAMPBELLS LEDGE DAM
PENNSYLVANIA GAS AND WATER COMPANY
RESULTS OF VISUAL INSPECTION
JANUARY 1979
PLATE B-1

a. General. The overall appearance of the dam is good. However, some deficiencies were observed as noted below. A sketch of the dam with the location of some of the deficiencies is presented on Plate B-1. Survey information acquired for this report is summarized in Appendix B. During the inspection the pool was about 4.5 feet below the spillway crest.

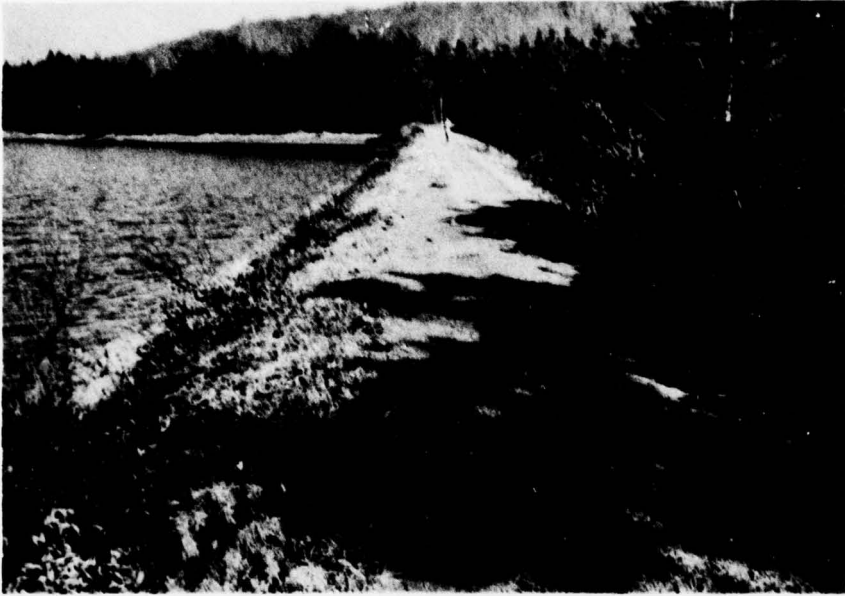
A. South Embankment - View from Right Abutment.

b. Embankment. The South Embankment appears in good condition. The entire top of the embankment is at or above the design elevation as noted in Appendix B. Tire ruts, approximately 4 inches deep, were noted along the top of the embankment. No seepage or wet areas were observed on or downstream of the embankment. There is minor bulging of the riprap on the upstream slope about 4 feet below top of dam. There is a sparse cover of brush, about 1 inch in diameter, on the embankment except at both abutments on the upstream slope, where the brush is up to 2 inches in diameter and much thicker (Photograph A). Mature trees are growing at the toe of slope to the right of the outlet works.

(2) Embankment. Tire ruts on the top of dam, if not repaired, can result in a lower elevation of the top of dam. Brush and trees on the embankment and at the toe are undesirable. The bulging of the riprap is probably caused by uneven grading during construction. The low area on the North Embankment is probably caused by uneven grading during construction, although a slight settlement of the embankment may have occurred. The wet area downstream of the North Embankment is not of major concern, as no seepage or standing water was observed.

(4) Monitor bulges at the upstream slope of the South Embankment. If changes are noted, an evaluation of the embankment stability should be made.

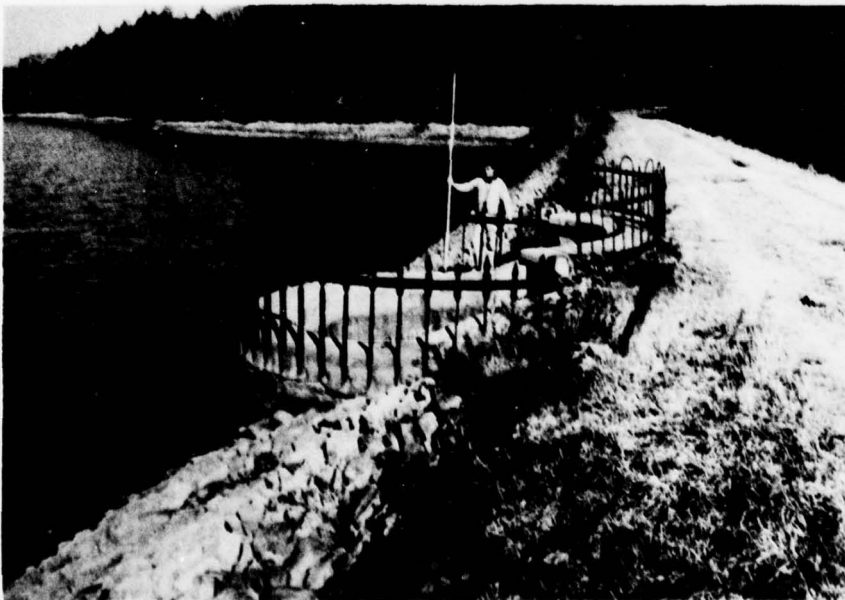
B. Spillway.

The spillway is in fair condition. An iron fence surrounds the spillway (Photograph B). The upper 6 feet of the Morning Glory shaft appears to have been repaired previously and the concrete appears to be in good condition. Below this elevation, the concrete is severely scoured and spalled over most of the vertical shaft. A maximum spall depth of 0.5 foot was estimated, but the area was inaccessible for exact measurements. A small pipe, the purpose of which is unknown, extends through the right wall of the vertical shaft about 6 feet below the crest. Seepage was observed from this pipe. Seepage was also observed over the face of the shaft below this elevation. The elbow juncture of the vertical shaft and the horizontal conduit is also severely spalled. The conduit appears to have been rough-formed. The entire bottom of the conduit is severely scoured. The walls and roof of the conduit are in good condition except, at many points, the reinforcing bars are exposed. These bars are severely rusting and deteriorated. It appears that little concrete cover was provided for these bars during construction.

(1) Perform additional hydraulic and structural design studies to determine the best method of repairing the spillway vertical shaft and conduit without decreasing the spillway capacity. The study should also address both the necessary repairs to the stilling basin and the suitability of removing the iron fence around the spillway. To increase the spillway capacity, the embankment should be raised to its design elevation.

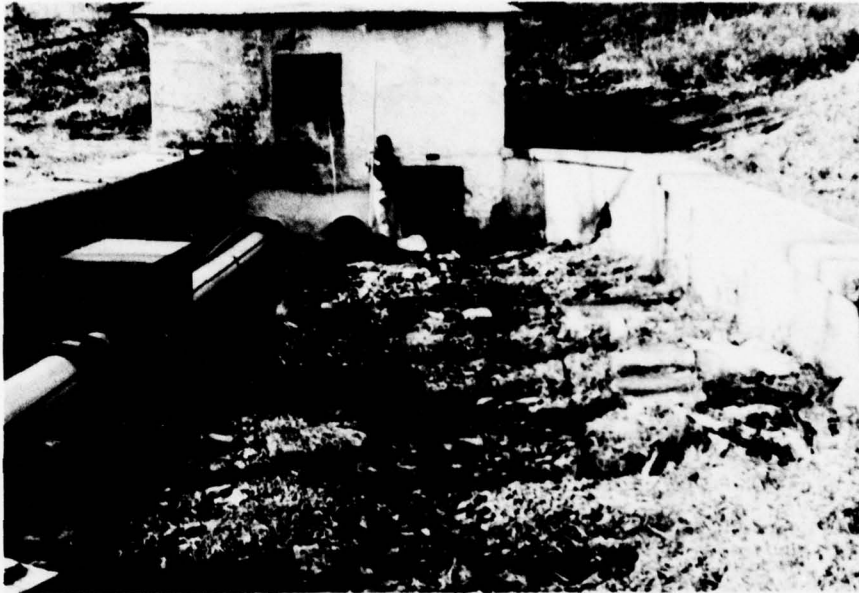
C. Spillway and Outlet Works Outlet

The spillway and emergency drawdown line discharge jointly into a stilling basin (Photographs C and D). The concrete bottom of this basin is almost completely scoured. The left wall of the basin has a shrinkage crack about 15 feet beyond the outlet works and another at the curved section of wall near the outlet works. There is spalling evident at the latter crack. At the right wall, there is a crack

about 15 feet downstream of the outlet works. Upstream of this crack, the wall is tilted towards the stilling basin. The total seepage at the downstream end of the conduit was estimated at 0.5 gpm, although it appeared that a greater quantity was seeping into the throat of the spillway. Some of the seepage may have been infiltrating through the bottom of the conduit.

The conditions at the stilling basin are an indication of inadequate design and lack of maintenance. From review of the periodic inspection reports by the Commonwealth, the damage to the stilling basin appears to have occurred between 1941 and 1943. A major flood occurred in the area during 1942.
