MAPLE LAKE DAM

NDI ID NO. PA-00294

PENNSYLVANIA GAS AND WATER COMPANY

PHASE I INSPECTION REPORT
NATIONAL DAM INSPECTION PROGRAM

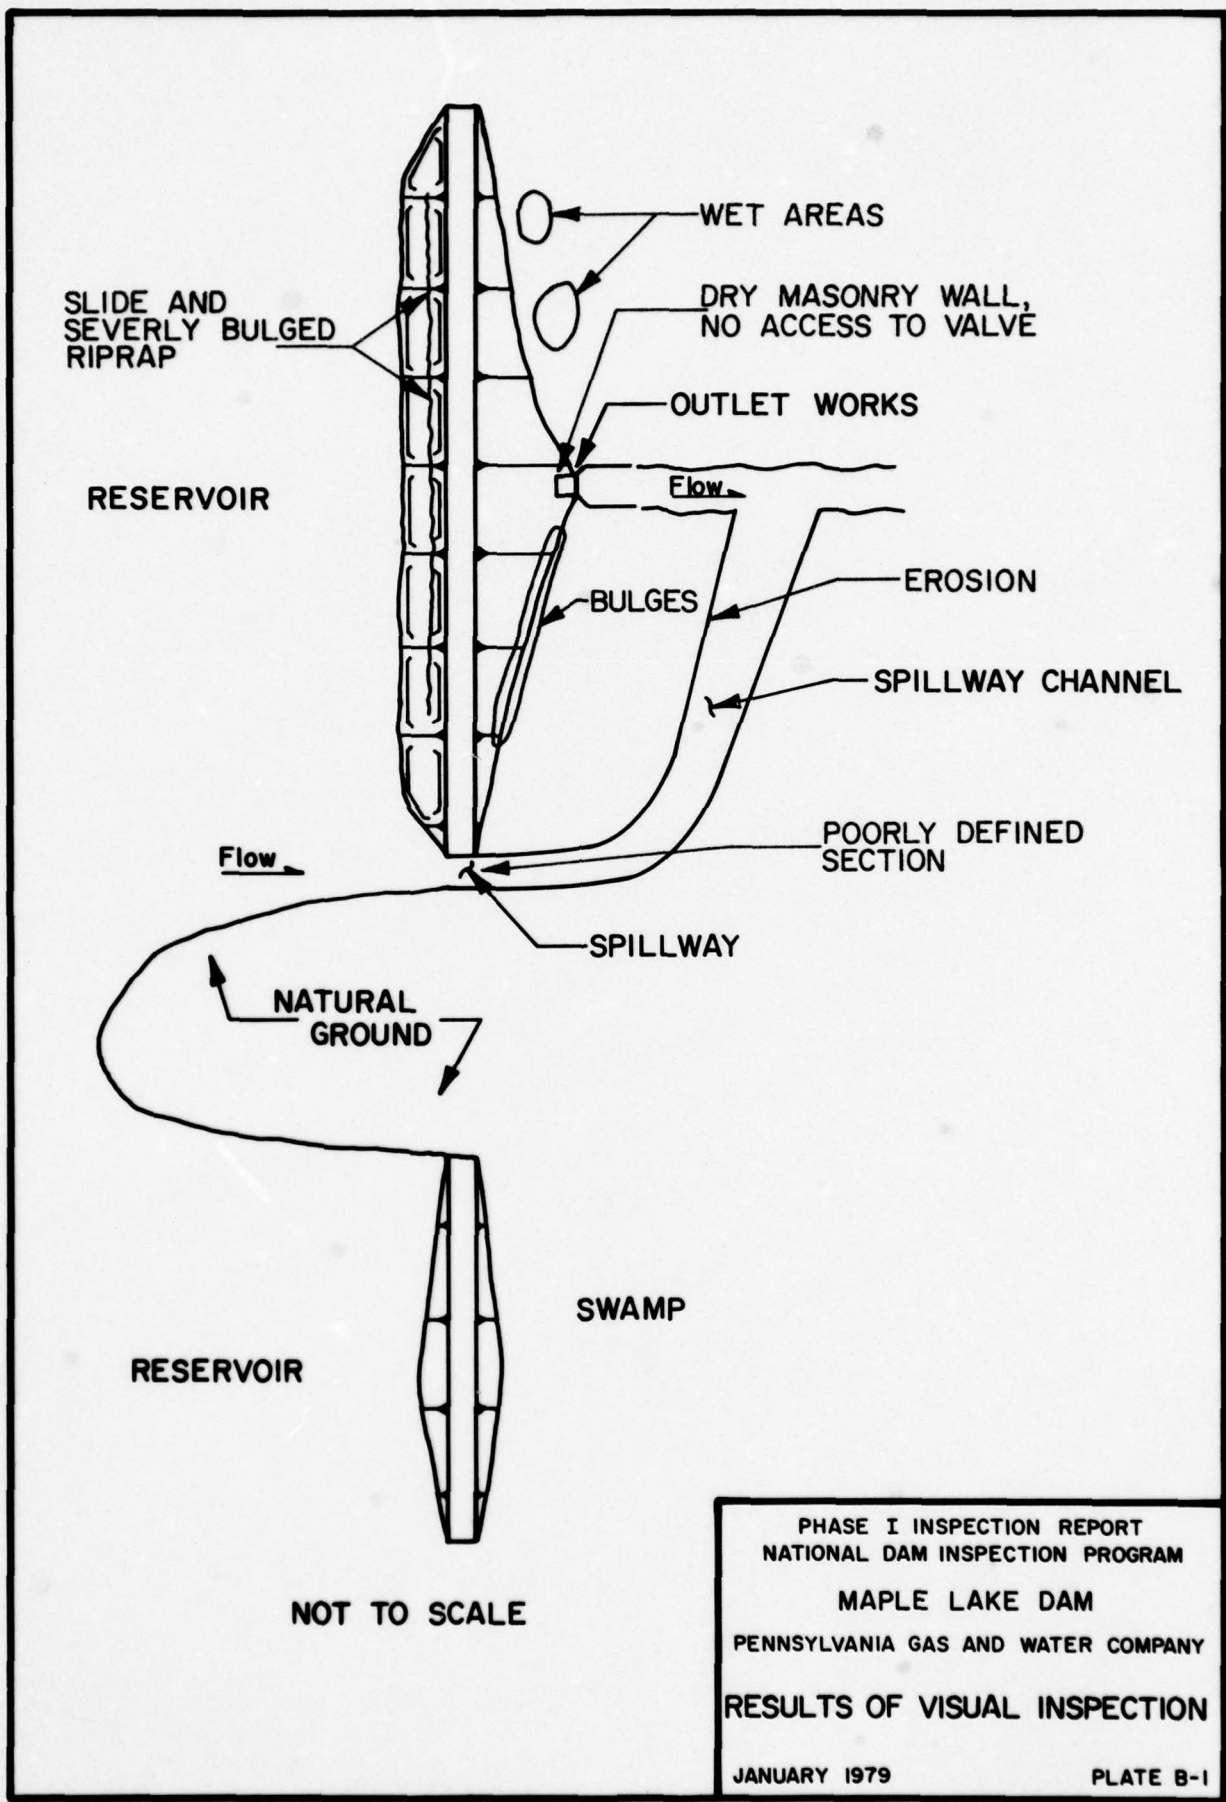
PHASE I INSPECTION REPORT
 NATIONAL DAM INSPECTION PROGRAM
 MAPLE LAKE DAM
 PENNSYLVANIA GAS AND WATER COMPANY
 RESULTS OF VISUAL INSPECTION
 JANUARY 1979
 PLATE B-1

a. General. The overall appearance of the dam is poor. Deficiencies were observed as noted below. A sketch of the dam with the location of some deficiencies is presented in Appendix B on Plate B-1. Survey information acquired for this report is summarized in Appendix B. On the day of the inspection, the pool was 1.4 feet below spillway crest.

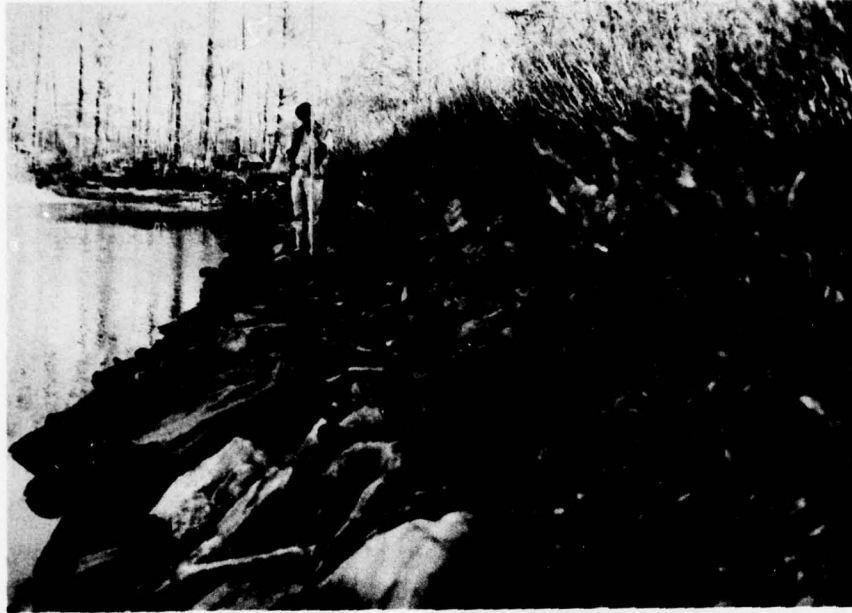
(2) Embankment. Brush and trees on the embankment slopes or at the toe are undesirable. The failure of the dry masonry wall and the accompanied embankment slide at the top of the dam along the upstream slope is of major concern. The embankment sliding behind the wall indicates that the failure of the wall was a shear type failure. The slide surface is relatively fresh in some areas indicating that movement was relatively recent. It was not possible to determine if the failure was a shallow shear failure or a deep-seated shear failure, however, the failure appeared to be a shallow shear failure. Because of the slide in some areas, the top width of the embankment is only about 4 feet wide. Where the dry masonry wall failed, there is no upstream slope protection at the top of the dam. A review of photographs in the PennDER files shows that the top of dam was approximately level in 1914. Subsequent photographs and Plate 2 show that failure of the dry masonry wall and accompanied embankment failure has been occurring over an extended period. The downstream slope is steeper than the design slope listed in the Pennsylvania Water Supply Commission Report of 1914. The steep downstream slope may be related to the bulges observed at the toe. It was not possible to determine if the wet areas and seepage at the downstream toe of the slope were related to seepage from the embankment or to poor surface drainage.

C. Upstream Slope of Embankment.

(1) Perform additional studies to determine the extent of movement of the embankment and to ascertain the structural factors of safety for the embankment. In this regard, additional investigations will be necessary to determine the engineering soil properties of the embankment and the foundation, as well as the location of the water level in the embankment. The latter may be accomplished with the observation wells recommended below. Take remedial measures as required to restore the embankment to either its original template or a more suitable template.

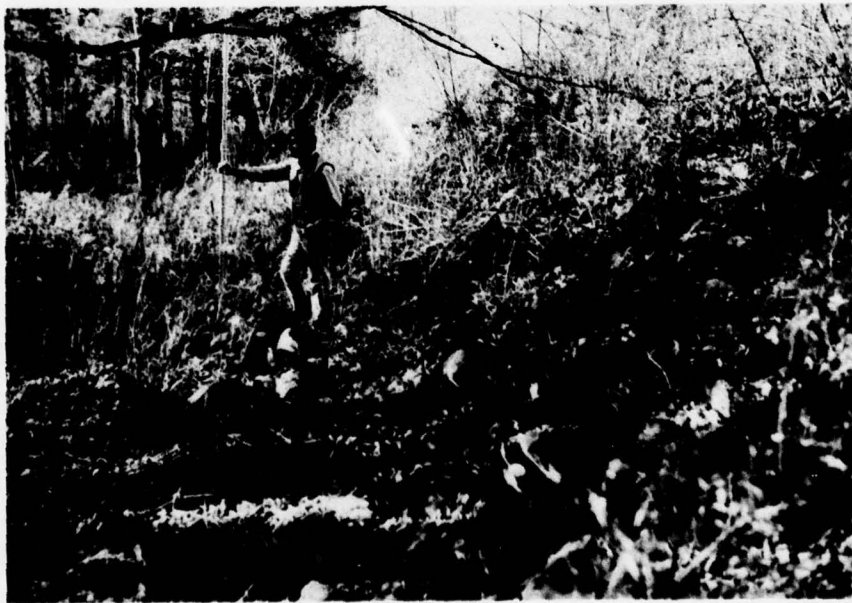
D. Downstream Toe.

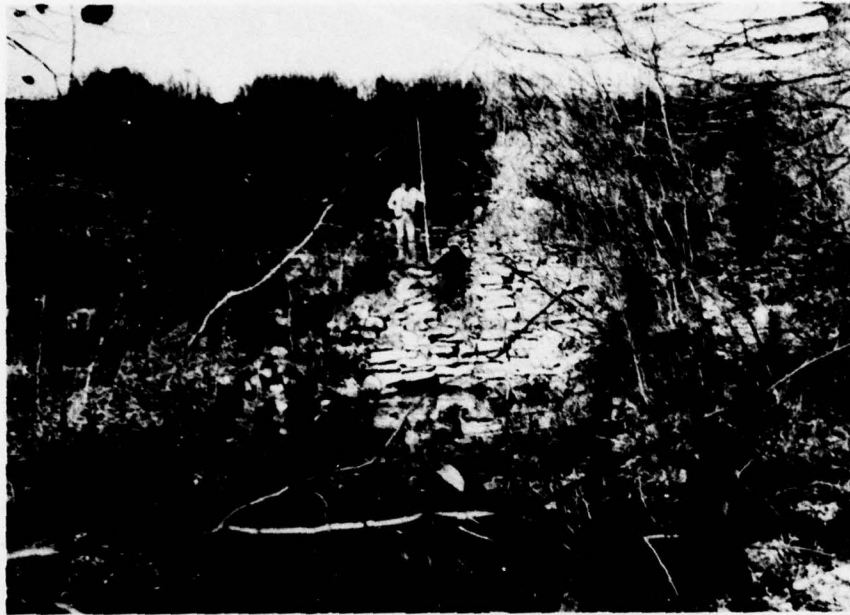
E. Outlet Works

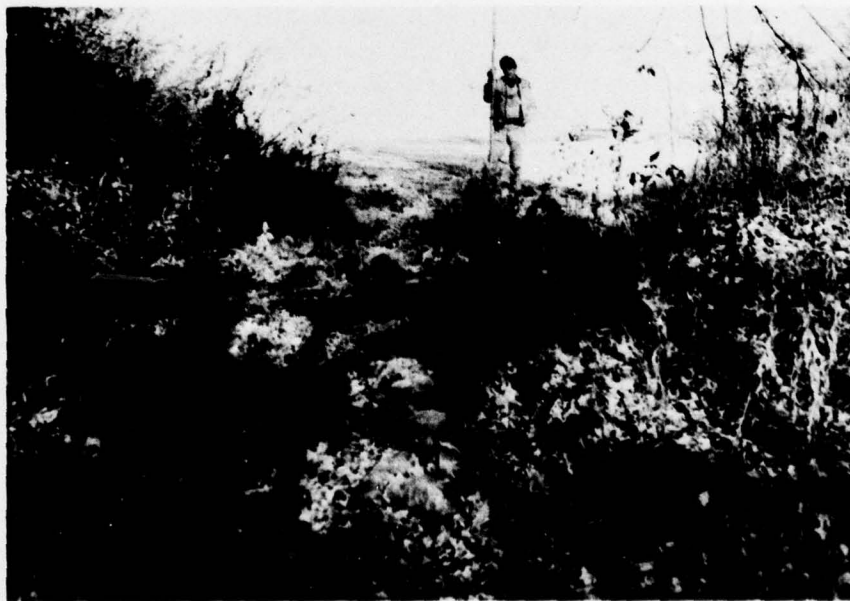
c. Appurtenant Structures. The spillway is in poor condition. The spillway control section is poorly defined. The timber spillway weir is rotted and collapsed. The spillway outlet channel is severely eroded, especially along the right bank. There is also some debris in the channel. The outlet works is in good condition; however, most of the outlet works could not be viewed. The operating platform was constructed with dry masonry, which abut the embankment on 3 sides. On the day of the inspection, the outlet works valve was partially open; water was being released into Rattlesnake Creek. The end of the pipe is beneath the dry masonry operating floor ledge. The end of the pipe could not be inspected or measured. The valve stem protrudes through the operating floor. There did not appear to be any means of access to the valve without removing the dry masonry operating floor.

F. Spillway - Looking Upstream.

(2) Perform additional studies to more accurately ascertain the spillway capacity required for Maple Lake Dam as well as the nature and extent of mitigation measures required to make the spillway hydraulically adequate and to remove the erosion hazard. Designing the dike to be overtopped may be a suitable approach, but the spillway should be provided with a weir and the spillway channel should be protected against erosion.

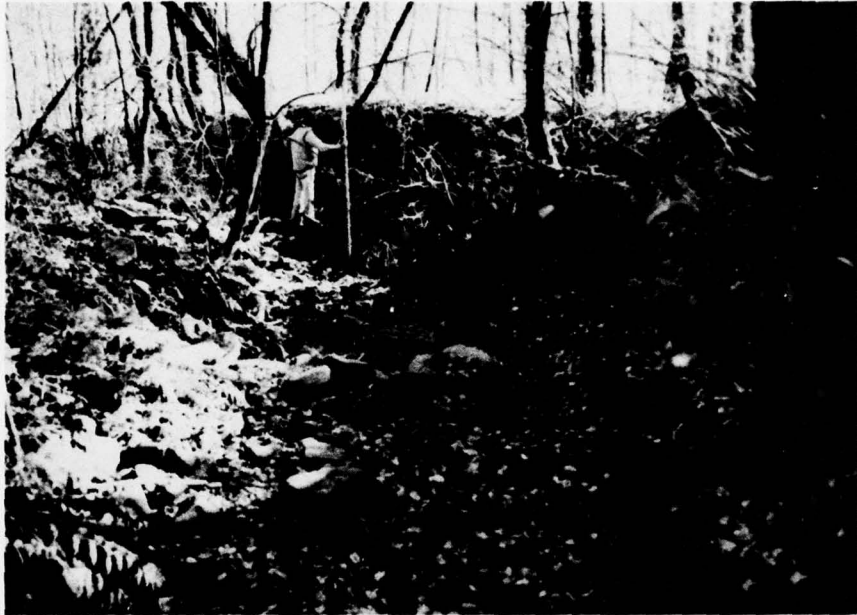
G. Spillway Outlet Channel - Looking Downstream.

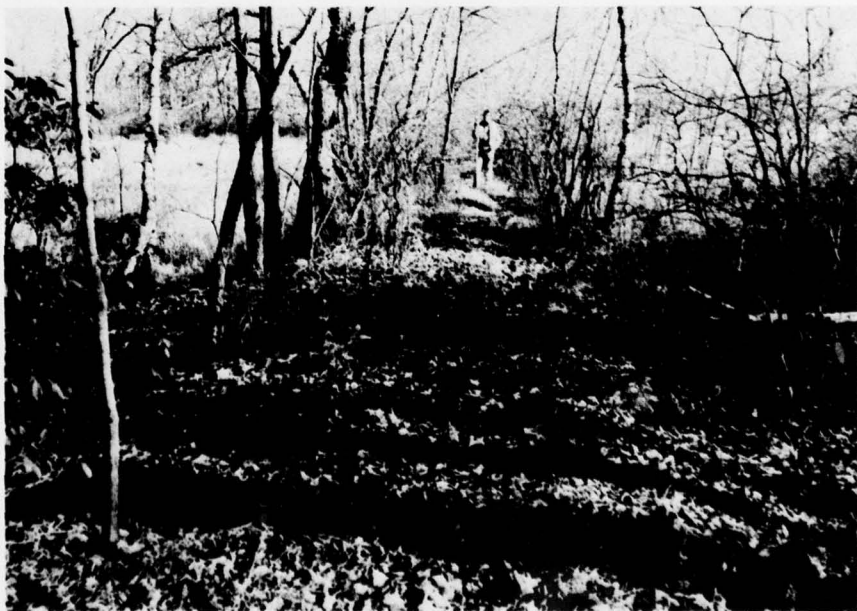
Brush and trees on the dike are undesirable. The uneven top elevations on the dike are probably caused by poor construction practice.

H. Dike - View from Left Abutment.
