WAYNESBURG WATER COMPANY DAM

NDI I.D. NO: PA-195

PHASE I INSPECTION REPORT  
NATIONAL DAM INSPECTION PROGRAM

WAYNESBURG WATER COMPANY DAM  
NDI I.D. NO. PA-195  
DECEMBER 18, 1978

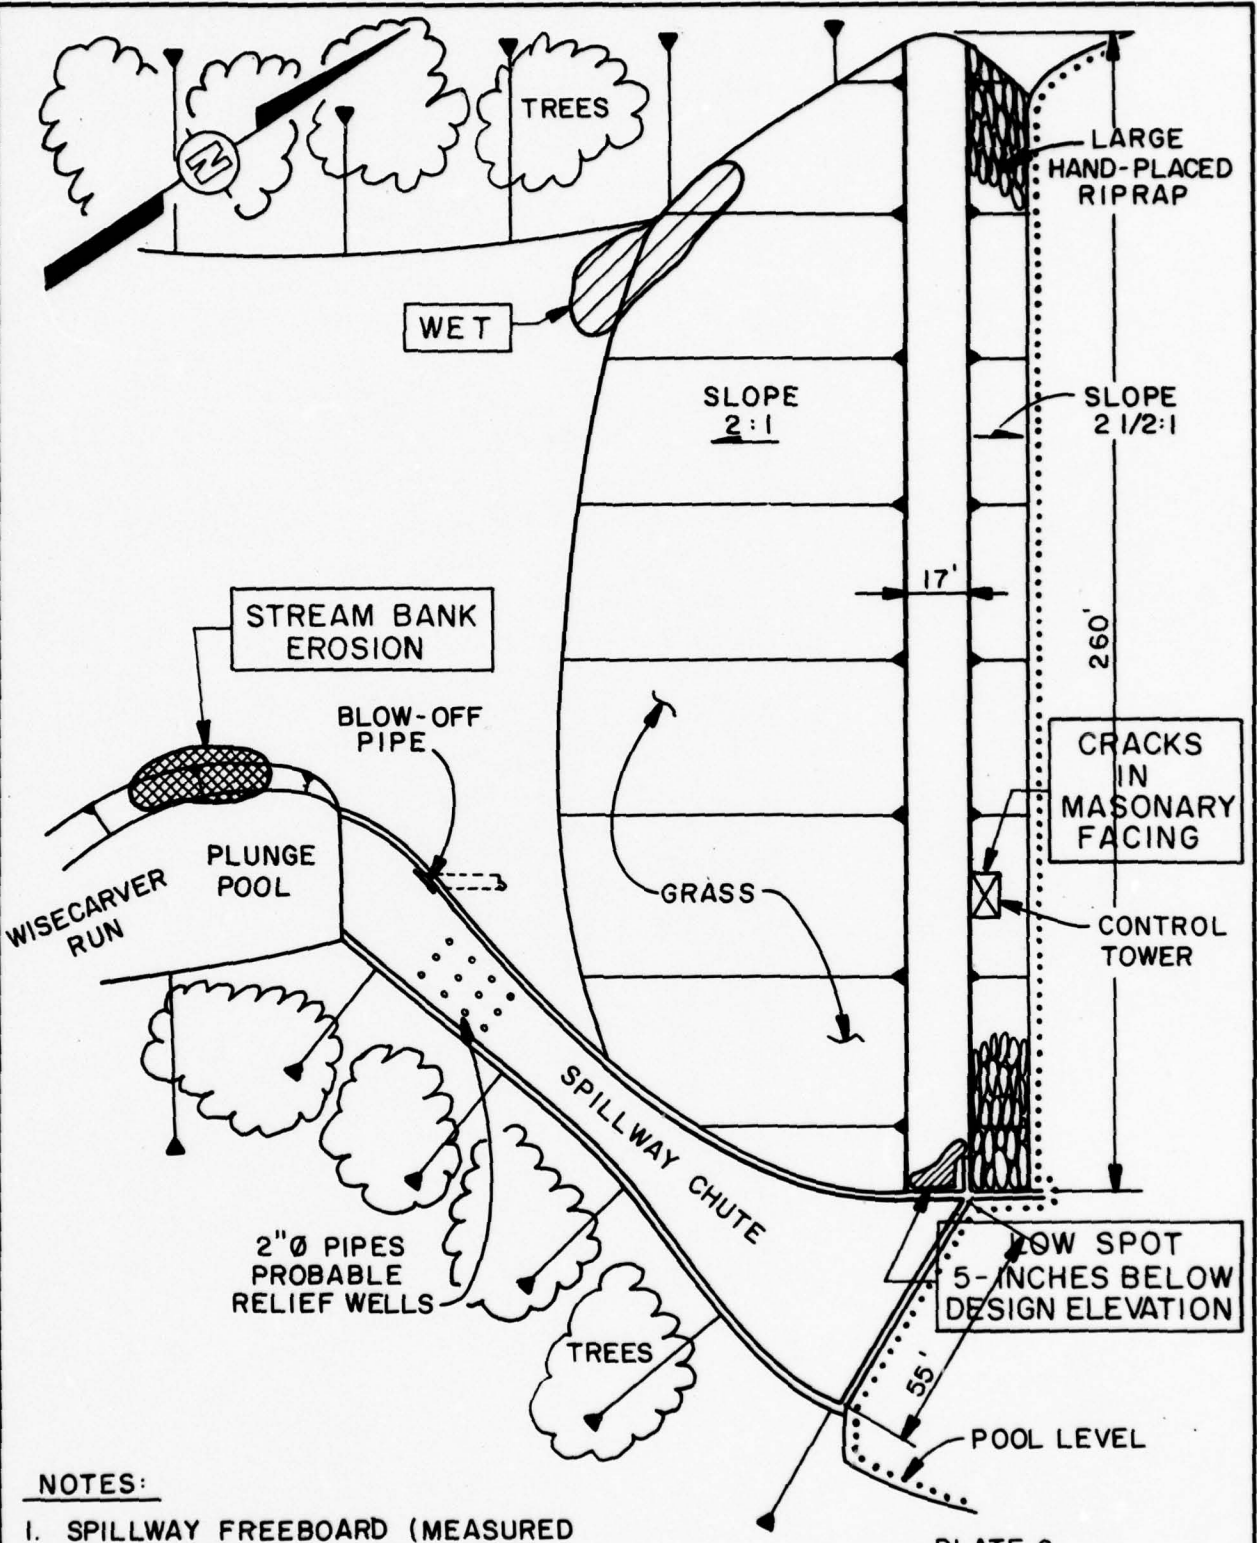
1. SPILLWAY FREEBOARD (MEASURED FROM LOW SPOT) = 5.3 FEET.
2. POOL LEVEL DATE OF INSPECTION: 1 INCH OVER SPILLWAY CREST.

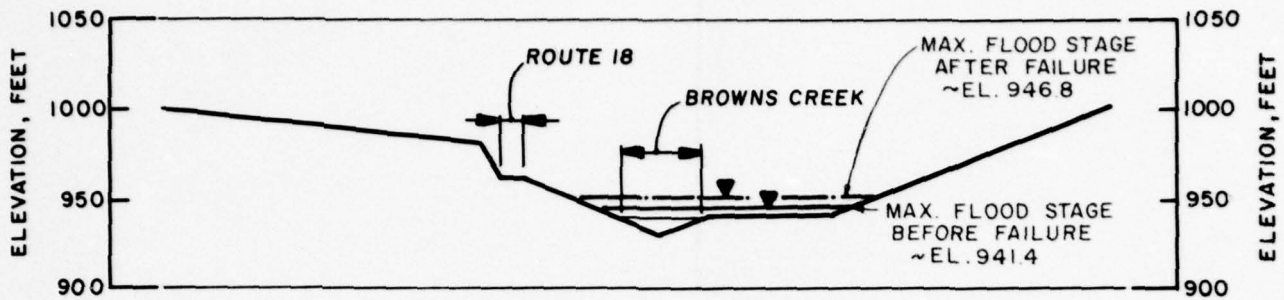
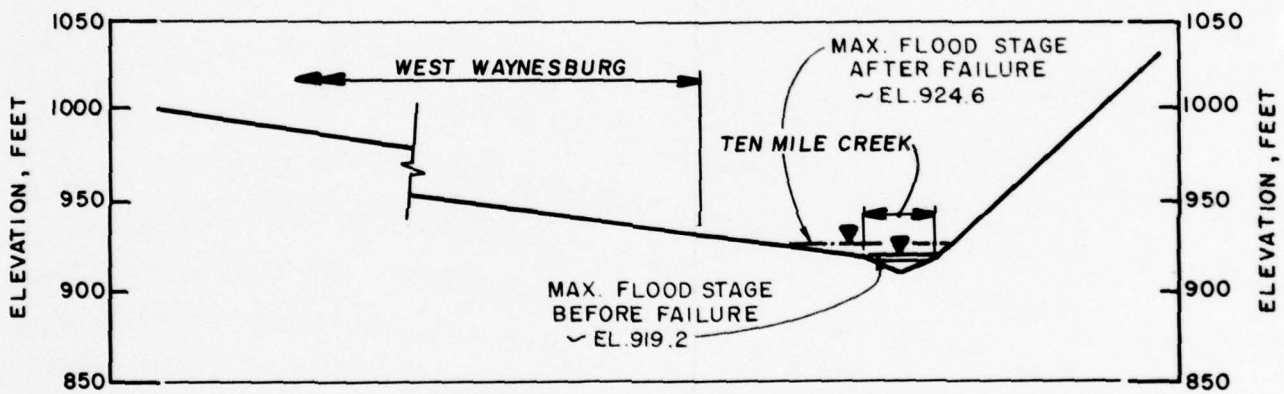
Plate 7 illustrates the cross sections at which the flood stages were determined. The first cross section, which is identified as Station 3, is located across Browns Creek immediately downstream from the mouth of Wisecarver Run. The second cross section was taken across the South Fork of Ten Mile Creek downstream from its confluence with Browns Creek. This cross section was identified as Station 4. Total flow passing through the spillway and over the dam was routed through these sections. In view of the uncertainties involved in the areal distribution of a storm that can cause overtopping failure and for the purpose of isolating and conservatively estimating downstream effects of flow from the dam site alone, discharge from Browns Creek and the South Fork of Ten Mile Creek were neglected in determining the flood stages. The flood stages that would exist just before overtopping failure of the dam are identified in the cross sections in Plate 7. Computer outputs labeled as Step 1 show the flood stages in the potential drainage area (Station 4) prior to overtopping failure.

Review of the flood stages in the potential damage area before and after failure indicates that flood stages would be raised by about five feet due to dam failure, and this is considered to be a significant increase in the loss of life or damage potential. Therefore, the spillway is classified to be seriously inadequate.

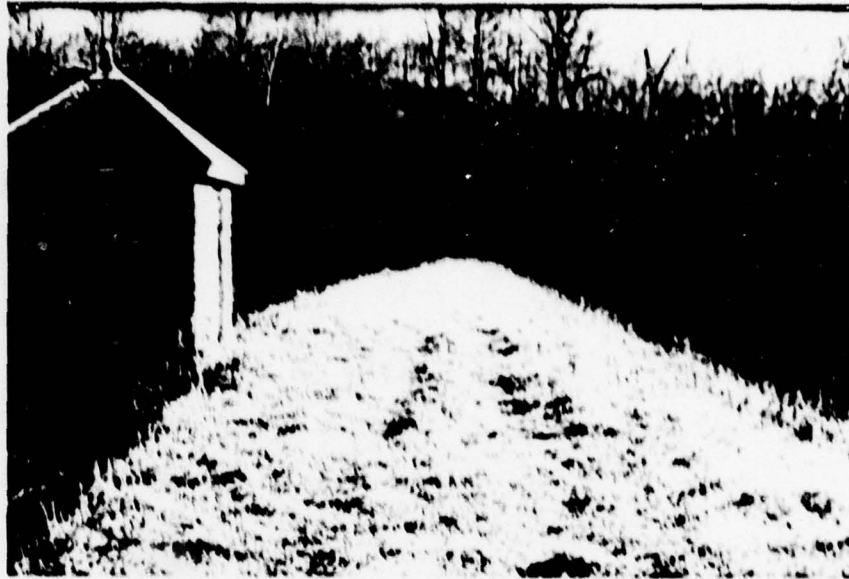
The top of the dam was surveyed relative to the spillway crest elevation and was found to have some vertical irregularities. While the design freeboard for the dam was 6 feet, the survey indicated freeboards ranging from 5.4 to 5.8 feet. The lowest area occurred in a short section adjacent to the spillway.

Photograph No. 1  
Crest (looking east).

3. Crest of the embankment should be surveyed to establish the extent of low areas and the low areas should be filled to design elevation.
4. Around-the-clock surveillance should be provided during unusually heavy runoff and a formal warning system should be developed to alert the downstream residents in the event of an emergency.
5. The dam and appurtenant structures should be inspected regularly and necessary maintenance should be performed.

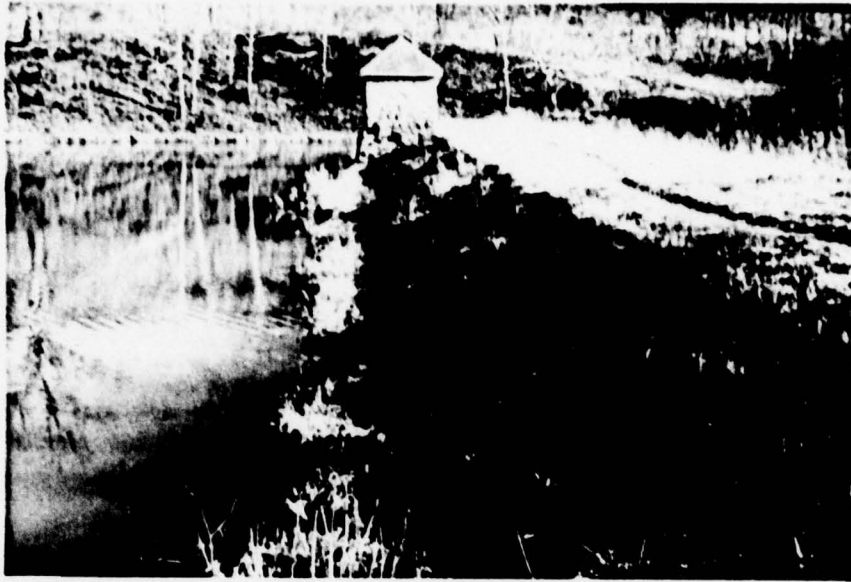
4.3 Maintenance of Operating Facilities. The maintenance of the operating facilities is considered to be fair. Due to inadequate access into the control tower, the blow-off valve located at the bottom of the control tower was not observed. However, the blow-off valve was operated and observed to be functional. Water company personnel reported that the blow-off valve is operated annually. However, no formal records of valve operation are being maintained.

Photograph No. 5  
Control tower.
