PA-479 DAM

NDI I.D. NO: PA-509

PHASE I INSPECTION REPORT  
NATIONAL DAM INSPECTION PROGRAM

✓ D'APPOLONIA CONSULTING ENGINEERS  
10 DUFF ROAD  
PITTSBURGH, PA. 15235  
MARCH 1979

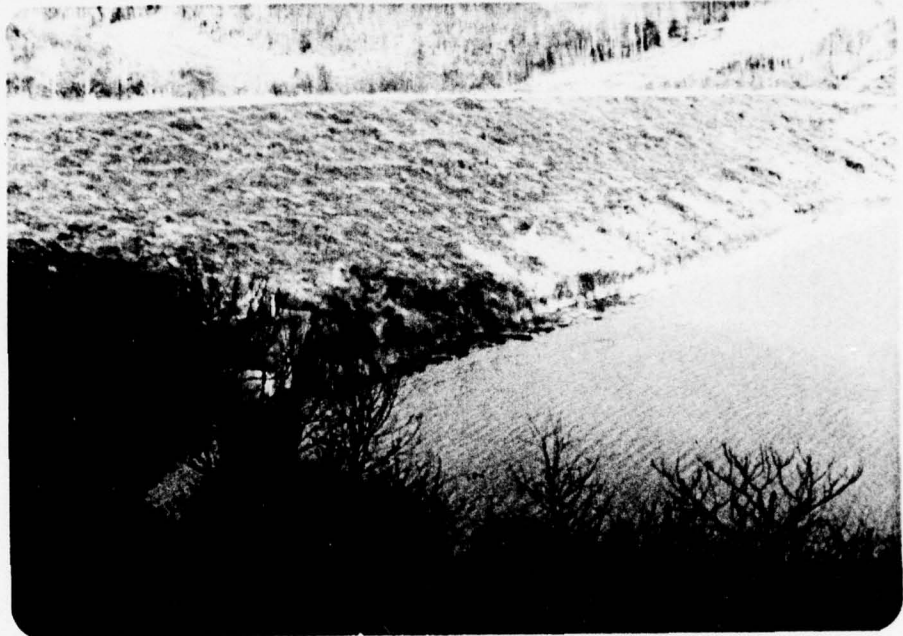
Upstream Face

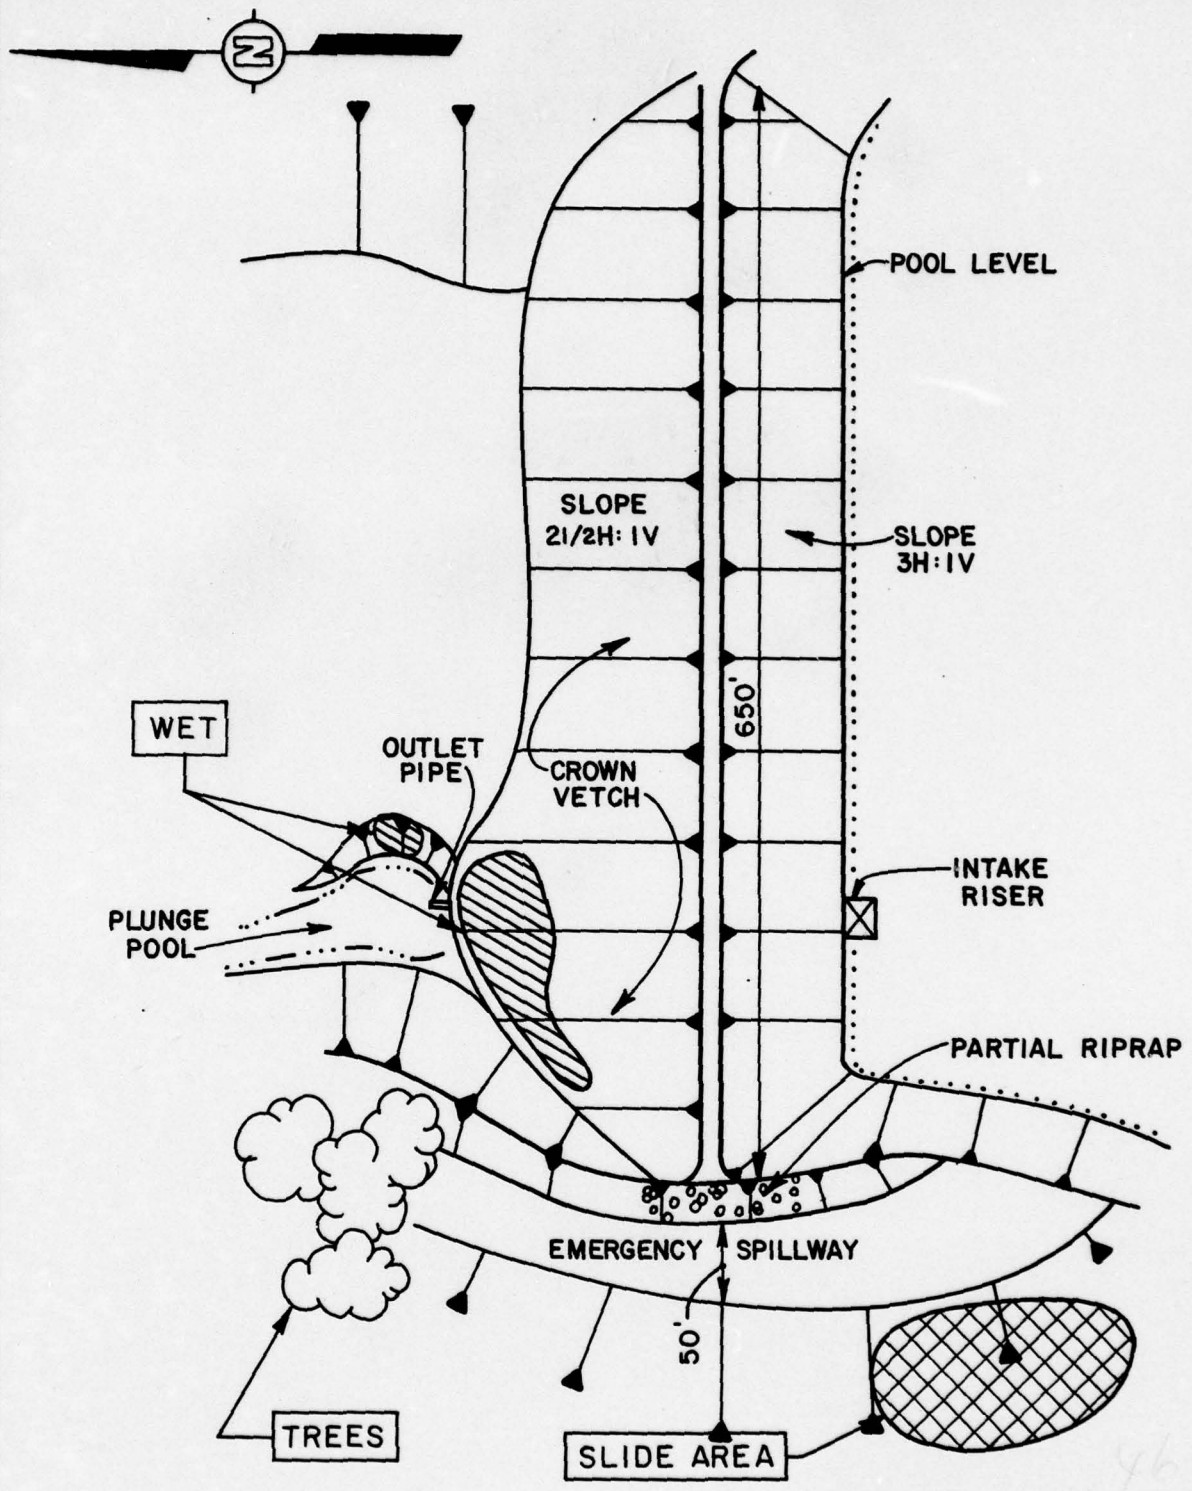
PLATE 12  
 PA.479 DAM  
 GENERAL PLAN  
 FIELD INSPECTION NOTES  
 FIELD INSPECTION DATE: DEC. 5, 1978

- NOTES:**
1. EMERGENCY SPILLWAY FREEBOARD: 5.1 FT.
  2. POOL LEVEL DATE OF INSPECTION: 30.3 FT. BELOW CREST OF DAM

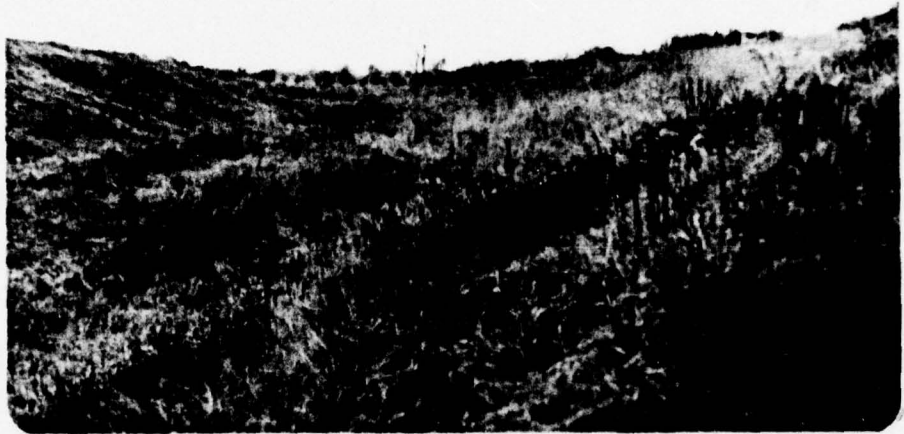
Photograph No. 1  
Emergency spillway approach channel.

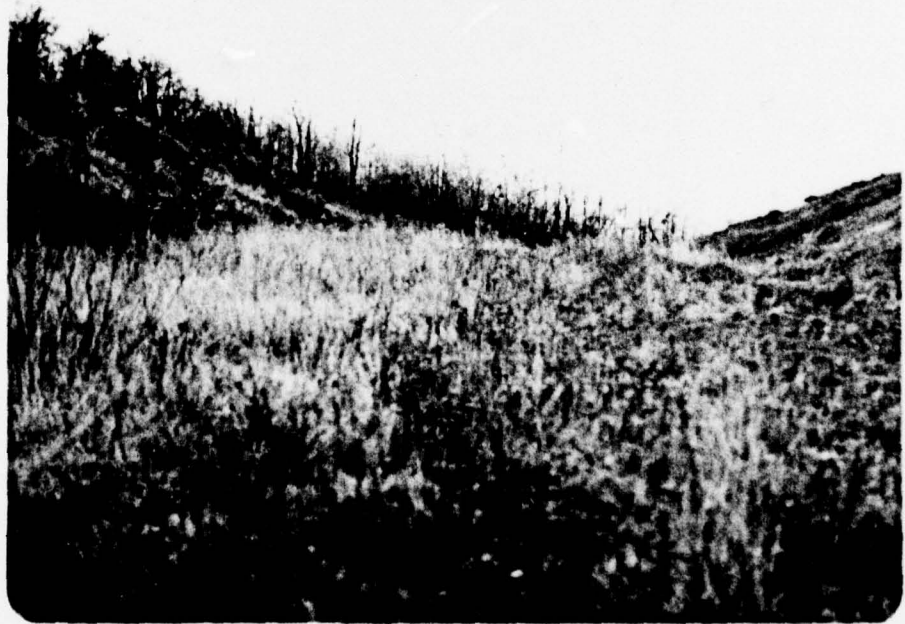
Photograph No. 2  
Emergency spillway discharge channel.

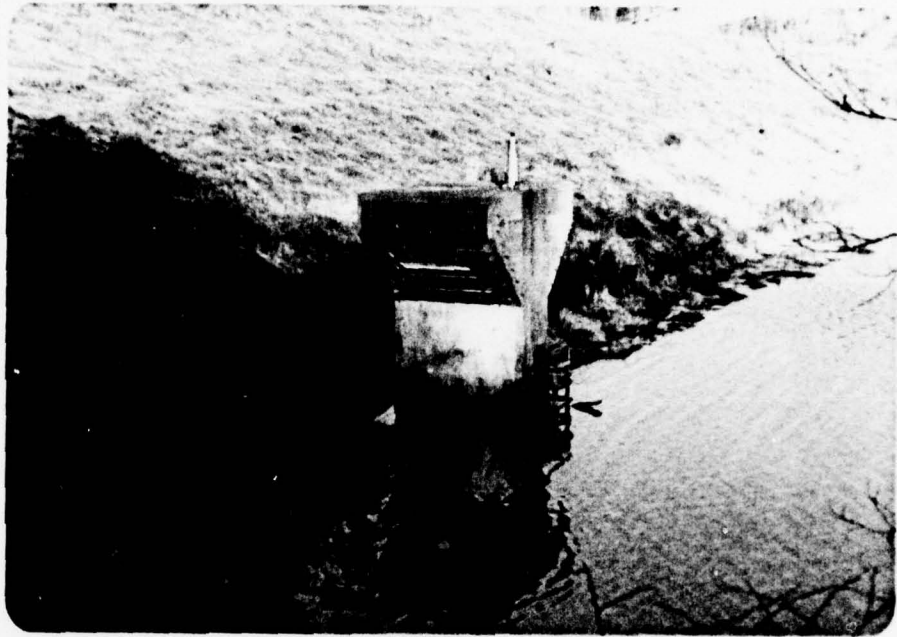
Photograph No. 3  
Primary spillway drop inlet structure.

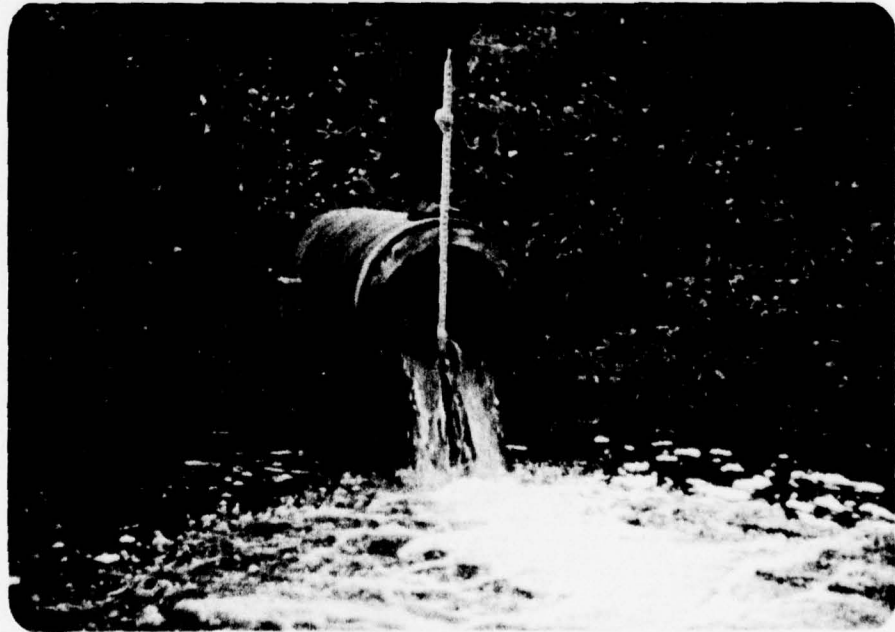
Photograph No. 4  
Outlet pipe.
