National Dam Inspection Program,
Carbondale Number 4 Dam (NDI ID Number
PA-00384, DER ID Number 35-13),
Susquehanna River Basin, Racket Brook,
Lackawanna County, Pennsylvania.

Phase I Inspection Report.

NDI ID No. PA-00384
DER ID No. 35-13

PENNSYLVANIA GAS AND WATER COMPANY

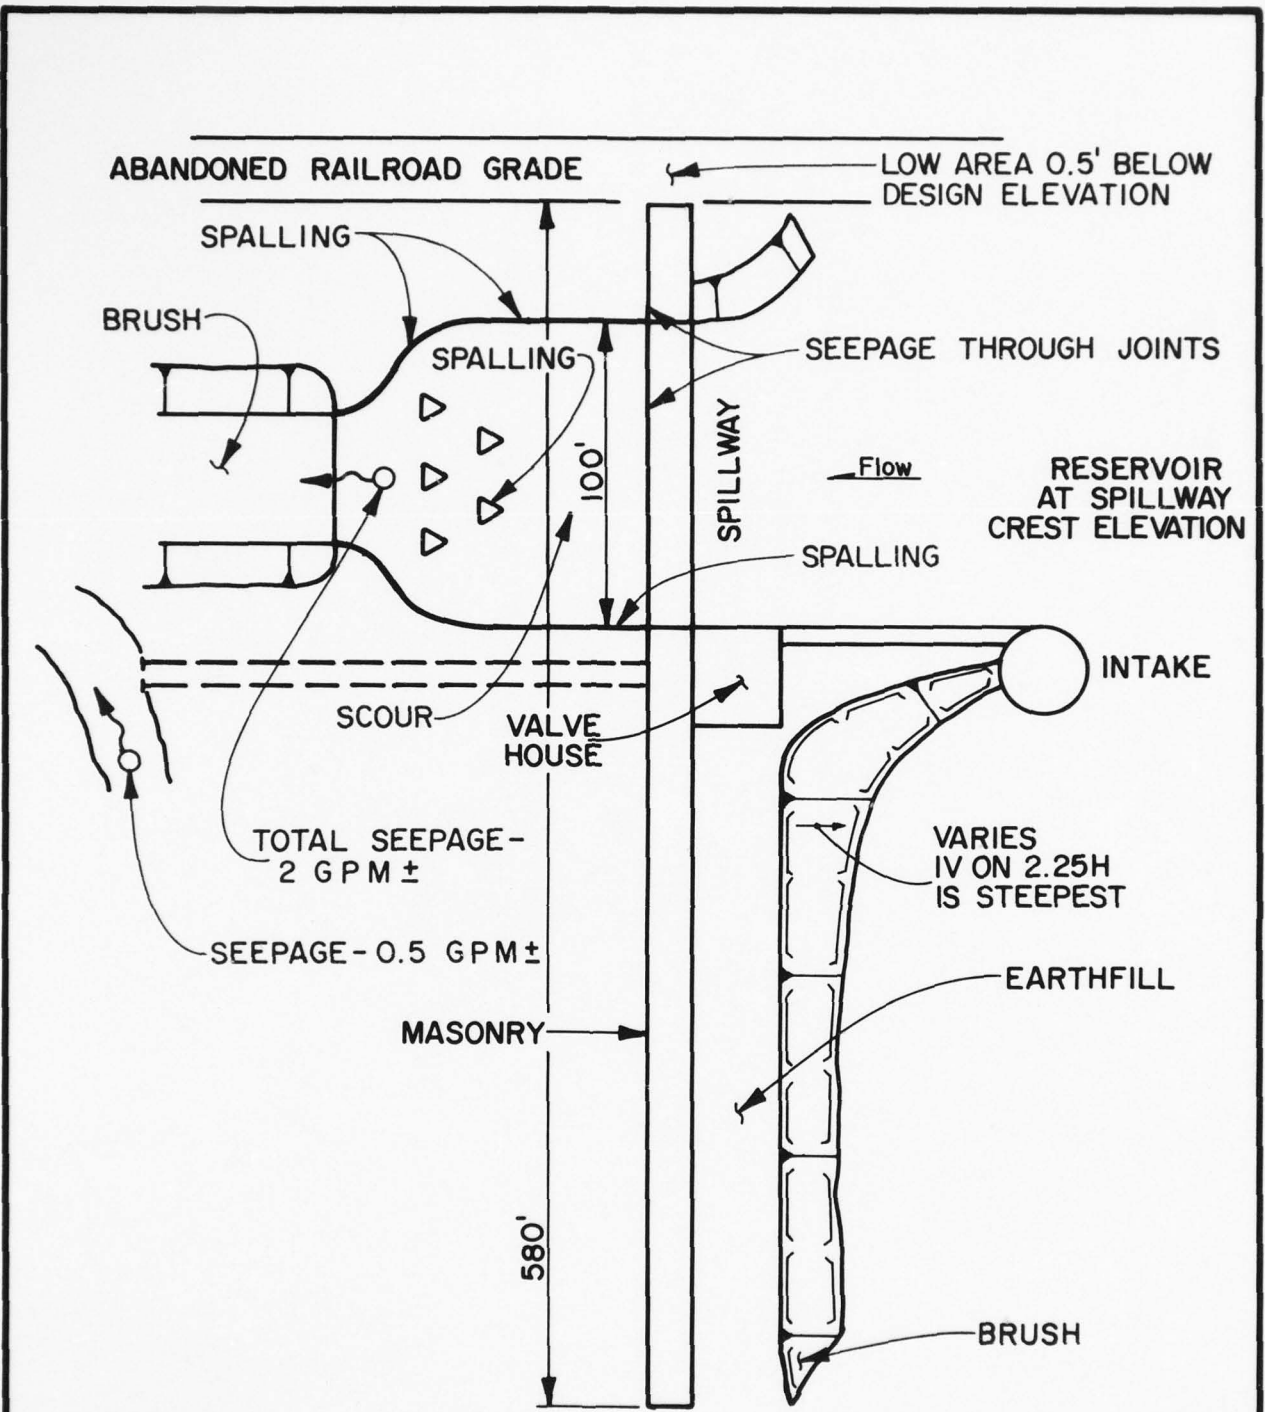
PHASE I INSPECTION REPORT
 NATIONAL DAM INSPECTION PROGRAM
 CARBONDALE NO. 4 DAM
 PENNSYLVANIA GAS AND WATER COMPANY
 RESULTS OF VISUAL INSPECTION
 FEBRUARY 1979

a. General. The overall appearance of the dam was good, with some deficiencies as noted herein. The locations of some of these deficiencies are shown in Appendix B on Plate B-1. Survey data acquired during this inspection is presented in Appendix B. On the day of the inspection, the pool was at spillway crest elevation.

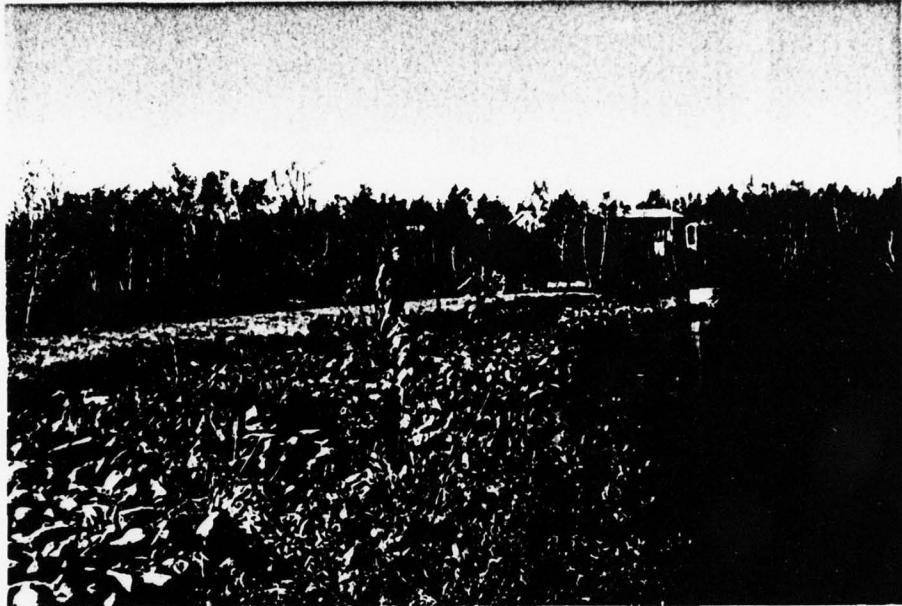
A. Upstream Slope

VISUAL EXAMINATION OF	OBSERVATIONS	REMARKS OR RECOMMENDATIONS
RIPRAP	GOOD CONDITION	
BRUSH	SPARS EXCEPT NEAR LEFT ABUTMENT WHERE IT IS THICKER.	1-3" DIA. TREE IN RIGHT ABUTMENT EMBANKMENT

- (1) Raise the top of the dam to the design elevation.
- (2) Repair the concrete in the stilling basin and the mortar in the spillway weir masonry joints.
- (3) Remove the brush from the embankment slopes and from the spillway discharge channel.

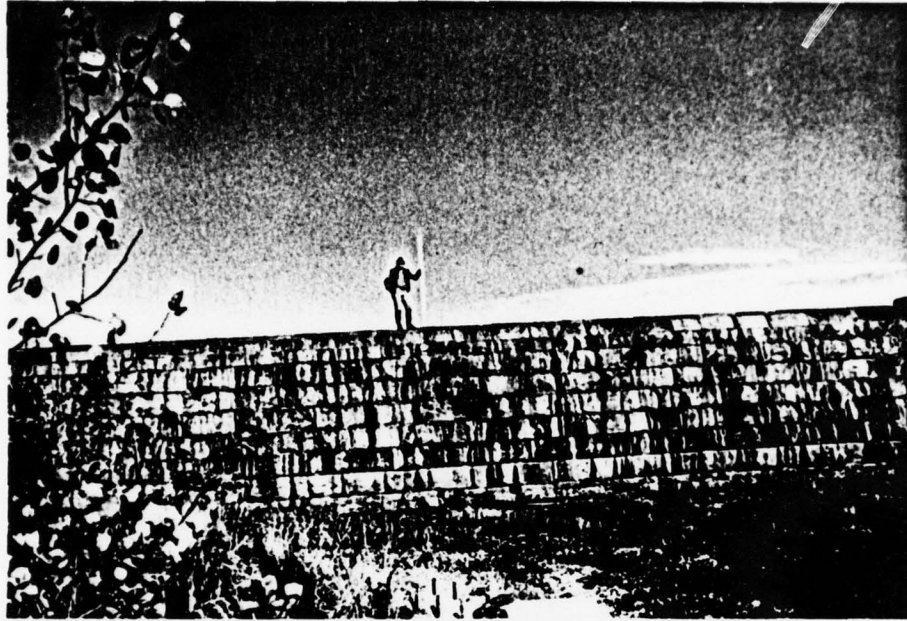
C. Spillway

The spillway is in fair condition. There is a flow of about 1 gpm seeping from a joint located a few inches below the crest. There is seepage from many other joints. The seepage is from both the joints in the spillway and those immediately to the right of the spillway (Photograph C).

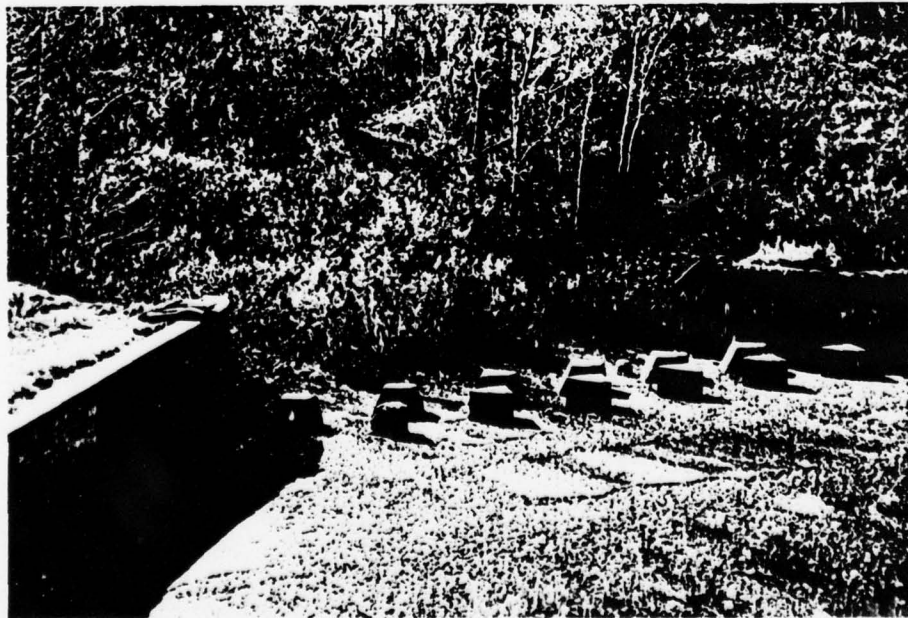
D. Spillway Outlet Channel

There are many deficiencies in the stilling basin (Photograph D). One baffle block is badly spalled. Pattern cracking and leaching were observed at the right wall. The right wall is badly spalled in many areas. The reinforcing bars are exposed along the top of this wall. There is also some spalling at the left wall near its junction with the spillway. About 80 percent of the bottom of the stilling basin is scoured. In some areas, the concrete appears to have scoured completely. A total flow of 2 gpm was observed in the stilling basin. It was not possible to determine whether this flow was seeping from beneath the stilling basin or whether it was the accumulated seepage from the spillway joints.

The brush in the spillway outlet channel will reduce its carrying capacity. The backwater effect will not reduce the spillway discharge capacity. However, it may cause overtopping of the stilling basin

walls. If the walls should overtop, erosion of the downstream earthfill would occur. Although undesirable, it would not create a significant hazard to the embankment.
