BEAR CREEK LAKE DAM

NDI-PA 00545
PA DER 40-47

PHASE I INSPECTION REPORT
NATIONAL DAM INSPECTION PROGRAM

MARCH 1979

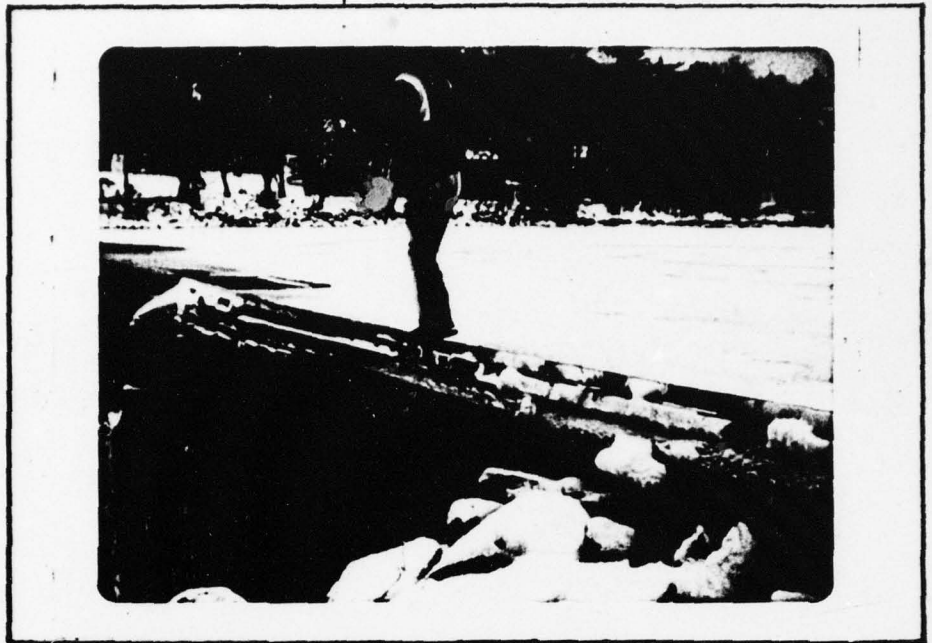
LEFT ABUTMENT SHOWING SOME TIMBER DETERIORATION

Replace timbers which
are missing or rotten
along the headwall

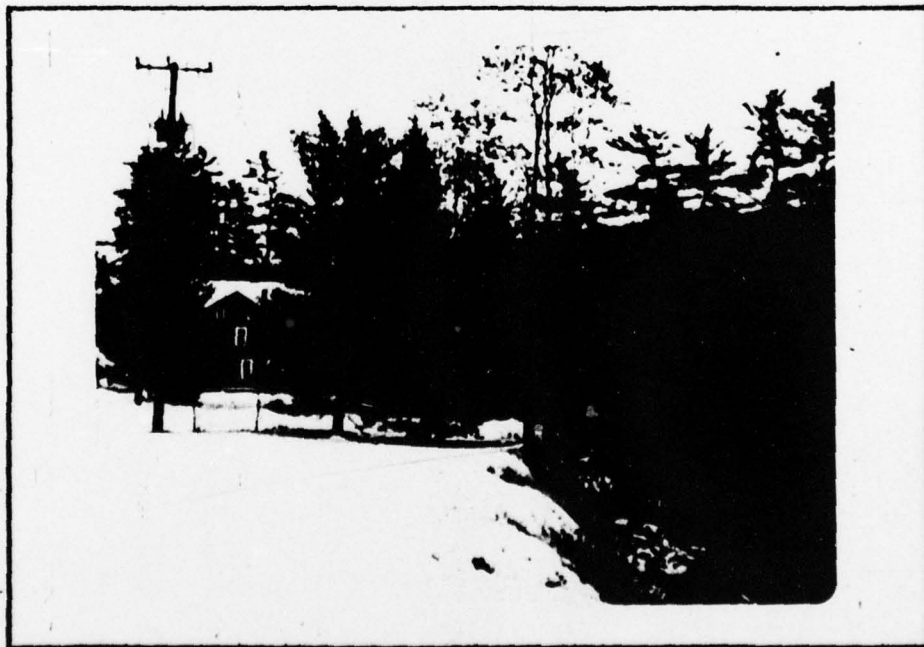
*DAMAGE AREA APPROXIMATELY 600 FEET
DOWNSTREAM FROM THE DAM*

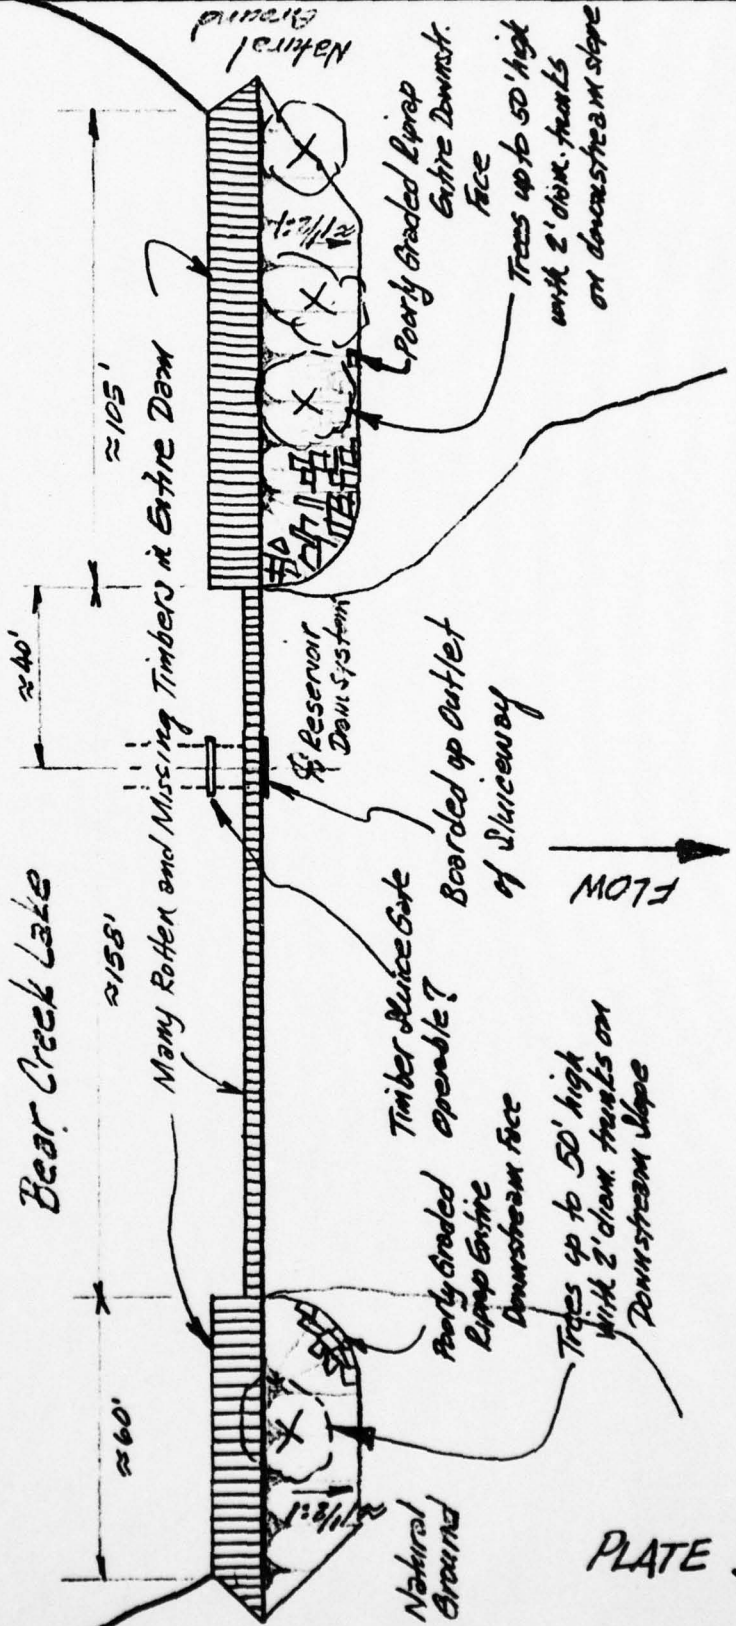
PLAN VIEW BEAR CREEK DAM AS OF 12/14/73

Dam is of rock filled timber crib construction.
