MERRIMAN DAM

PHASE I INSPECTION REPORT

NATIONAL DAM SAFETY PROGRAM.

Name of Dam: Merriman Dam
County and State: Ulster County, State of New York
Inventory Number: NY 00121

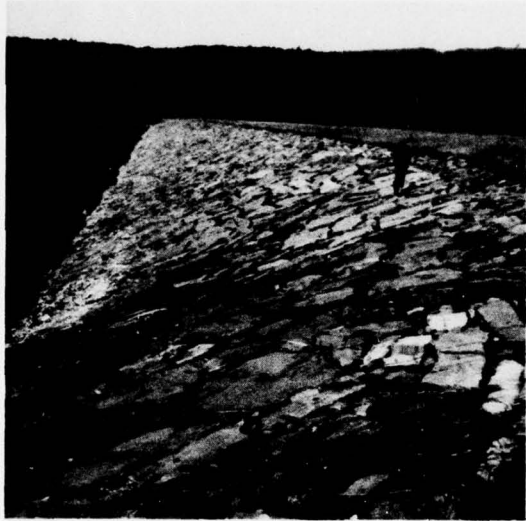
UPSTREAM FACE OF DAM

d. Upstream Face - The "Rock Paving" on the upstream face is exposed and appears to be in excellent condition. Rectangular rocks, four (4) to five (5) feet on a side and approximately two (2) feet thick, make up most of the cover of the upstream face. Smaller rocks fill the voids between these larger rocks. An attempt was made to dislodge a few of these smaller rocks by hand. In all cases, this was impossible. Weathering was apparent on the surfaces of a few of the larger rocks.

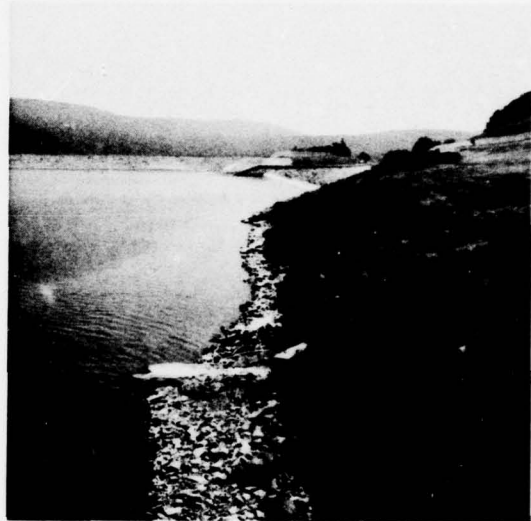
UPSTREAM FACE OF DAM, SPILLWAY AND
RIGHT BANK OF RESERVOIR

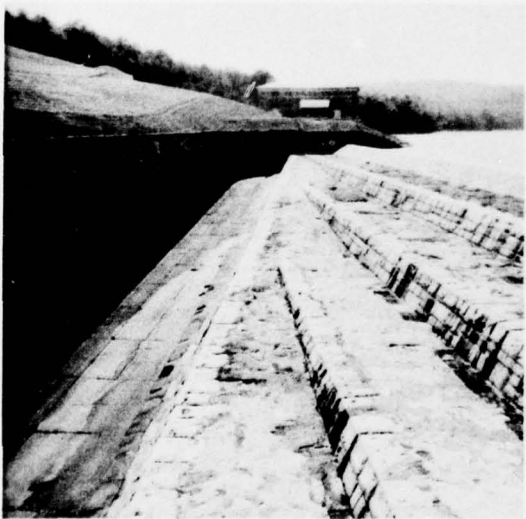
SIDE CHANNEL AND SPILLWAY

e. Overflow Spillway and Channel - The overflow spillway, channel and entrance to the discharge tunnel were examined from the top of the dam. No water was flowing over the spillway; therefore, the entire overflow structure, up to and including the tunnel entrance, was visible. The spillway, downstream channel and tunnel entrance appear to be in excellent condition with virtually no deterioration visible. There is minor seepage through the spillway about six (6) feet below the crest of the weir at the eastern end. The channel was clear and free of sediment or debris.

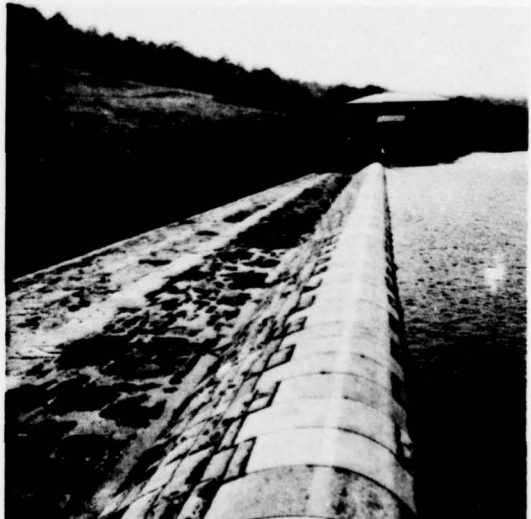
VIEW OF SPILLWAY

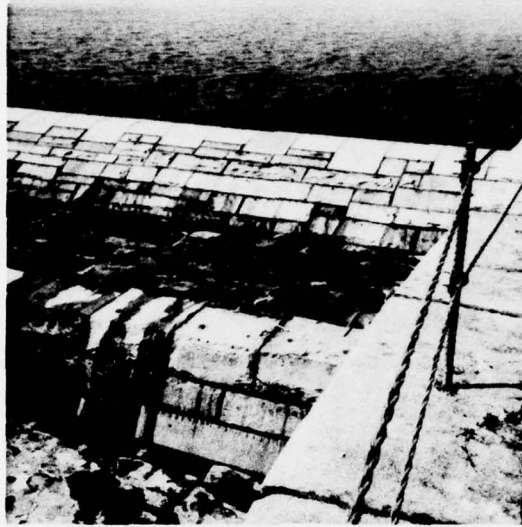
Minor seepage through the eastern end of the spillway was observed but should not affect the structural stability of the spillway section.

VISUAL EXAMINATION OF	OBSERVATIONS	REMARKS OR RECOMMENDATIONS
CUT STONE WEIR	Generally in excellent condition, minor seepage through the spillway approximately 6' below the crest near the eastern end.	Monitor seepage, insure that it does not increase. If increase occurs, make structural repairs.
APPROACH CHANNEL	Excellent condition.	None.
DISCHARGE CHANNEL A-8	Excellent condition. Well-maintained, free of debris, adequate to pass probable maximum flow.	None.
BRIDGE AND PIERS	None.	None.

SPILLWAY SHOWING SEEPAGE

2. Seepage through the eastern section of the spillway should be monitored; if the flow increases, remedial measures should be taken. A partial drawdown of the reservoir may be necessary to make the necessary repairs at the source of the flow.

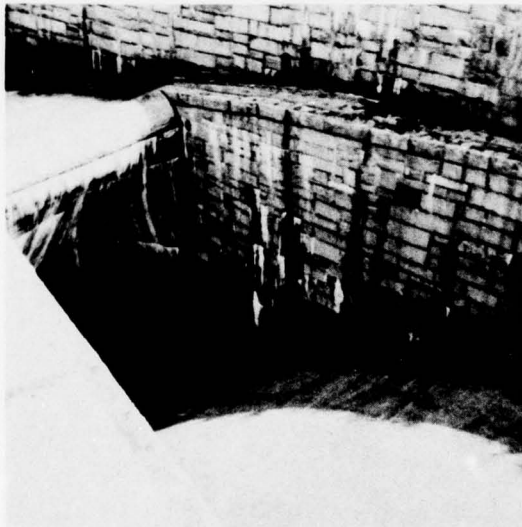
ENTRANCE TO TUNNEL AT DOWNSTREAM END OF CHANNEL
