# SENECA FALLS DAM

PHASE I INSPECTION REPORT  
NATIONAL DAM SAFETY PROGRAM

Name of Dam: Seneca Falls Dam  
County and State: Seneca County, New York State  
Inventory Number: NY 00708

Name of Dam: Seneca Falls Dam  
State Located New York  
County Located Seneca  
Stream Seneca River  
Date of Inspection June 5, 1978

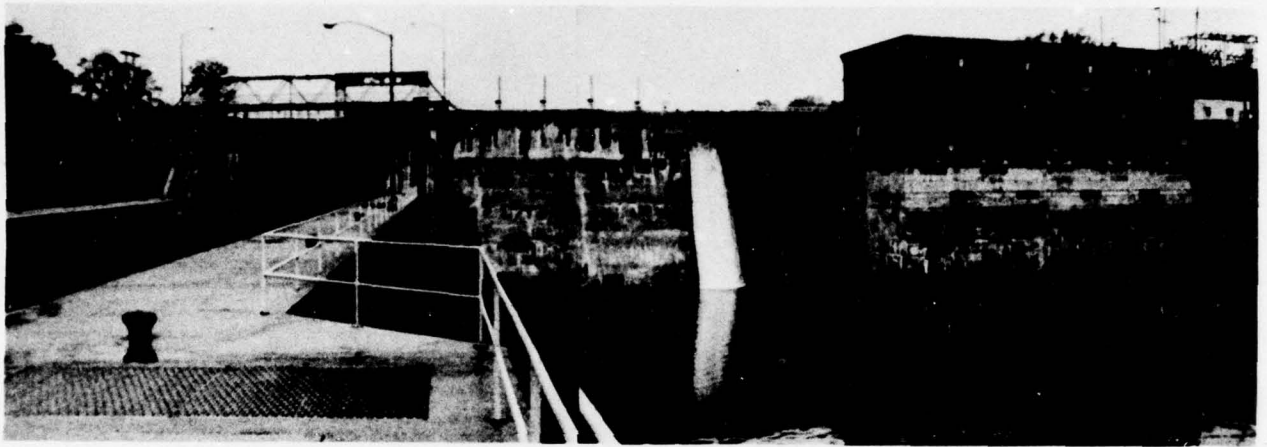
The Seneca Falls Dam appears to be in good condition and is well maintained. No significant deficiencies were noted during the visual inspection. However, based on the hydrologic analysis, the Probable Maximum Flood (PMF) would cause overtopping of the dam by about 7 feet. The concrete structures might withstand overtopping, but severe damage or failure of the earth embankments would be expected.

OVERALL VIEW OF DAM

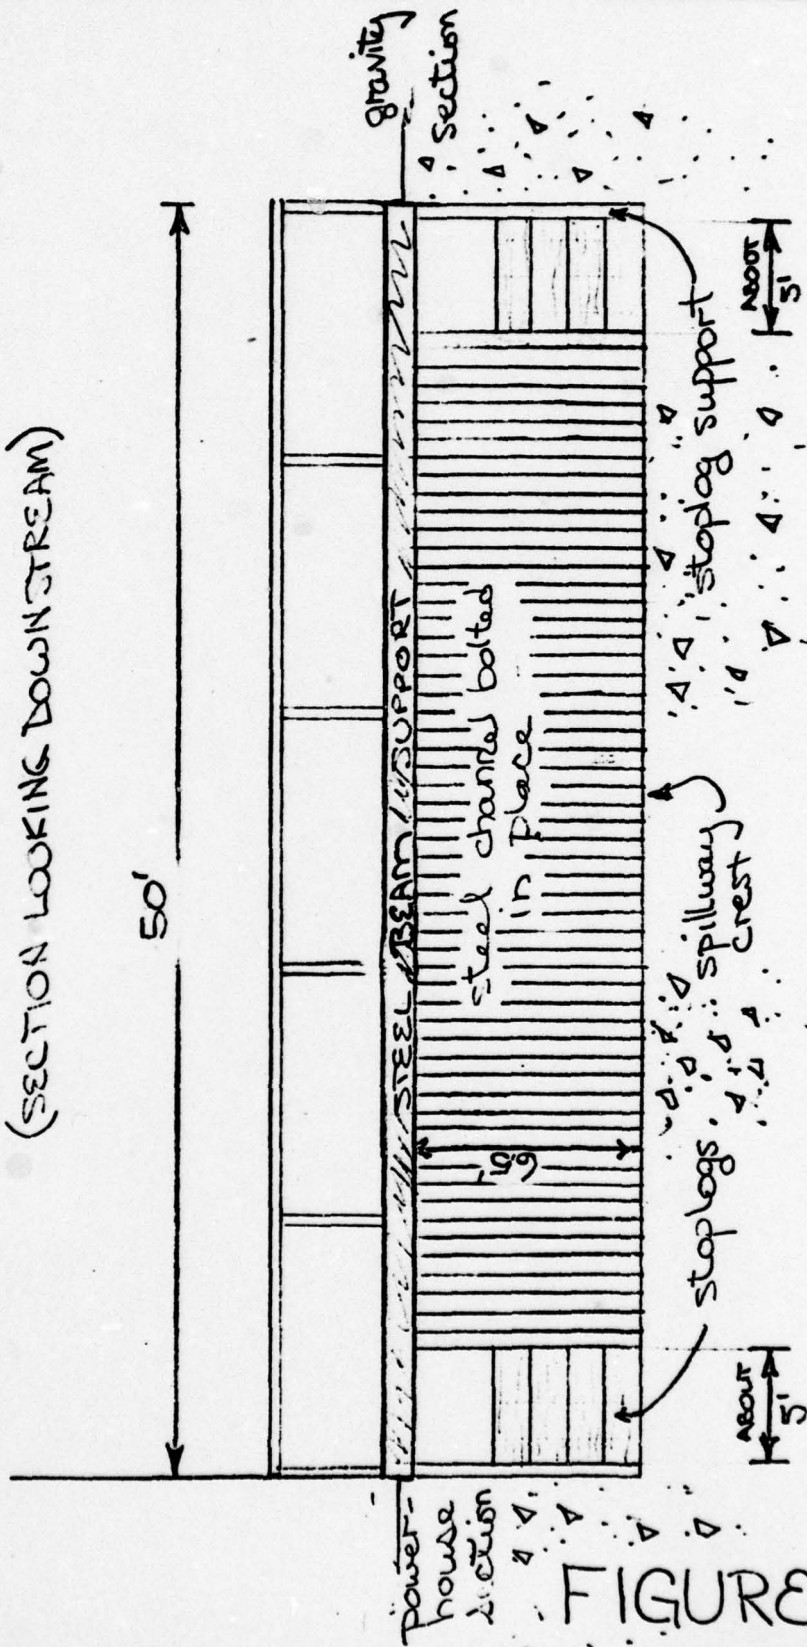
FIGURE 3

LONGITUDINAL SECTION OF OVERFLOW SPILLWAY  
AT SENECA FALLS DAM SHOWING THE  
LOCATION OF THE STOPLOGGED OPENINGS  
(SECTION LOOKING DOWNSTREAM)

VISUAL EXAMINATION OF	OBSERVATIONS	REMARKS OR RECOMMENDATIONS
CONCRETE WEIR	The overflow spillway appears to be in good condition. No spalling or cracking was noted. The spillway has been blocked as shown on Figure 3.	The weir should be provided with removable stoplogs or flashboards for the entire length.
APPROACH CHANNEL	None.	None.
DISCHARGE CHANNEL	Discharge is into the tailwater pool downstream of the dam.	None.
BRIDGE AND PIERS	The spillway is provided with a clearspan serviceway.	None.

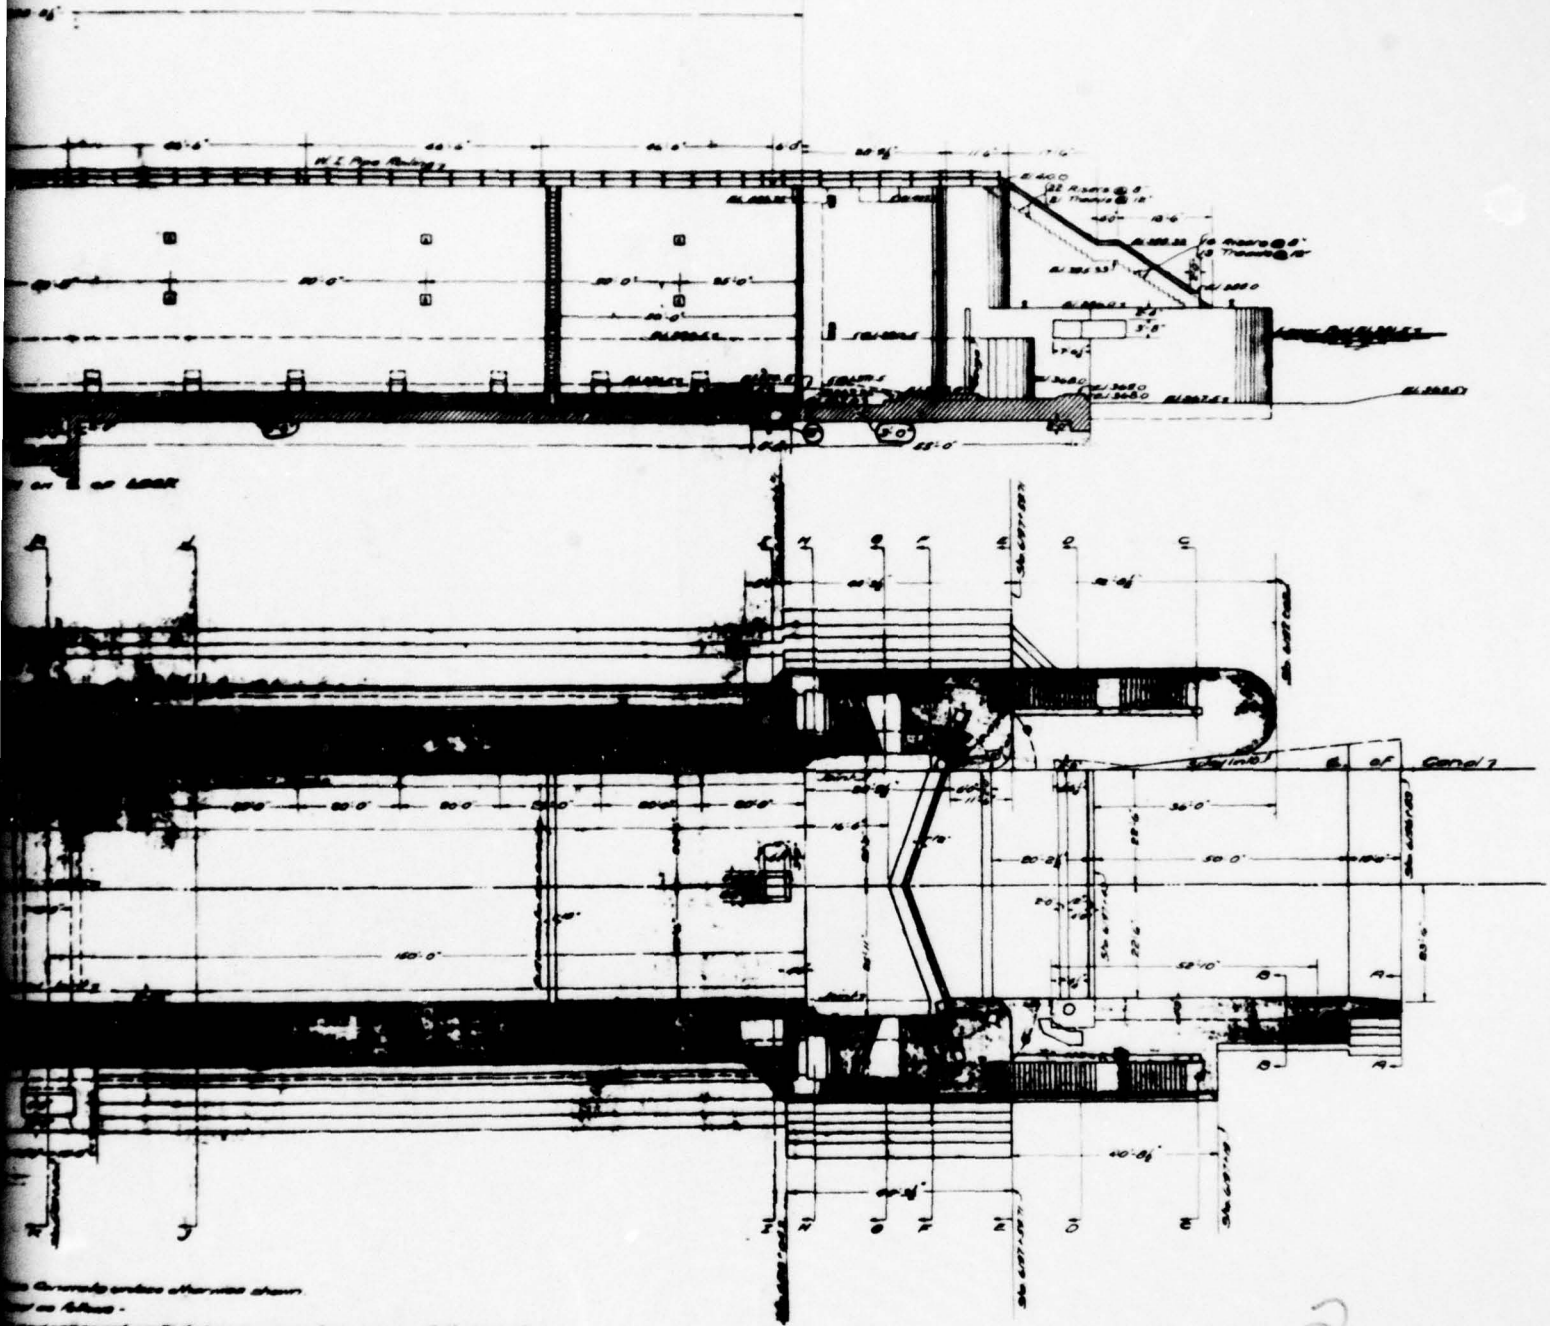
**FIGURE 4**

The lock structures (See Figures 4 and 5) appear to be in excellent condition. Operating personnel stated that extensive remedial work on the lock structures was completed in November, 1977. According to Mr. Michael LaVere, lock operator, the top 6 to 12 inches of concrete was removed from all of the lock structures, followed by resurfacing. Viewing the north lock wall from the concrete gravity section of the dam, some of the older concrete of the wall was observed to be exposed below the extent of resurfacing. Some aggregate is exposed, but the concrete appears to be in good condition. All steel walkways, railings, and structures have been recently painted. The lock system was operated during the inspection visit, and was found to be in excellent condition. The lock gates can be operated from any of three control panels located on the south walkway, or from the control building.

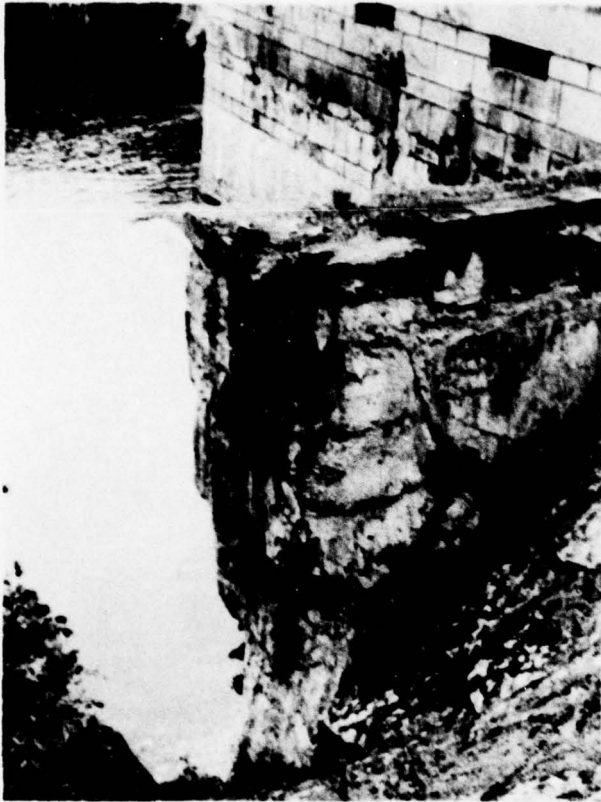
POWERHOUSE  
RETAINING WALL

Weep holes were observed at the powerhouse retaining wall. The weep hole near the tailwater elevation was discharging about 1 gpm of clear water.
