LAKE TIORATI DAM
PHASE I INSPECTION REPORT
NATIONAL DAM SAFETY PROGRAM

NY 00043

Name of Dam: Lake Tiorati Dam
County and State: Orange County, State of New York
Inventory Number: NY 43

PHASE I INSPECTION REPORT
NATIONAL DAM SAFETY PROGRAM

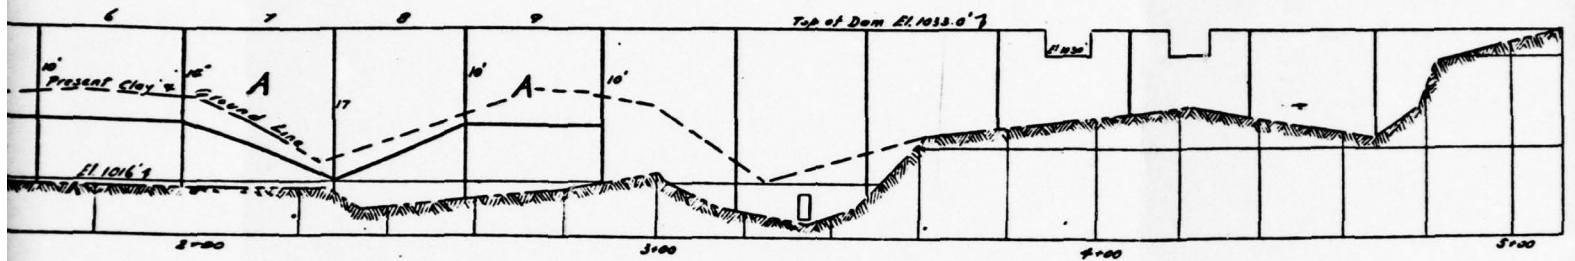
ELEVATION
 SCALES: 1"=20' HOR. 1"=10' VERT.

NOTE: SECTIONS MARKED "A" ARE WHERE
 CONCRETE WAS AFFECTED BY FROST
 ACTION IN ORIGINAL DAM

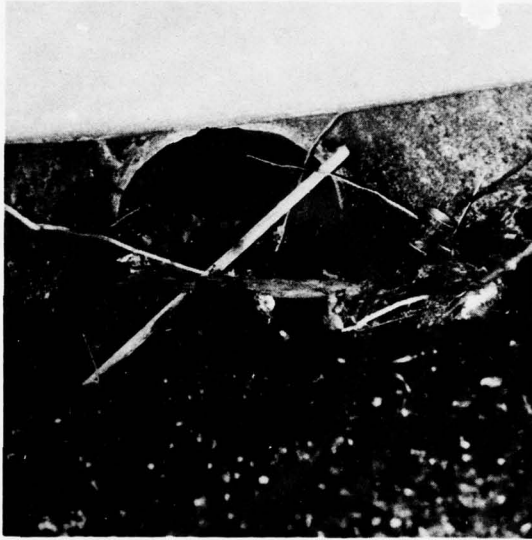
DEBRIS IN UPSTREAM CONDUIT OPENING

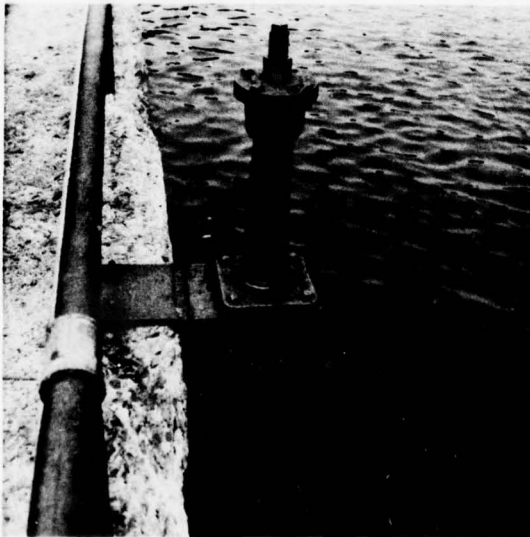
No operable means of drawdown is available at the Lake Tiorati Dam. The placement of the earth embankment on the downstream face has buried the outlet through the concrete structure. A sluice gate is shown on the plans, and the stem was observed during the field inspection. It is reported that the mechanism is not operable.

OPERATING MECHANISM OF SLUICE GATE

The outlet conduit is a 36 inch square channel with a sluice gate at the inlet. The inlet channel is at the bottom of the reservoir and was not inspected. According to Bob Santbro, the sluice gate is not operational.

Repairs of the sluice gate should be commenced to allow the reservoir to be drained in an emergency situation.

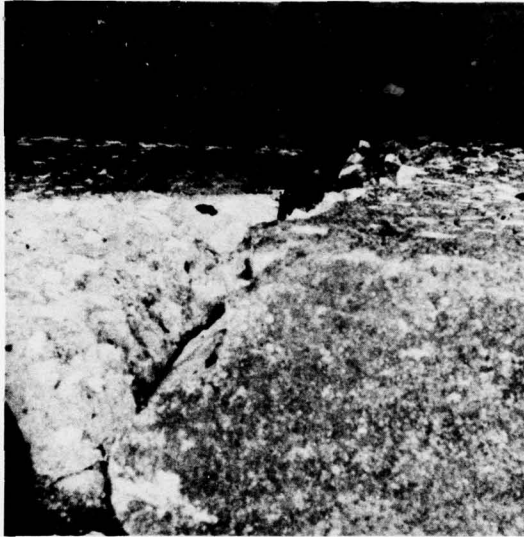
Seepage at the downstream toe of the earth embankment indicates the possibility of some small leakage through the vertical construction joints. This leakage might create future problems concerning the embankment fill, but should not affect the stability of the concrete dam unless the flow increases.

CRACKED AND SPALLED CONSTRUCTION
JOINT ON UPSTREAM FACE

The construction joints are in poor condition. Spalling and cracking was observed in joints in the middle of the upstream face. Also these joints had undergone horizontal movement. The joints have no bituminous material to seal them.

- 1) The spalled upstream face of the concrete should be repaired by guniting or a similar repair process.
- 2) A flexible adhesive sealing compound should be applied to the upstream portion of the vertical construction joints to reduce ice damage and seepage.
- 3) The spillway transition chambers should be cleaned of all debris.
- 4) Trash racks should be installed at the spillways to prevent further accumulation of debris.
- 5) The outlet area from the spillways should be provided with a clear and well defined channel to permit unobstructed flow.
- 6) The sluice gate should be restored to its original working condition and its outlet conduit extended through the roadway fill. This will permit draining the reservoir when needed.

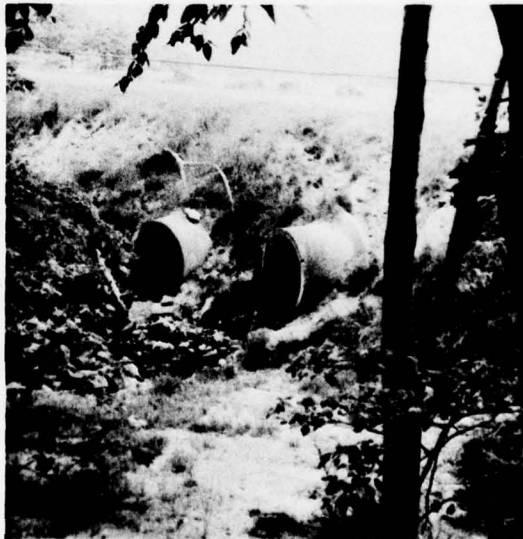
OUTLET CONDUITS

A considerable amount of debris is at the outlet of each conduit. This debris extends from each conduit outlet to the downstream channel, a distance of about 50 feet.

Remove the debris from the outlet of both conduits to the downstream channel.
