TECHNICAL MEMORANDUM

AN/BQR-7/DT-276

HYDROPHONE FAILURE MODE ANALYSIS

19 January 1968

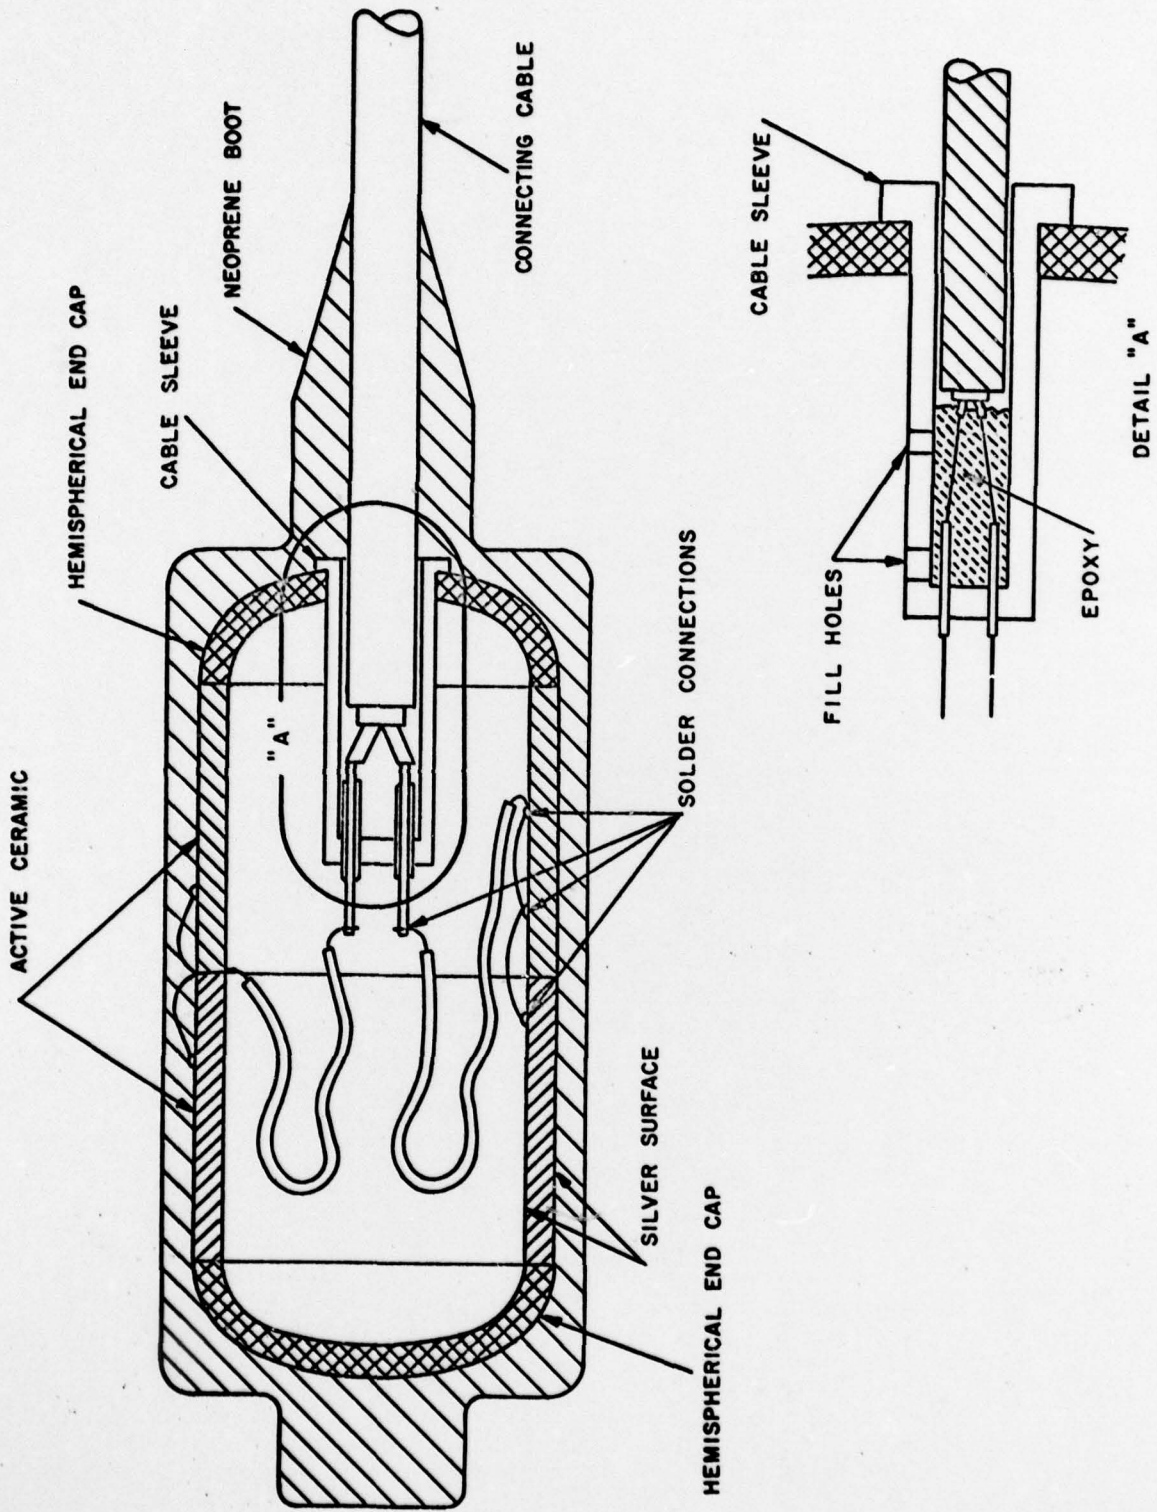
FIG. 1 DT-276/BQR-7 HYDROPHONE

Refer to Fig. 1.

Two patched areas were evident on the hydrophone cover but there was no evidence of water seepage through the boot. The silvering on the outside of the ceramic pulled away during boot removal. The cable sleeve showed definite evidence of water seepage along the potting compound/cable sleeve interface.

Intermittent cable connection could be made by lifting up and pushing down on the cable stub. At least 5 patched areas were evident in the boot. Careful slicing of all patched areas indicated no through-holes. Neoprene boot was very nonuniform, indicating that the unit had been off-center in the mold allowing a ratio of 3:1 in the thickness of the neoprene boot on opposite sides of the unit. The shield was in poor condition. Solder joints at the cable sleeve were in very poor condition; i.e., hardly attached to the prongs.

Two patched areas were investigated and indicated no water seepage. The neoprene boot was not well bonded to the lower half of the hydrophone. The glue joint between ceramic cylinders was found unbonded when cross-sectioned. The cable sleeve was corroded externally and internally. Soldering of the leads is suspect since the inner leads easily detached with a minimum of damage to the leads.

The inside surface of the hydrophone was clean and dry, however, there were definite signs of corrosion on the cable sleeve and indications of water seepage in the cable.

C-884 had a very uniform boot with a clean, unmarred, surface finish and clean fillets on the top and bottom. The boot bonding was good except in the area of the lower inactive ceramic end cap. The unit was half full of water. The cable sleeve was very badly corroded as was the connecting cable shield. The entire unit showed the effects of water.
