**COOPER LAKE DAM
AND WEST DIKE**

PHASE I INSPECTION REPORT

NATIONAL DAM SAFETY PROGRAM

NY 00081

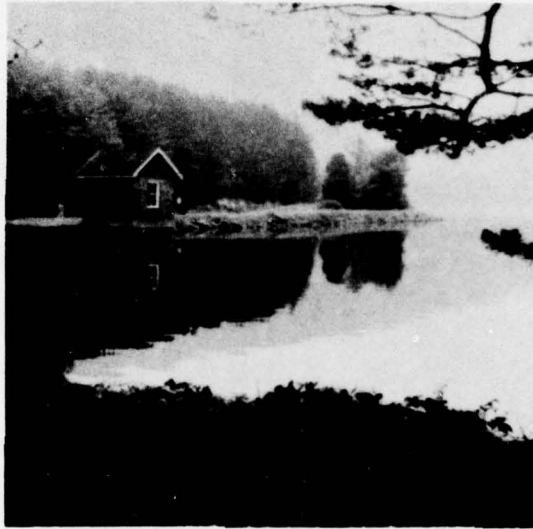
OVERALL VIEW OF COOPER LAKE DAM

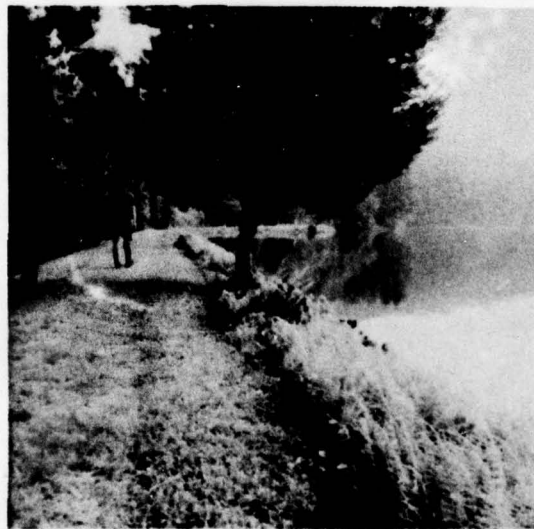
OVERALL VIEW OF WEST DIKE

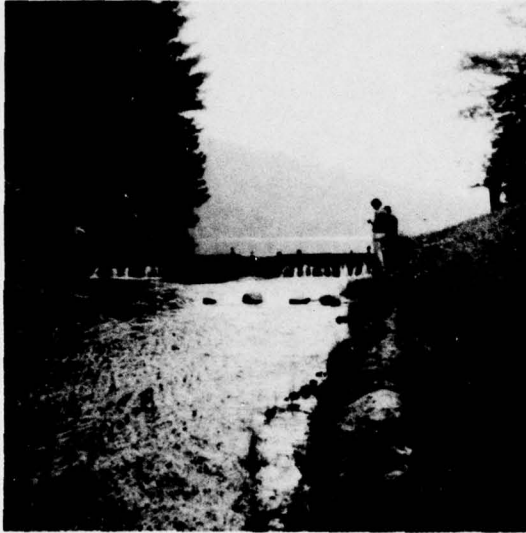
e. Downstream Channel - The downstream channel is adjacent to the toe of the main dam. Debris is present in the form of tree trunks and fallen trees. A small foot bridge is also present allowing access to fields downstream of the dam. The debris is sufficiently concentrated to cause considerable obstruction to flow in the event of high discharges.

CHANNEL DOWNSTREAM OF SPILLWAY

- 1) Piezometers should be installed to monitor pore pressures throughout the embankments of Cooper Lake Dam and West Dike.
- 2) A boring program should be implemented in order to determine the necessary design parameters to make a stability analysis of the downstream slope of Cooper Lake Dam especially at the section where the natural groundline is steeper than the downstream embankment slope.
- 3) All debris should be removed from the downstream channel, especially near the toe of the dam where fallen trees and tree trunks could cause considerable obstruction to flow.

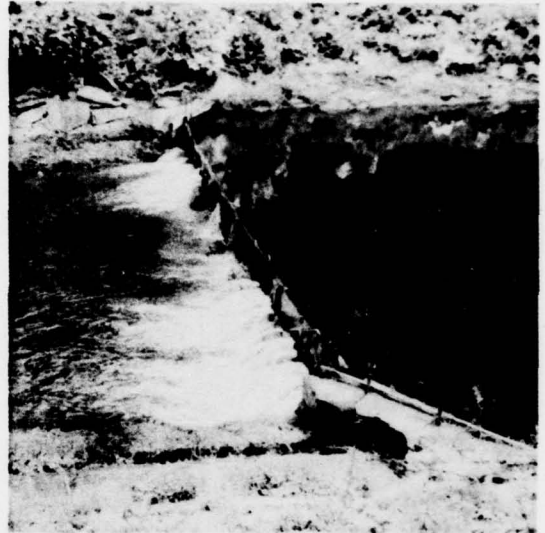
The timber stoplog installed above the crest of the concrete spillway is deteriorating and considerable seepage is evident between the concrete and the timber. The concrete lined spillway approach channel and downstream channel are in good condition with only minor concrete cracking.

SPILLWAY

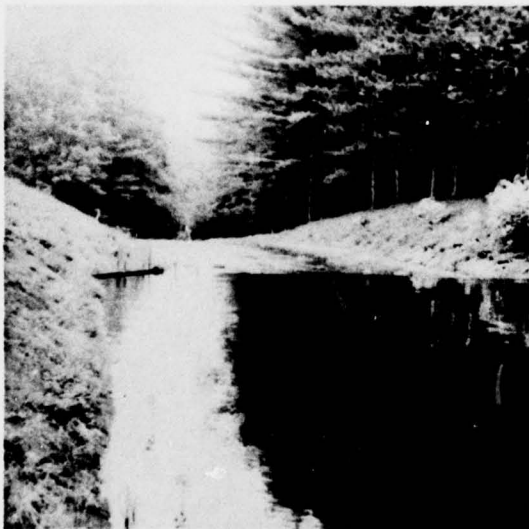
○ VIEW UPSTREAM AND DOWNSTREAM OF SPILLWAY

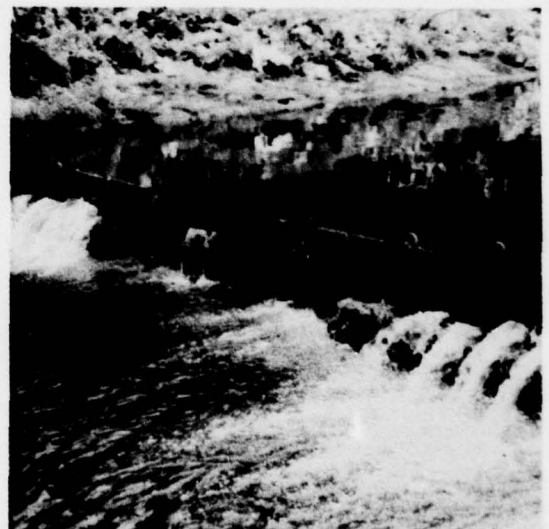
VISUAL EXAMINATION OF	OBSERVATIONS	REMARKS OR RECOMMENDATIONS
CONCRETE WEIR	The top of the concrete weir is at elevation 1103. The spillway was raised to an elevation of 1103.83 by adding a 10" high timber stoplog. Considerable seepage passes between the stoplog and top of concrete weir. The concrete is in good condition with minor cracking being observed.	Condition of the concrete should be frequently monitored as well as the condition of the timber stoplog.
APPROACH CHANNEL	Clear and well-maintained, minor cracking in the concrete lining the channel. This concrete is not structural, but rather used to prevent bank erosion.	Cracks should be filled in.
DISCHARGE CHANNEL A-5	Clear and well-maintained, minor debris present as well as minor concrete cracking in the apron.	Cracks should be filled in and debris removed.
BRIDGE AND PIERS	None.	None.

CLOSE-UP VIEW OF SPILLWAY

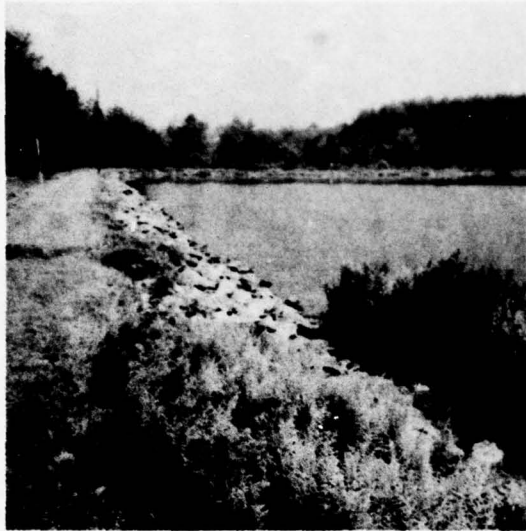
c. The West Dike - The upstream face of the West Dike and the surface of the top of the dike exhibit no significant signs of structural instability. A few trees and a thick cover of ferns or aquatic plants line the upstream face.

VIEW OF WEST DIKE

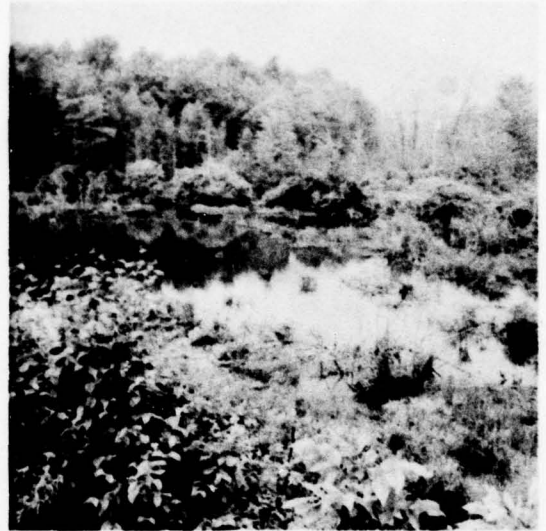
The downstream face of most of the dike is covered with trees, heavy brush and ferns or aquatic plants. Standing water is present at the downstream toe along most of the length of the dike and some of this water is discolored. Beaver dams exist downstream of the dike.

POND IMMEDIATELY DOWNSTREAM
OF WEST DIKE

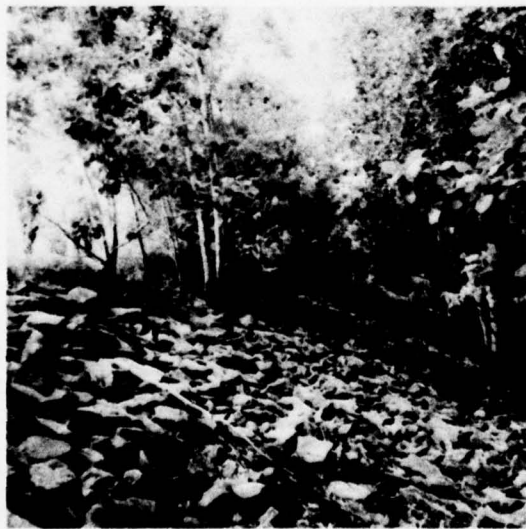
2) The West Dike - Most of the downstream face of the embankment is wooded indicating extensive root systems. In addition, standing water is present along most of the length of the West Dike at its toe. As discussed in Section 2 above, Beaver Dams may have caused this condition. Although the elevation of the roadway is fairly uniform, numerous small depressions were noted. No abnormal depressions were noted on the upstream face.

DOWNSTREAM FACE OF WEST DIKE

3) The downstream face of the dike should be cleared of the heavy growth of trees and brush. The few trees on the upstream face should also be cut near the groundline.

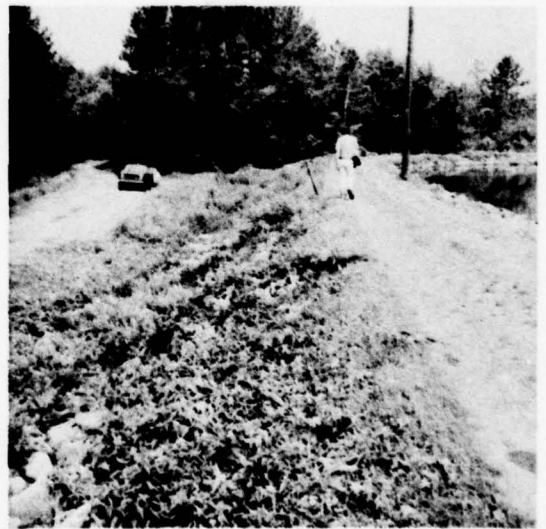
VIEW OF WEST DIKE

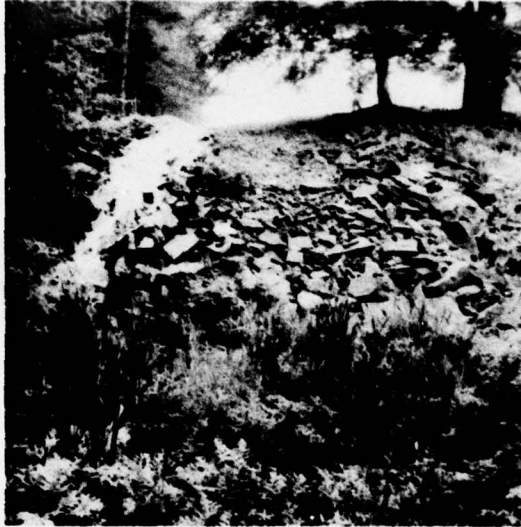
Good condition, tree trunks and other debris present, as well as a small foot bridge. These could cause obstructions in high flows.

CHANNEL DOWNSTREAM OF SPILLWAY

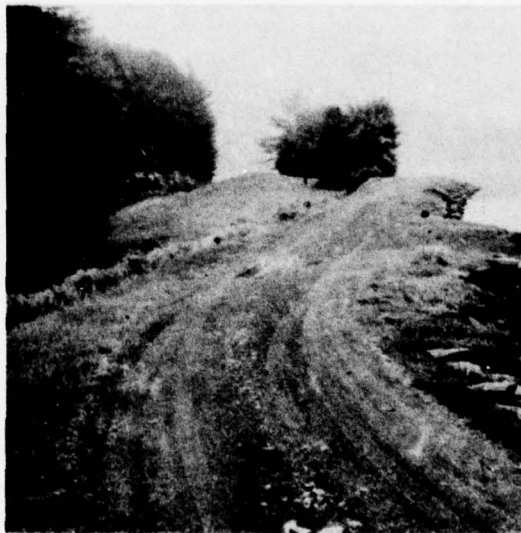
VIEW OF TOP OF DAM
