KINTZ CREEK DAM

NDI - PA 00415
PA DER 52-159
SCS PA-439

PHASE I INSPECTION REPORT NATIONAL DAM INSPECTION PROGRAM

Name of Dam: Kintz Creek Dam ID # PA 00415
State Located: Pennsylvania
County Located: Pike
Stream: Kintz Creek
Coordinates: Latitude 41° 16.9' Longitude 75° 14.0'
Date of Inspection: December 5, 1978

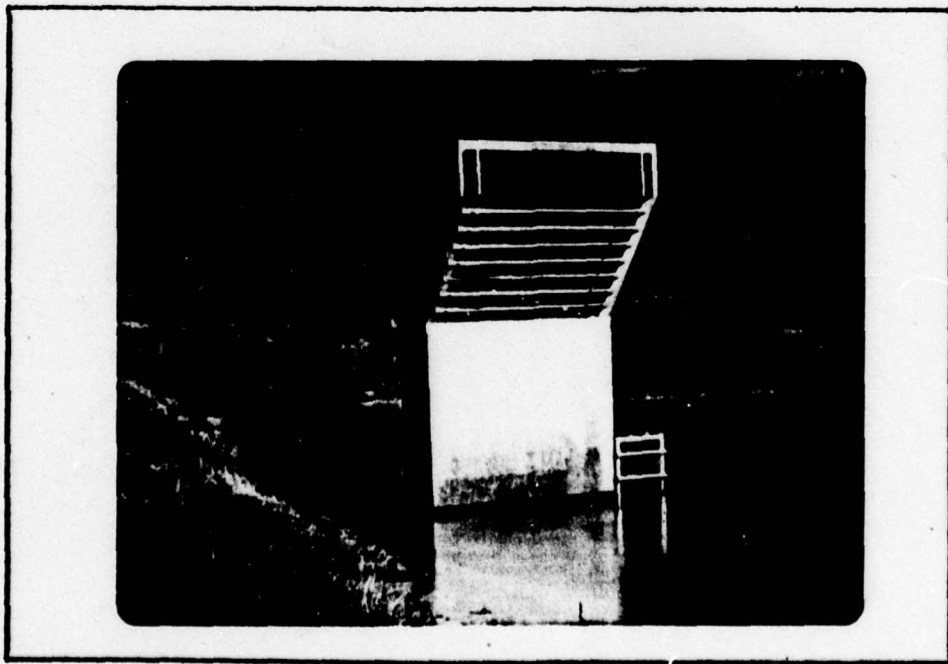
*RISER SHOWING DETAILS OF BOTH
THE HIGH STAGE AND LOW STAGE INLETS*

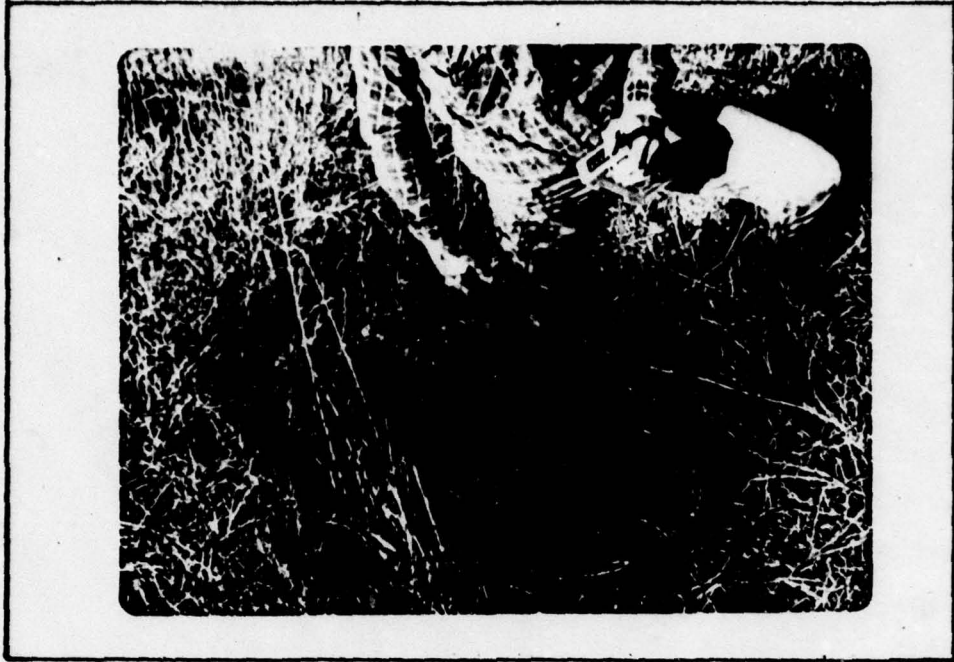
- b. Dam. On the date of the inspection, the upstream face of the embankment appeared to be in good condition. However, on the downstream face there are numerous holes, exposed boulders, depressions, and bulges (refer to Plate D2). Variations of several feet were observed in localized areas and there was evidence of soil erosion around the boulders. A survey of the top of the dam revealed variations in ground elevations of nearly a foot. Several depressions in the top of the dam correspond to areas of animal burrowing in the downstream face. The top of the dam also has tire ruts (up to 6 inches deep) with standing water.

***DIFFERENTIAL SETTLEMENT IN THE
DOWNSTREAM FACE OF THE DAM***
