# ELM LAKE DAM

PHASE I INSPECTION REPORT  
NATIONAL DAM INSPECTION PROGRAM

NDI - PA 00397  
PA DER 52 - 164

FEBRUARY 1979

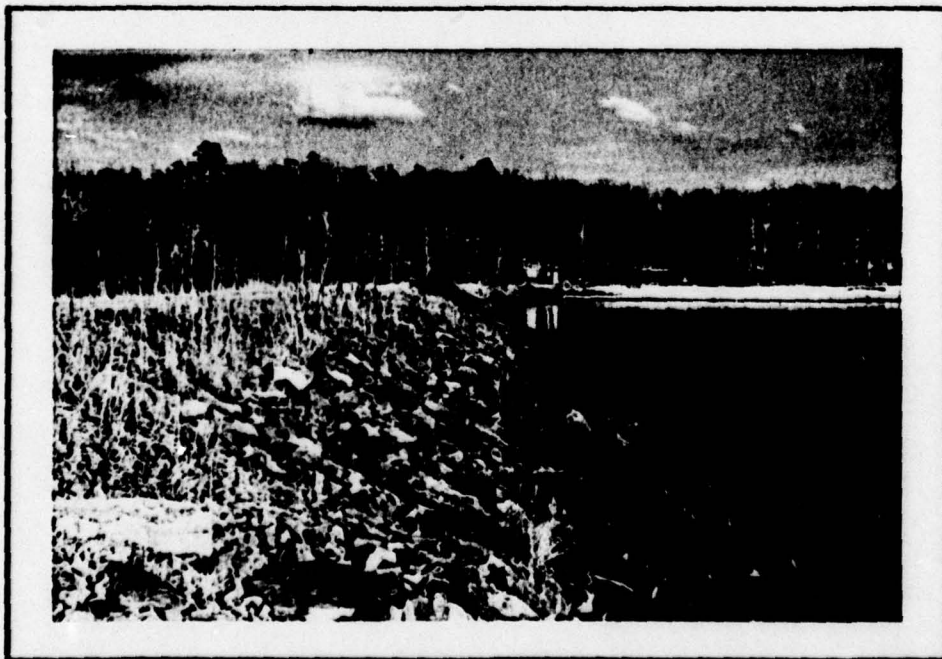
The riprap protection for the upstream slope of the embankment is poorly graded and sparse in many areas. The riprap on the upstream face should be supplemented, replaced and regraded where necessary.

*UPSTREAM FACE OF DAM  
LOOKING TOWARDS RIGHT ABUTMENT*

2. The riprap on the upstream face should be supplemented, regraded and replaced where necessary to provide adequate protection against wave erosion. The riprap should be removed so that a crushed stone base may be placed beneath the riprap in any location where such a base does not exist.

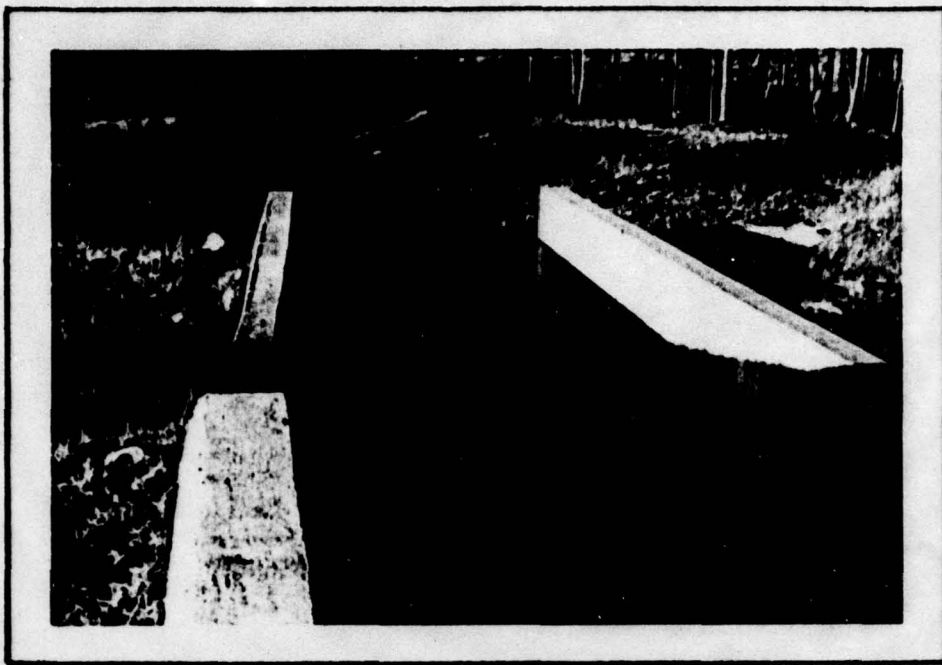
The drop spillway appears to be in good condition. The drop spillway outlet channel differed slightly from that shown on the drawings. According to the drawings, each training wall is to converge and then reduce the width of the channel by 2 feet along its 50-foot length. However, the right training wall is straight and the left training wall has an inward batter of 4 feet along its 50-foot length.

*SPILLWAY AND OUTLET CHANNEL  
LOOKING FROM SPILLWAY CREST*

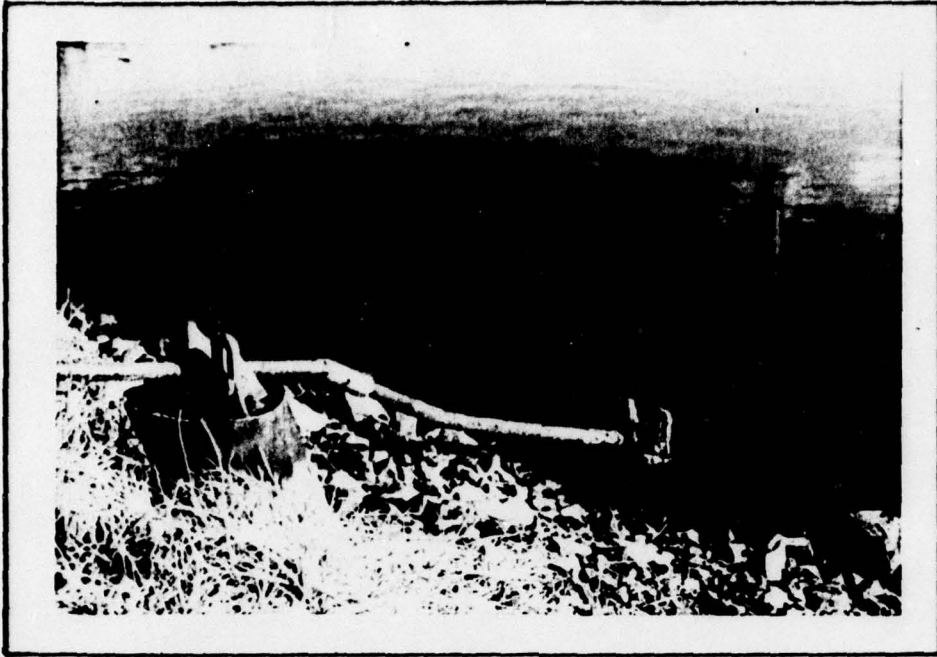
c. Appurtenant Structures. The reservoir drain system is inoperable. The stem leading to the sluice gate is bent, cracked, and rusted and the hoist mechanism is in very poor condition. Repairs to the stem had apparently been attempted since one section is welded, but the remainder of the stem is still in a state of disrepair. The outlet pipe is partially buried in mud and debris. A small amount of water is flowing from the toe drain outlets in the outlet structure.

*POORLY MAINTAINED HOIST STEM  
OF THE RESERVOIR DRAIN SYSTEM*

1. Immediate repairs should be made on the reservoir drain system to provide for reservoir draw down. The outlet structure should be cleared of mud and debris to allow free flow from the outlet pipe.

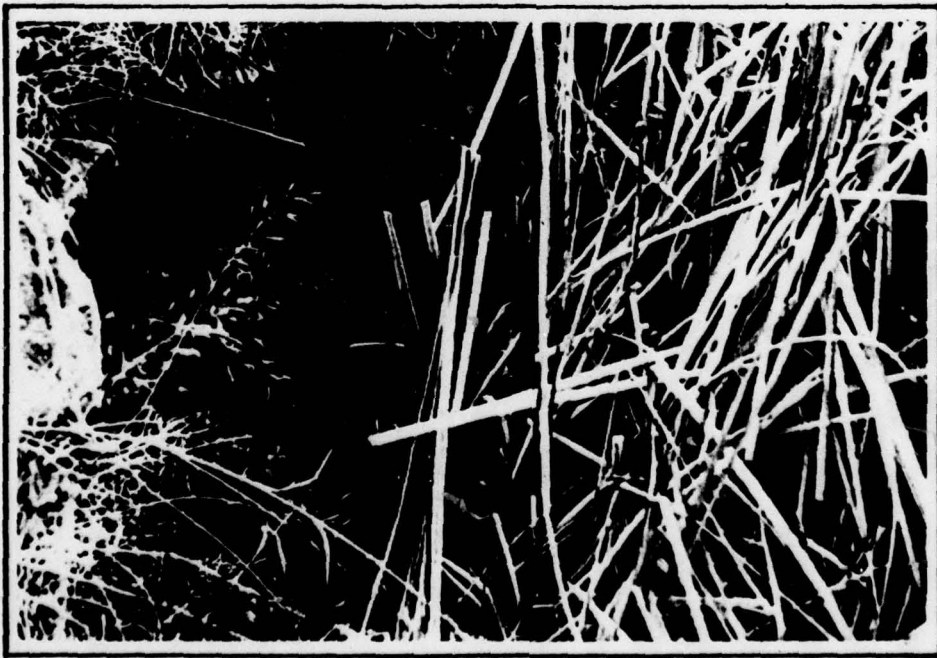
c. Visual Observations. The inoperable reservoir drain system could present a serious problem should a draw down of the reservoir be required. The outlet structure of the reservoir drain system is partially buried in mud and debris and needs to be cleaned out.

*PARTIALLY BURIED RESERVOIR  
DRAIN OUTLET STRUCTURE*
