DELAWARE RIVER BASIN  
SHOHOLA CREEK, PIKE COUNTY  
PENNSYLVANIA

# SHOHOLA MARSH DAM

PHASE I INSPECTION REPORT  
NATIONAL DAM INSPECTION PROGRAM

NDI-PA 00412  
PA DER 52-158

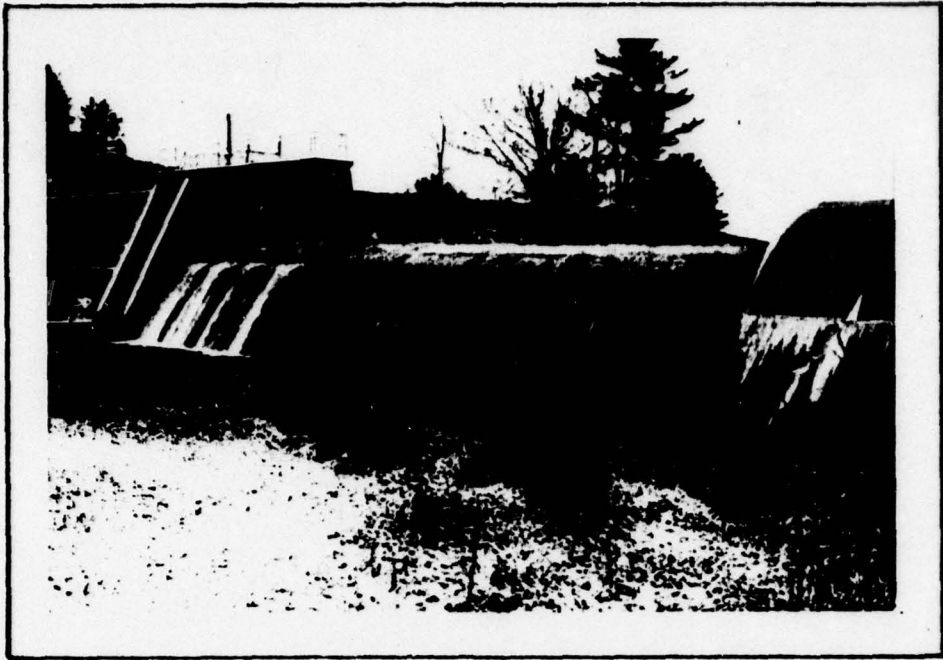
*SERVICE SPILLWAY WITH STOPLOG  
CONTROLLED PORTION TO THE LEFT*

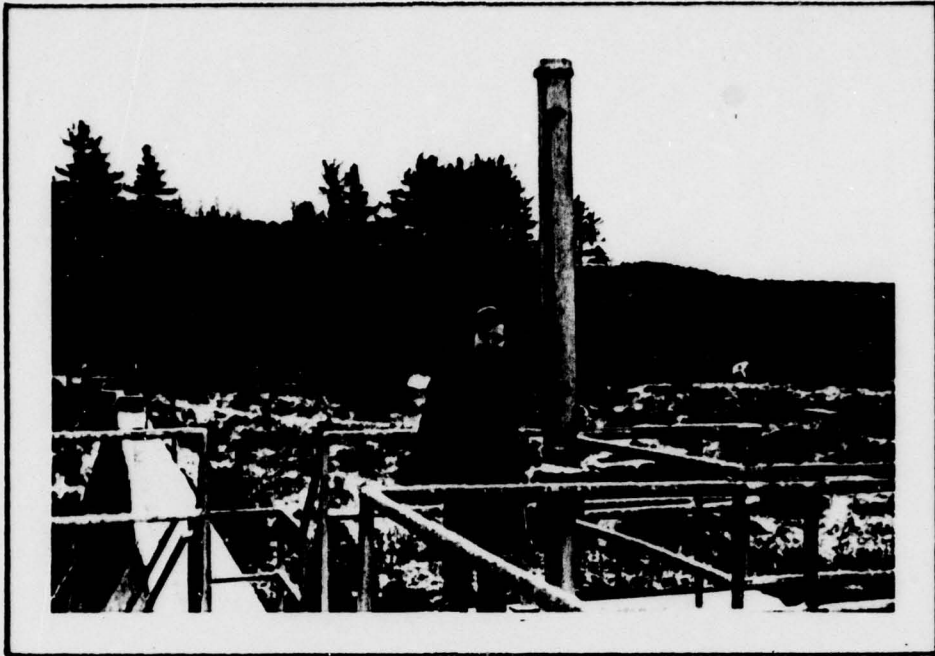
*ON SERVICE BRIDGE SHOWING  
RESERVOIR DRAIN HOIST AND STEM*

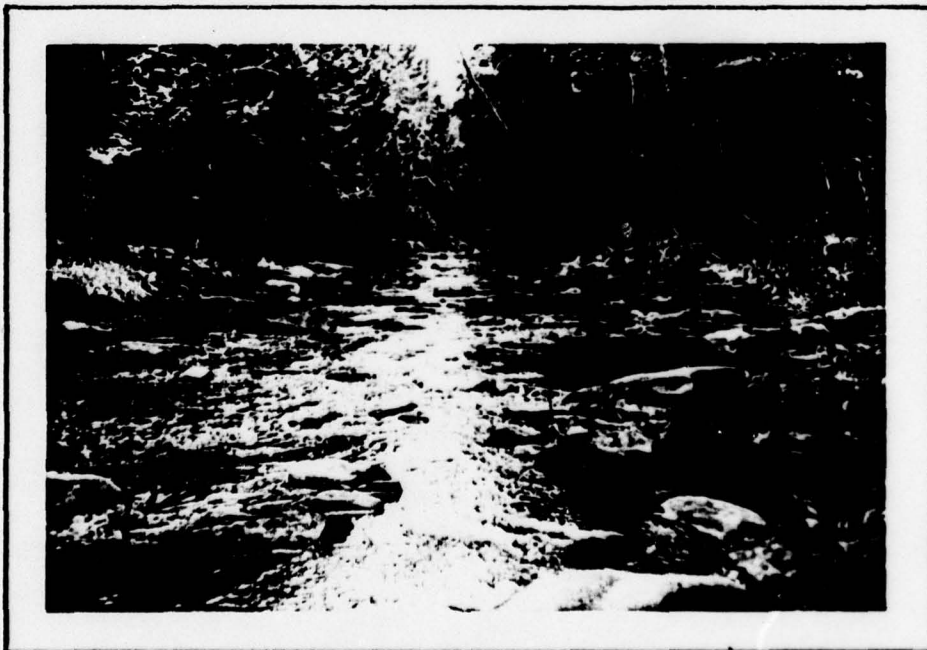
*CHANNEL 3 MILES DOWNSTREAM OF DAM*
