6 National Dam Inspection Program.
PA-482 Dam (NDI I.D. Number PA-469,
DER I.D. Number 63-72), Ohio River
Basin, Tributary of Harmon Creek,
Washington County, Pennsylvania.
Phase I inspection Report.

PHASE I REPORT
NATIONAL DAM INSPECTION PROGRAM

PA-482 DAM
NDI I.D. NO. PA-469
DECEMBER 1, 1978

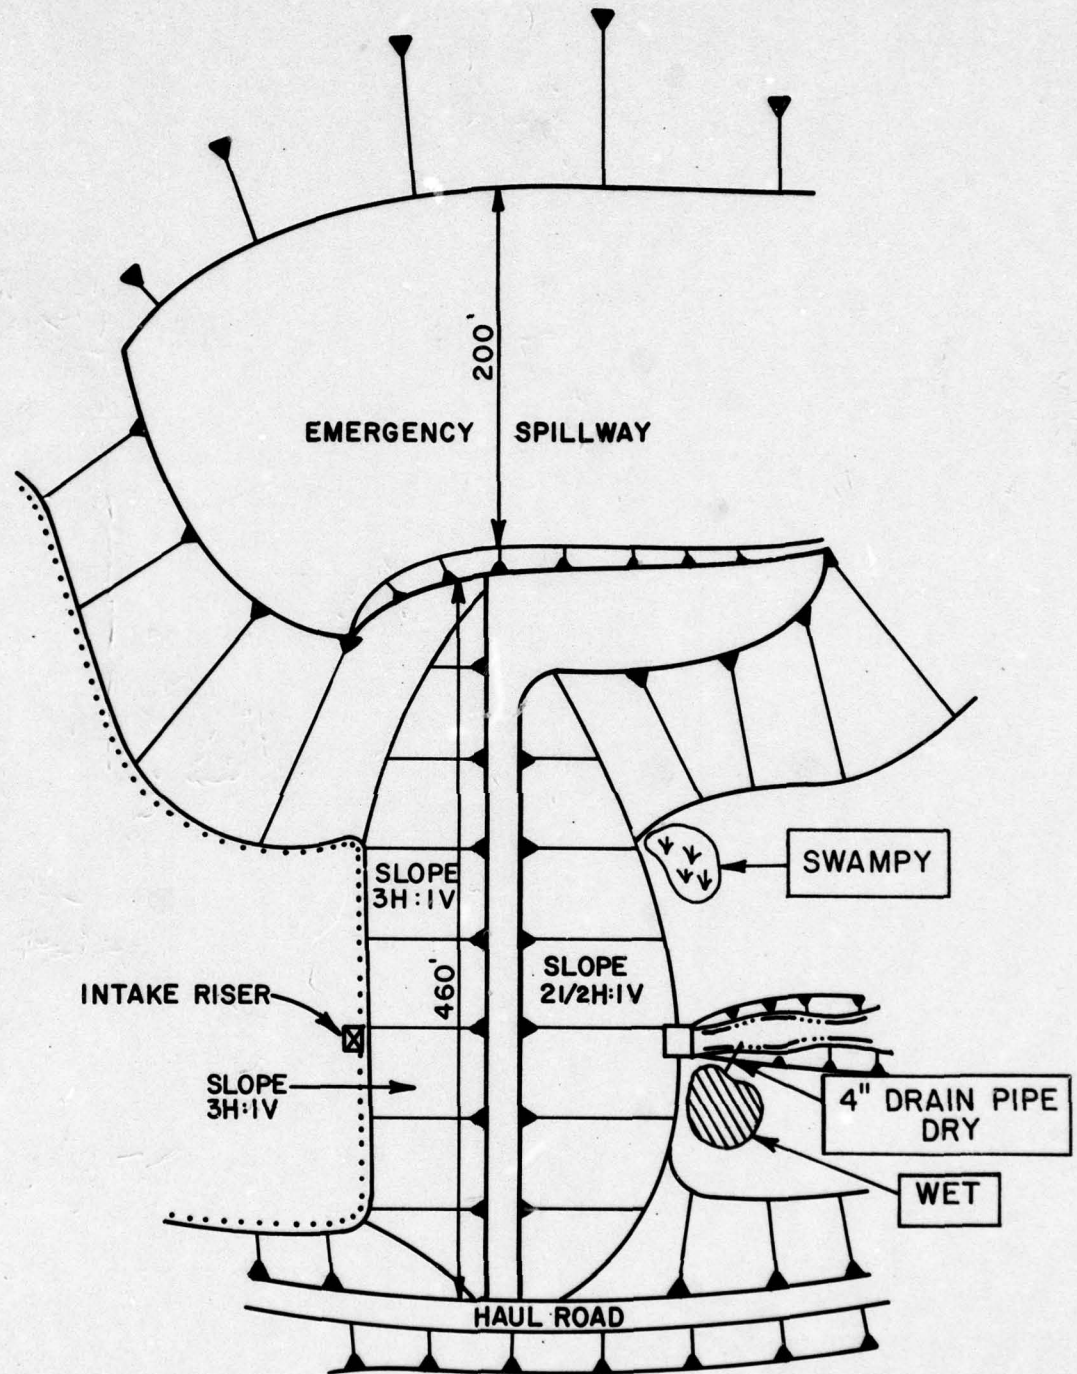
PLATE II
PA.482 DAM
GENERAL PLAN
FIELD INSPECTION NOTES
FIELD INSPECTION DATE: DEC. 1, 1978

In general, the condition of the dam is considered to be good. One swampy area and one wet area were found along the toe of the dam on each side of the outlet pipe discharge structure, respectively. However, no measurable seepage was associated with these areas.

- NOTES:**
1. EMERGENCY SPILLWAY
FREEBOARD: 5.1 FT.
 2. POOL LEVEL DATE OF
INSPECTION: 22 FT. BELOW
CREST OF DAM

1. The swampy and wet areas located along the toe of the embankment should be periodically observed. Necessary remedial work should be performed if the extent of the wet and swampy areas increases or seepage and sloughing conditions develop.
2. Around-the-clock surveillance should be provided during unusually heavy runoff and a formal warning system should be developed to alert downstream residents in the event of emergencies.
3. The dam and appurtenant structures should continue to be inspected regularly and necessary maintenance should be performed.

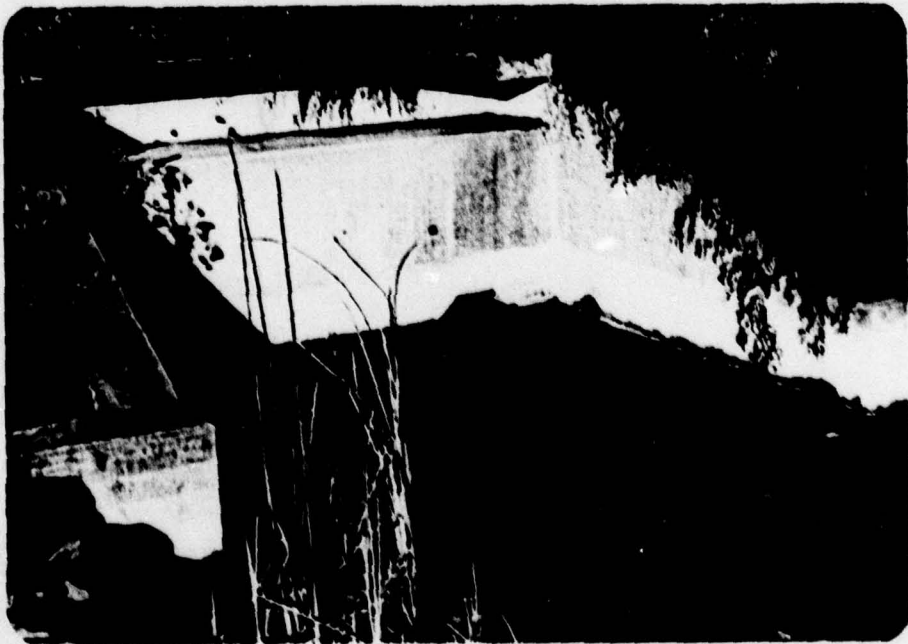
Photograph No. 4
Outlet pipe impact basin.

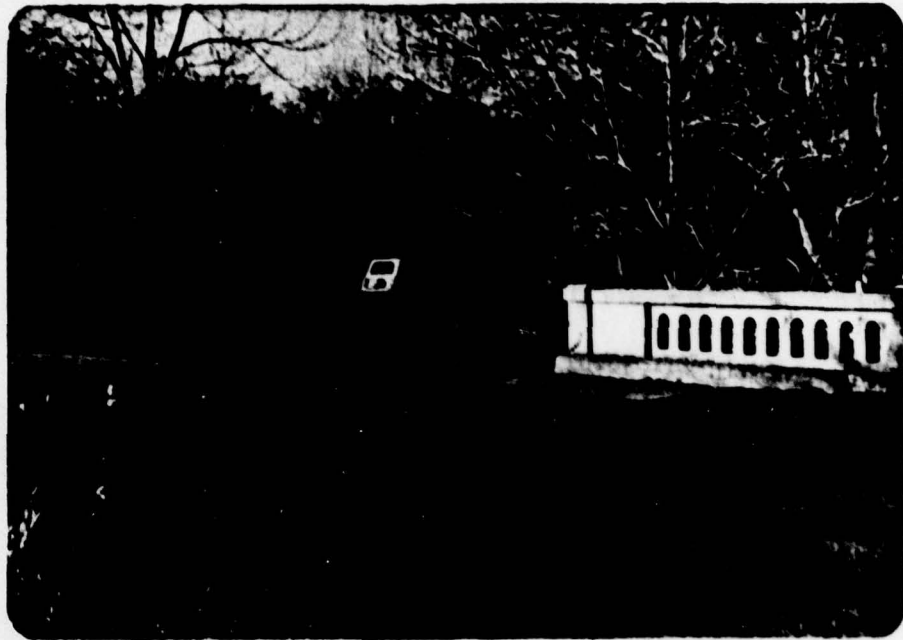
Photograph No. 5

**One house and one commercial building
approximately 1.5 miles downstream.**

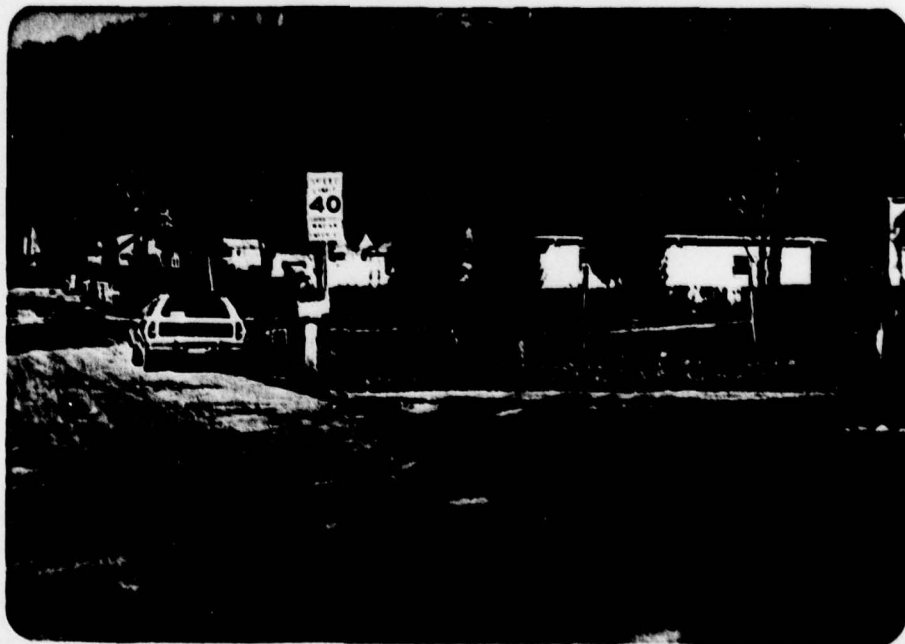
Photograph No. 6

**Community of Hanlin Station approximately
2.5 miles downstream.**
