WILSON CREEK DAM

NDI - PA 00318
PA DER 52-154
SCS PA - 440

PHASE I INSPECTION REPORT NATIONAL DAM INSPECTION PROGRAM

MAY 1979

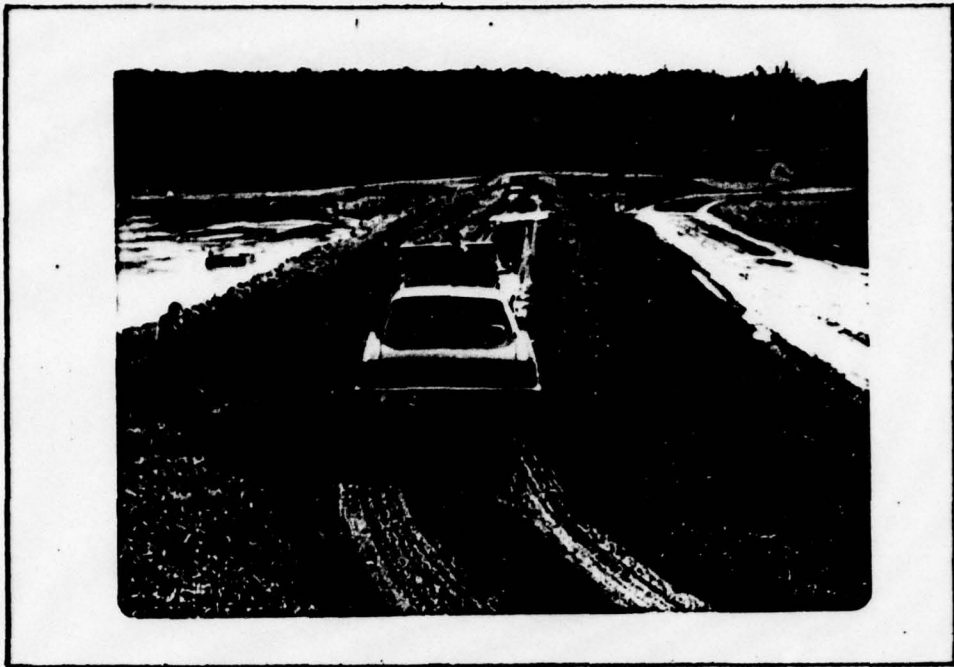
*VIEW LOOKING ACROSS THE TOP OF THE DAM FROM
THE RIGHT ABUTMENT*

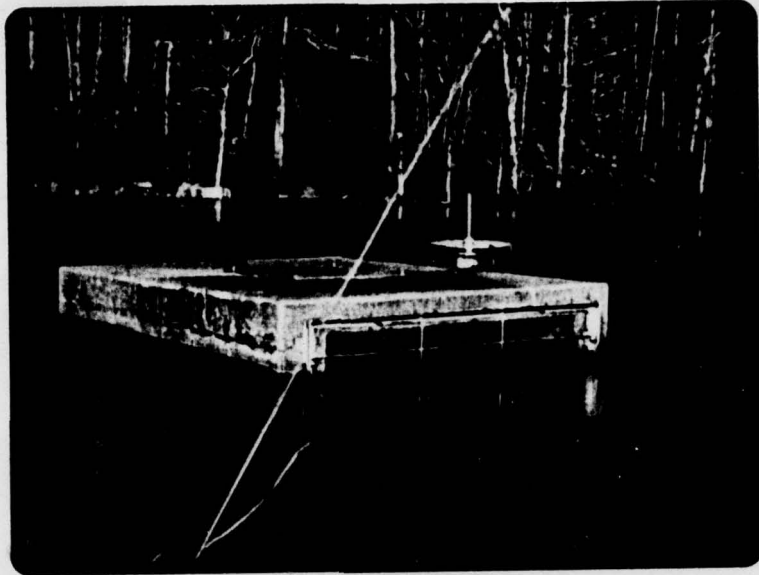
*DETAILS OF THE SINGLE STAGE DROP INLET
OF THE PRINCIPAL SPILLWAY*

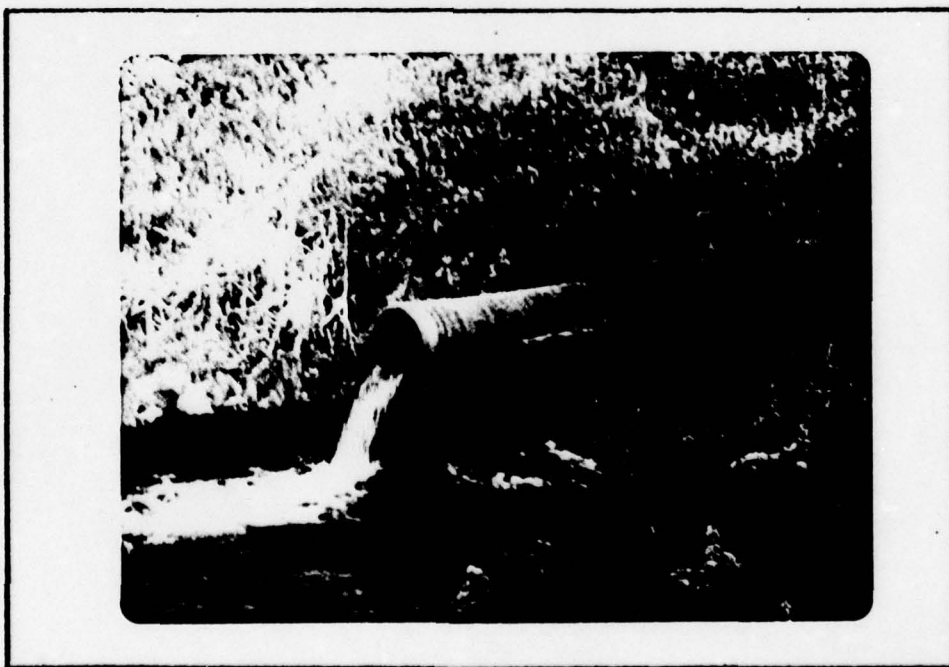
- b. Dam. The dam is in good condition. There are minor undulations (+ 0.5 feet) along the top of the dam and along both the upstream and downstream earth embankment slopes. There is slight seepage on the downstream earth embankment slope around the principal spillway conduit.

*CLOSE UP OF THE PRINCIPAL SPILLWAY OUTLET
SHOWING A DRAINAGE SYSTEM OUTLET PIPE*

1. There is slight seepage around the Principal Spillway conduit where the conduit projects from the downstream face of the dam. According to the plans, a trench backfilled with filter material is located along the conduit. Apparently the filter was capped with an earth cover at the downstream toe. It is recommended that minor excavation be performed at the outlet to examine the filter drain and determine if a riprap cover would be appropriate.
2. There is some erosion at the downstream end of the stilling basin. Riprap should be added to prevent further erosion.
3. The operating condition of the reservoir drain sluice gate should be assessed. The owner should provide access to the riser in order to operate and maintain the gate system.

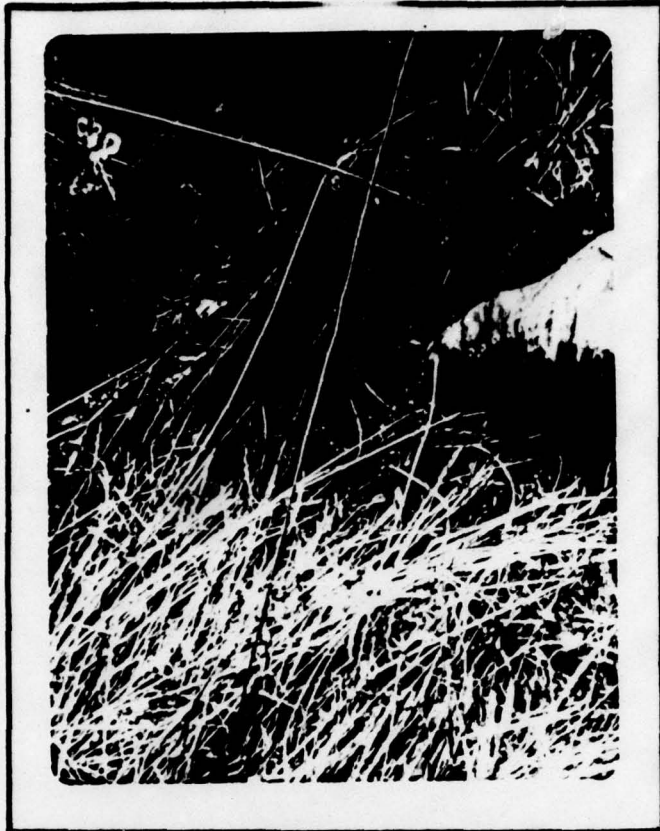
*TOKEN SEEPAGE DOWNSTREAM OF THE
RIGHT ABUTMENT*
