PHASE I INSPECTION REPORT NATIONAL DAM INSPECTION PROGRAM

Name of Dam: Hemlock Lake Dam

Inventory Number: PA 00399

6 National Dam Inspection Program.
Hemlock Lake Dam (NDI-PA 00399,
PA DER 52-71), Delaware River Basin,
Tributary Bush Kill Creek, Pike
County, Pennsylvania. Phase I Inspection Report.

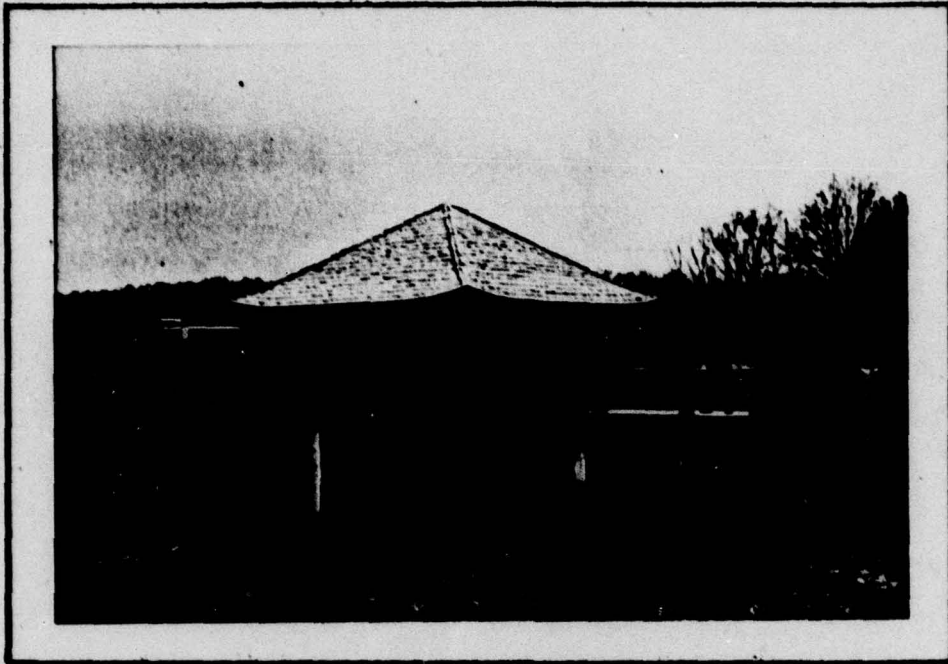
*PAGODA SHELTER BUILT ON TOP OF
RESERVOIR DRAIN GATE VALVE TOWER*
