TAYLOR POND DAM

NDI - PA 00315
PA DER 52-152
SCS - PA-446

PHASE I INSPECTION REPORT NATIONAL DAM INSPECTION PROGRAM

MAY 1979

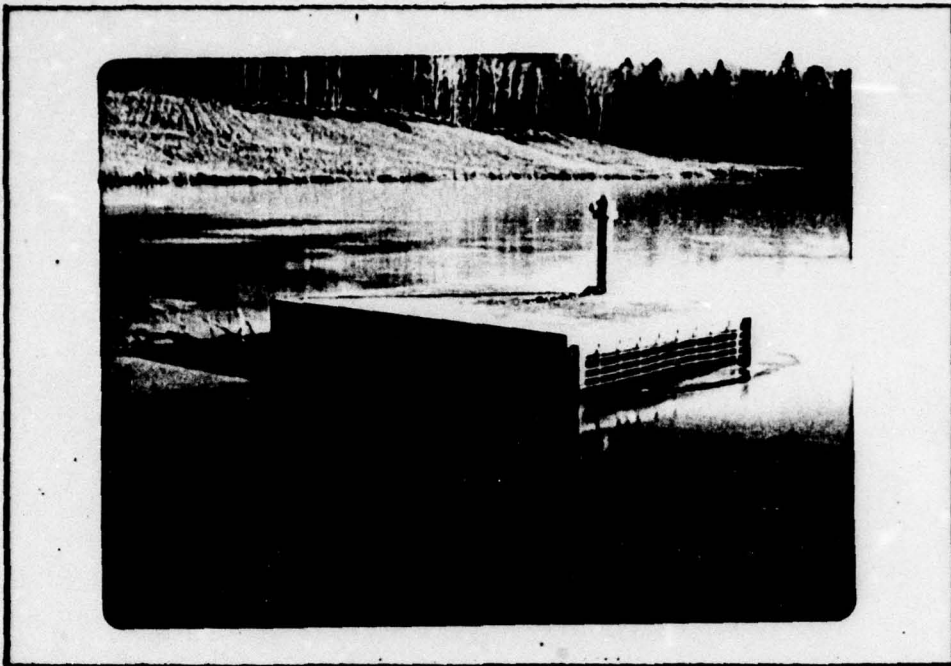
- c. Appurtenant Structures. The Principal Spillway appears to be in good operating condition. At the time of the inspection, approximately 20 cfs. was discharging from the spillway pipe. The owner was not available during the day of inspection to operate the hoist for the pond drain sluice gate.

*TOP OF THE RISER SHOWING TRASH RACK
DETAILS AND THE GATE HOIST*

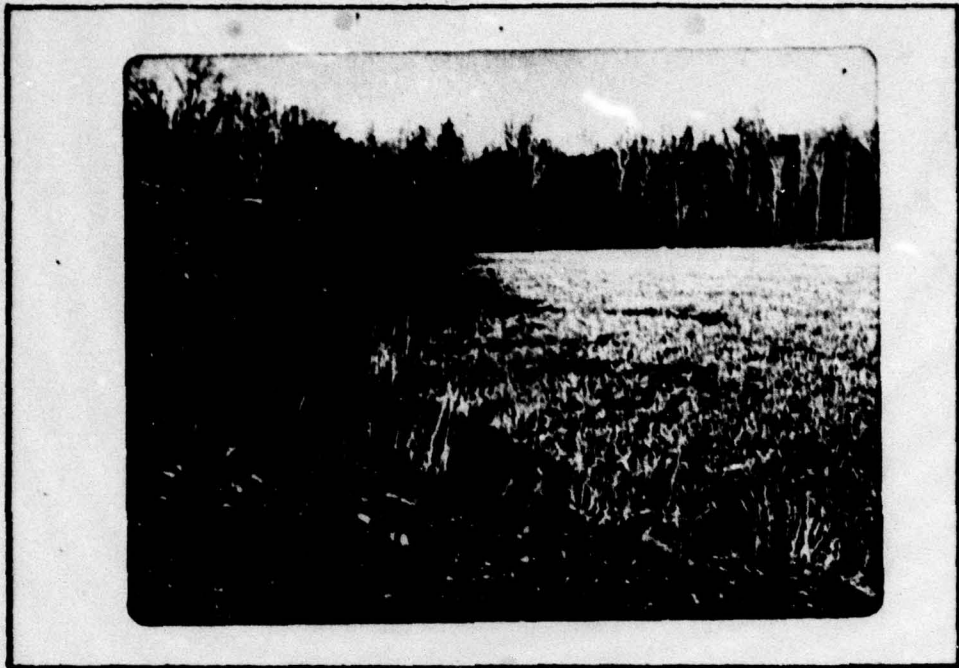
The Emergency Spillway also appears to be in good condition. The grass cover is adequate and the slopes show no signs of instability. The earth dike which separates the embankment from the earth and rock cut

EMERGENCY SPILLWAY LOOKING DOWNSTREAM
