CONESTOGA RIVER BASIN
NEW HOLLAND RESERVOIR DAM
NO. NO. PA-00346
SER. NO. 55-241
LANCASTER COUNTY, PENNSYLVANIA

PHASE I INSPECTION REPORT
NATIONAL DAM INSPECTION PROGRAM

BY
Sargent Associates, Inc.
Harrisburg, Pennsylvania
JULY 1979

OVERVIEW
NEW HOLLAND RESERVOIR DAM

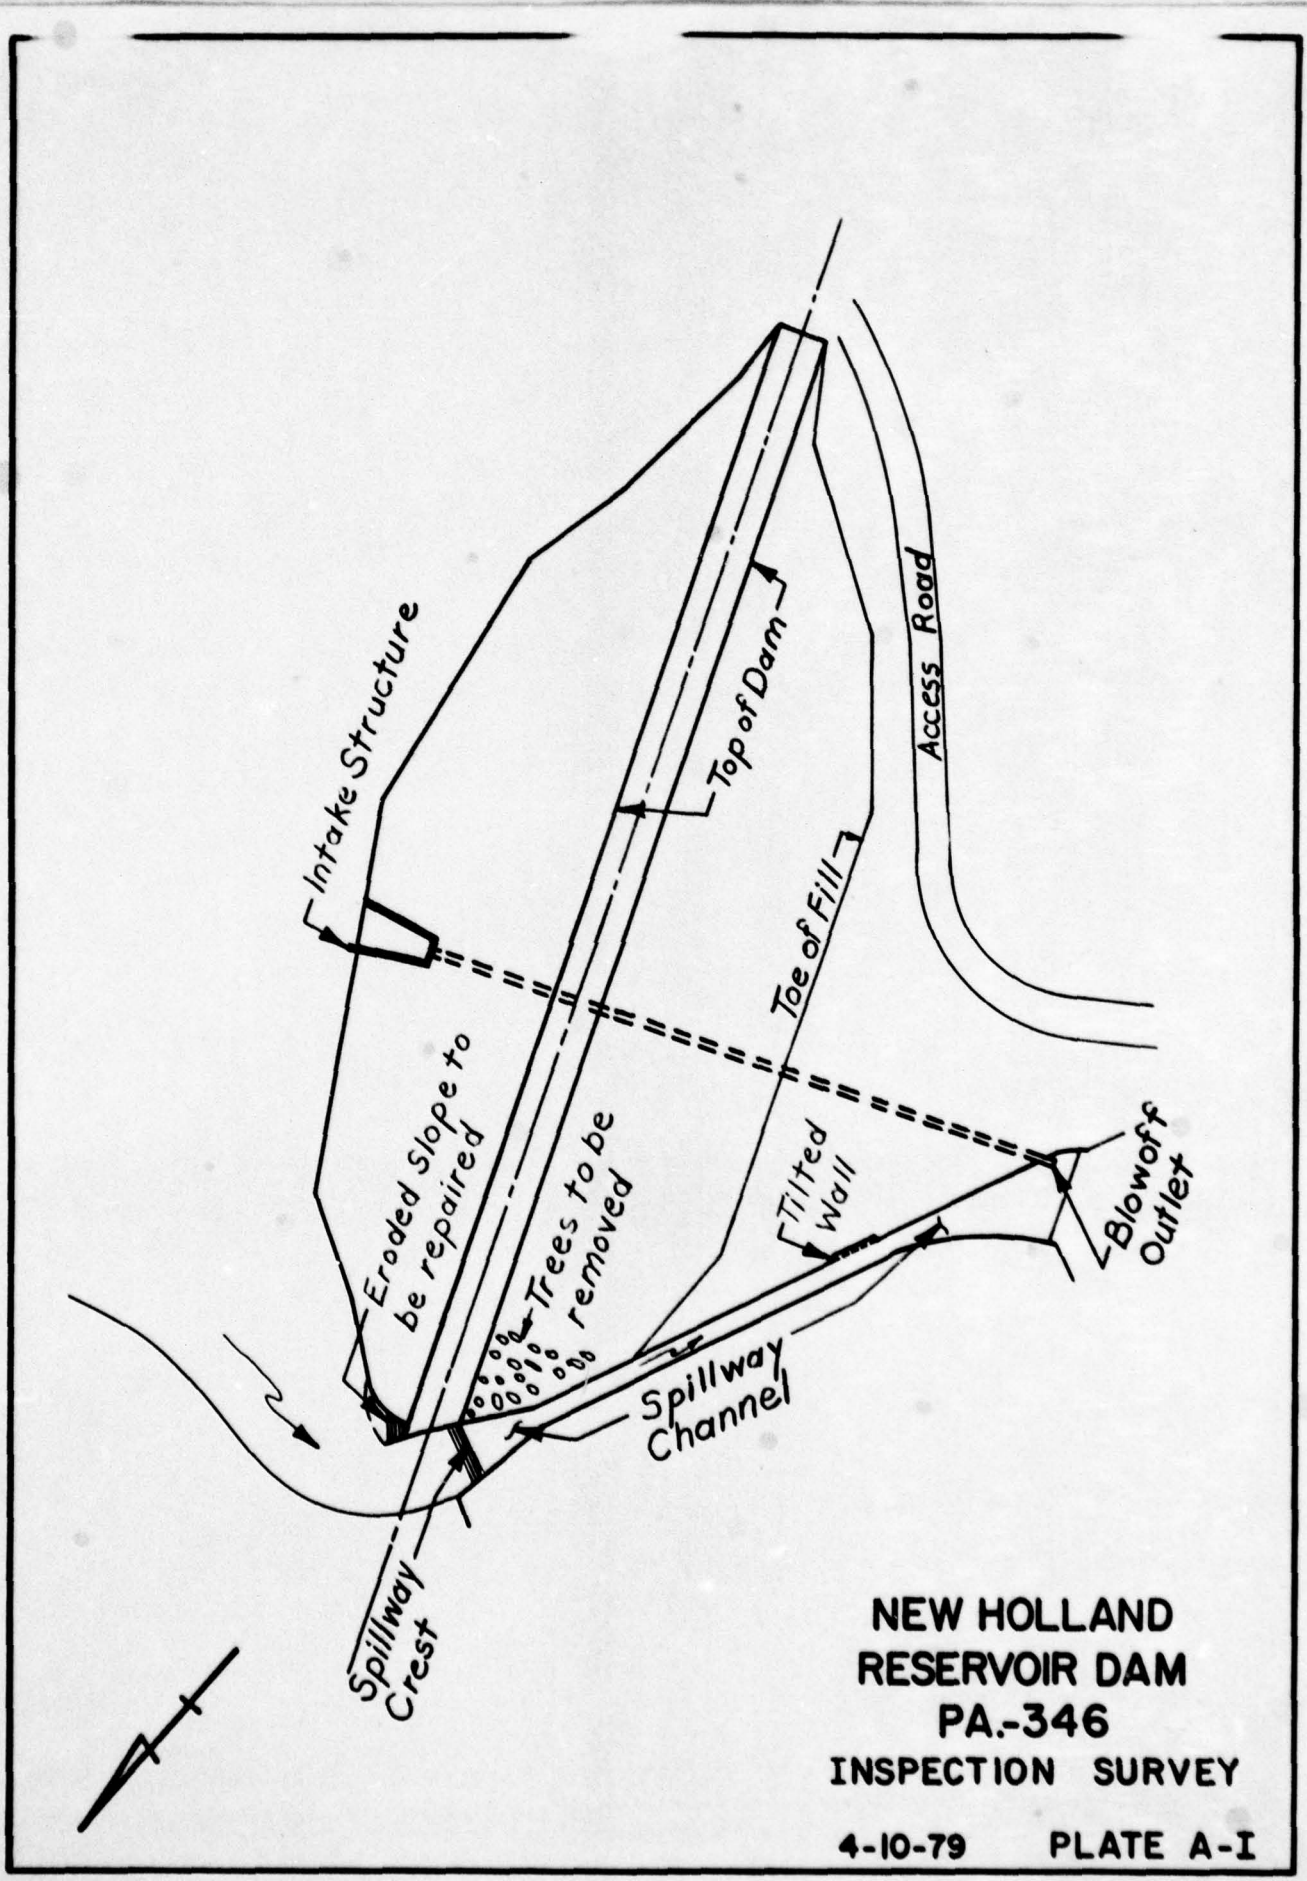
4-10-79 PLATE A-I

There were no indications of embankment instability or distress as a result of the visual inspection. The surveyed profile and cross section show a crest elevation variation of 0.3 foot maximum from the design elevation of 664.5 (Refer to Appendix A, Plate A-II). Erosion of the embankment was observed immediately adjacent to the spillway wall. This condition can be repaired and does not affect the stability of the embankment.

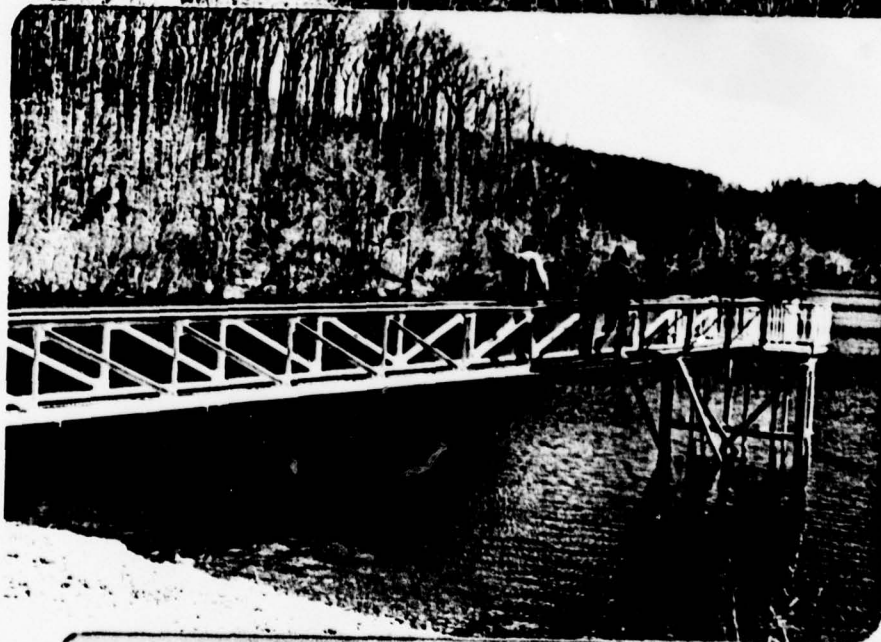
The operating facilities at this dam are in good condition. The footbridge leading from the crest of the dam to the intake structure appears sound. It is in the process of being painted on the date of this inspection. The three sluice gate controls are operable and appear to be well greased.

Footbridge
to
Intake Structure

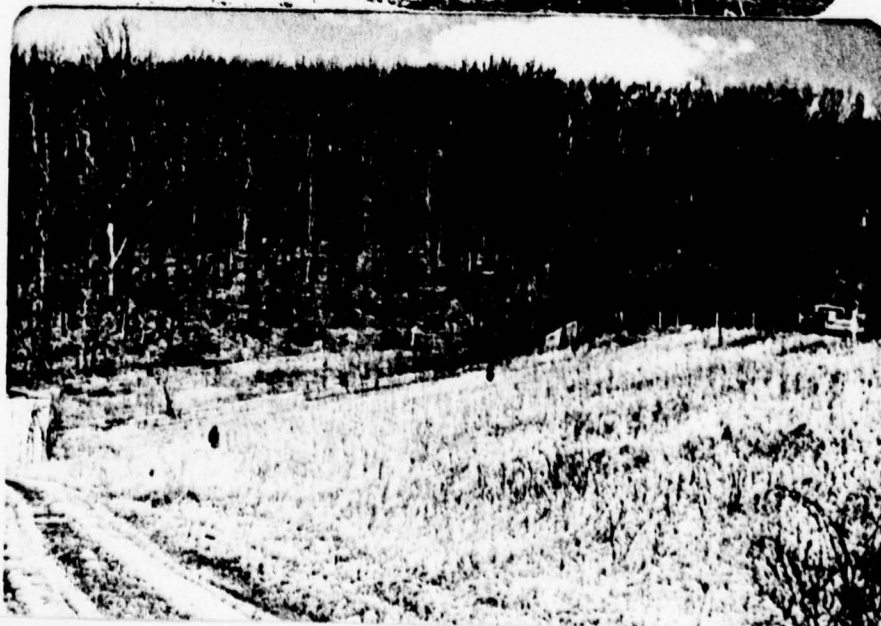
The downstream slope was essentially dry, even though some moisture was detected at the grassed surface. This is considered to be a normal condition as the result of heavy rains the day before this inspection. Low spots in the surface drainage swale along the toe of the embankment held some free water. This is also attributed to the previous day's rain.

One groundhog hole was observed on the downstream slope in the area of the trees. This should be filled.

Downstream
Slope

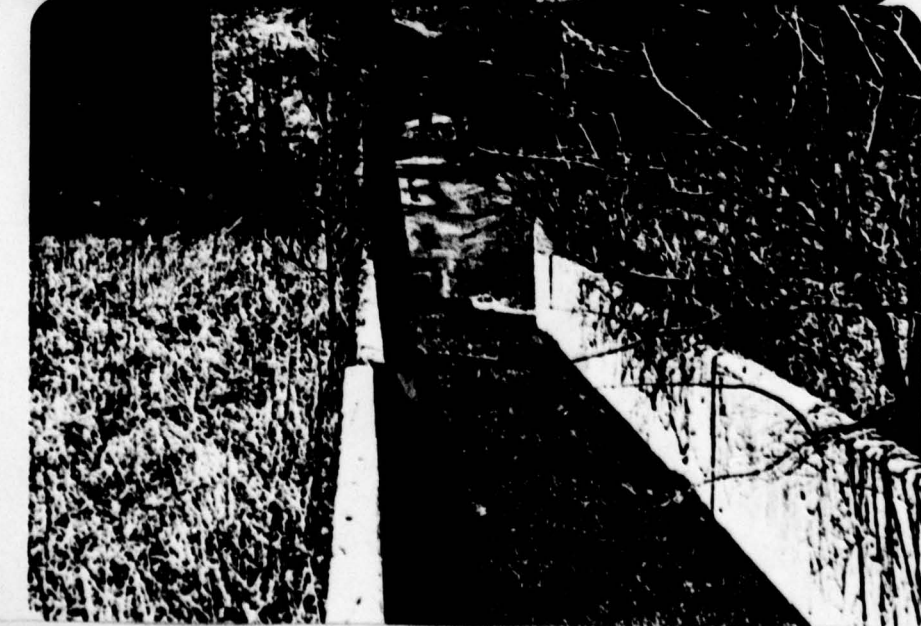
The spillway is a concrete ogee section type weir. There was no evidence of displacement or settlement of this structure. The surface condition is considered good with only slight deterioration evident as a result of weathering. One section of the left spillway channel wall has been displaced inward about 3.5 inches at the top (see Plate E-II) and several of the keys at the joints between wall sections were observed to be cracked.

The section where the wall tipped forward is a U-type section with the walls tied to the bottom slab with #3 bars at 9-inch centers. The tipping of the 8-in thick wall can be caused by either failure of the reinforcing steel or flexing of the bottom slab. The visual inspection did not reveal any deformation of the slab and if the rebars would have failed, the wall would have toppled. The wall was measured in the field as 4.5 feet high, rather than the 4-feet as shown on the construction drawing. It also appeared that the weepholes were not installed at 10-foot centers as shown on the construction drawings.

Assuming reinforcement with an allowable stress of 18,000 psi, a 3-inch cover on the steel and a fully saturated fill behind the wall, an overstress of 30 percent of the steel would occur with a 4.5 foot high wall. This overstress would not be sufficient to cause failure. However, if steel was not placed in accordance with the plans, failure could occur.

Spillway Chute
(Note tilted left
wall and trees
close to wall)

Complete failure of this wall section would not immediately endanger the safety of the dam. It is recommended that close observation be maintained by the owner and if movement continues, that measures be taken at that time to repair the condition.

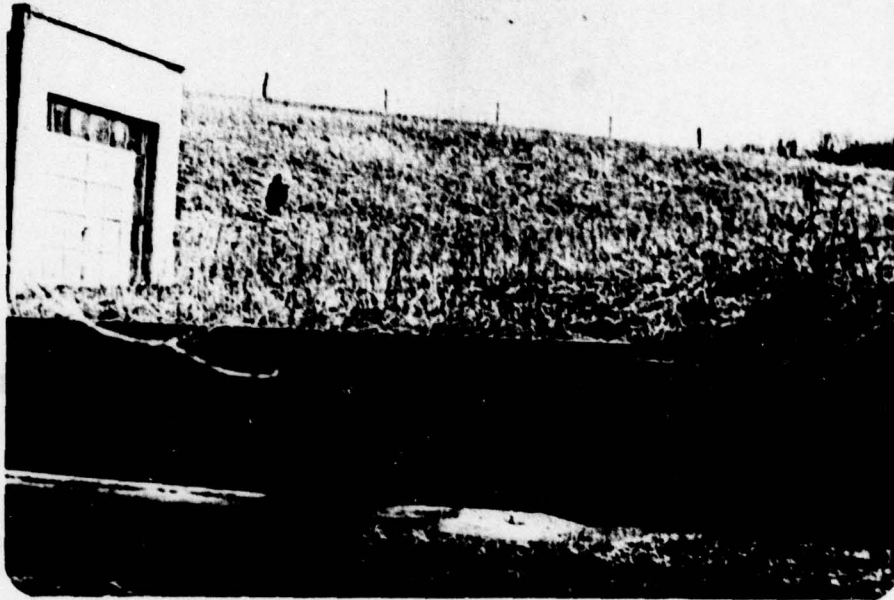
The outlet from the blowoff line (42-inch CMP) consists of an opening through the spillway outlet channel wall near its terminus. Refer to Appendix F, Plate IV. The condition of the discharge outlet in the wall is good.

Drawdown Pipe Outlet

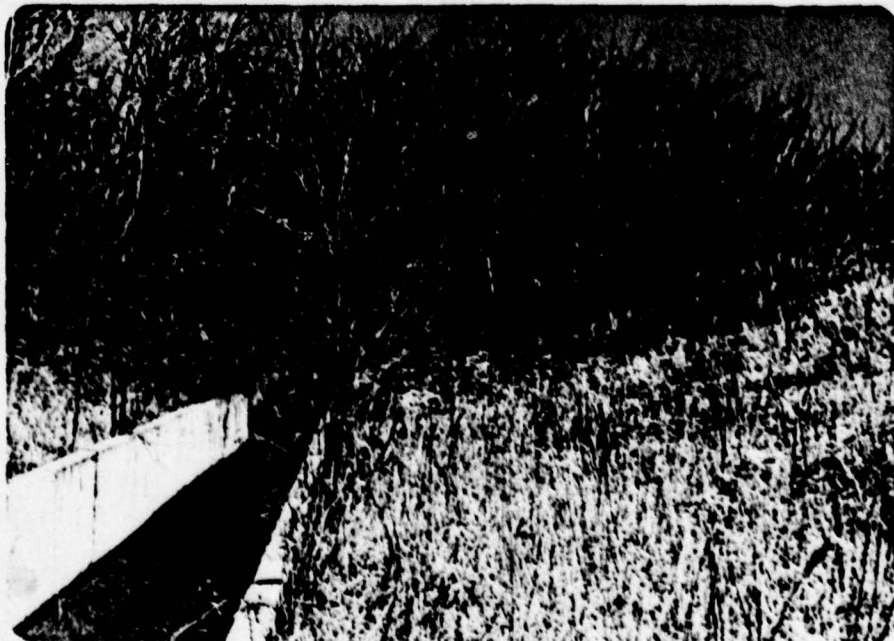
The visual inspection of the embankment did not reveal any structural distress or seepage conditions on this structure. The upstream slope cover consists of dumped riprap, about 12-inch maximum size. With the exception of two small trees or bushes on this area, the slope is clear. The downstream slope cover is field grass, weeds and brush. The brush was not dense at the time of this inspection. A moderate stand of trees, 6 inches to 8 inches in diameter, is situated on the embankment slope adjacent to the left spillway channel wall. These trees could become troublesome to the walls as well as the slope and should be removed.

The visual inspection of this dam indicates that the facility is maintained in good operating condition. With the exception of the moderate stand of small trees at the right abutment adjacent to the spillway outlet channel wall, the slopes are free of any sizable brush or heavy growth.

Spillway Chute Looking Upstream
Note trees on Embankment

1. That the trees at the right abutment of the embankment slope, adjacent to the spillway outlet channel, be removed.
2. That the groundhog hole be filled.
3. That the eroded portion of the upstream slope adjacent to the spillway approach channel be repaired.
4. That the distressed section of the spillway outlet channel wall be closely observed for further movement. If movement continues, take remedial action to arrest the condition.
