6 National Dam Inspection Program.
Middle Creek Dam (NDI Number PA-00731,
DER Number 36-259), Susquehanna River
Basin, Lancaster County, Pennsylvania.
Phase I Inspection Report.

PHASE I REPORT
NATIONAL DAM INSPECTION PROGRAM

Name of Dam: MIDDLE CREEK DAM, NDI NO. PA-00731
State & State No: PENNSYLVANIA, 36-259
County: LANCASTER
Stream: MIDDLE CREEK
Date of Inspection: April 17, 1979

PHASE I INSPECTION REPORT
NATIONAL DAM INSPECTION PROGRAM

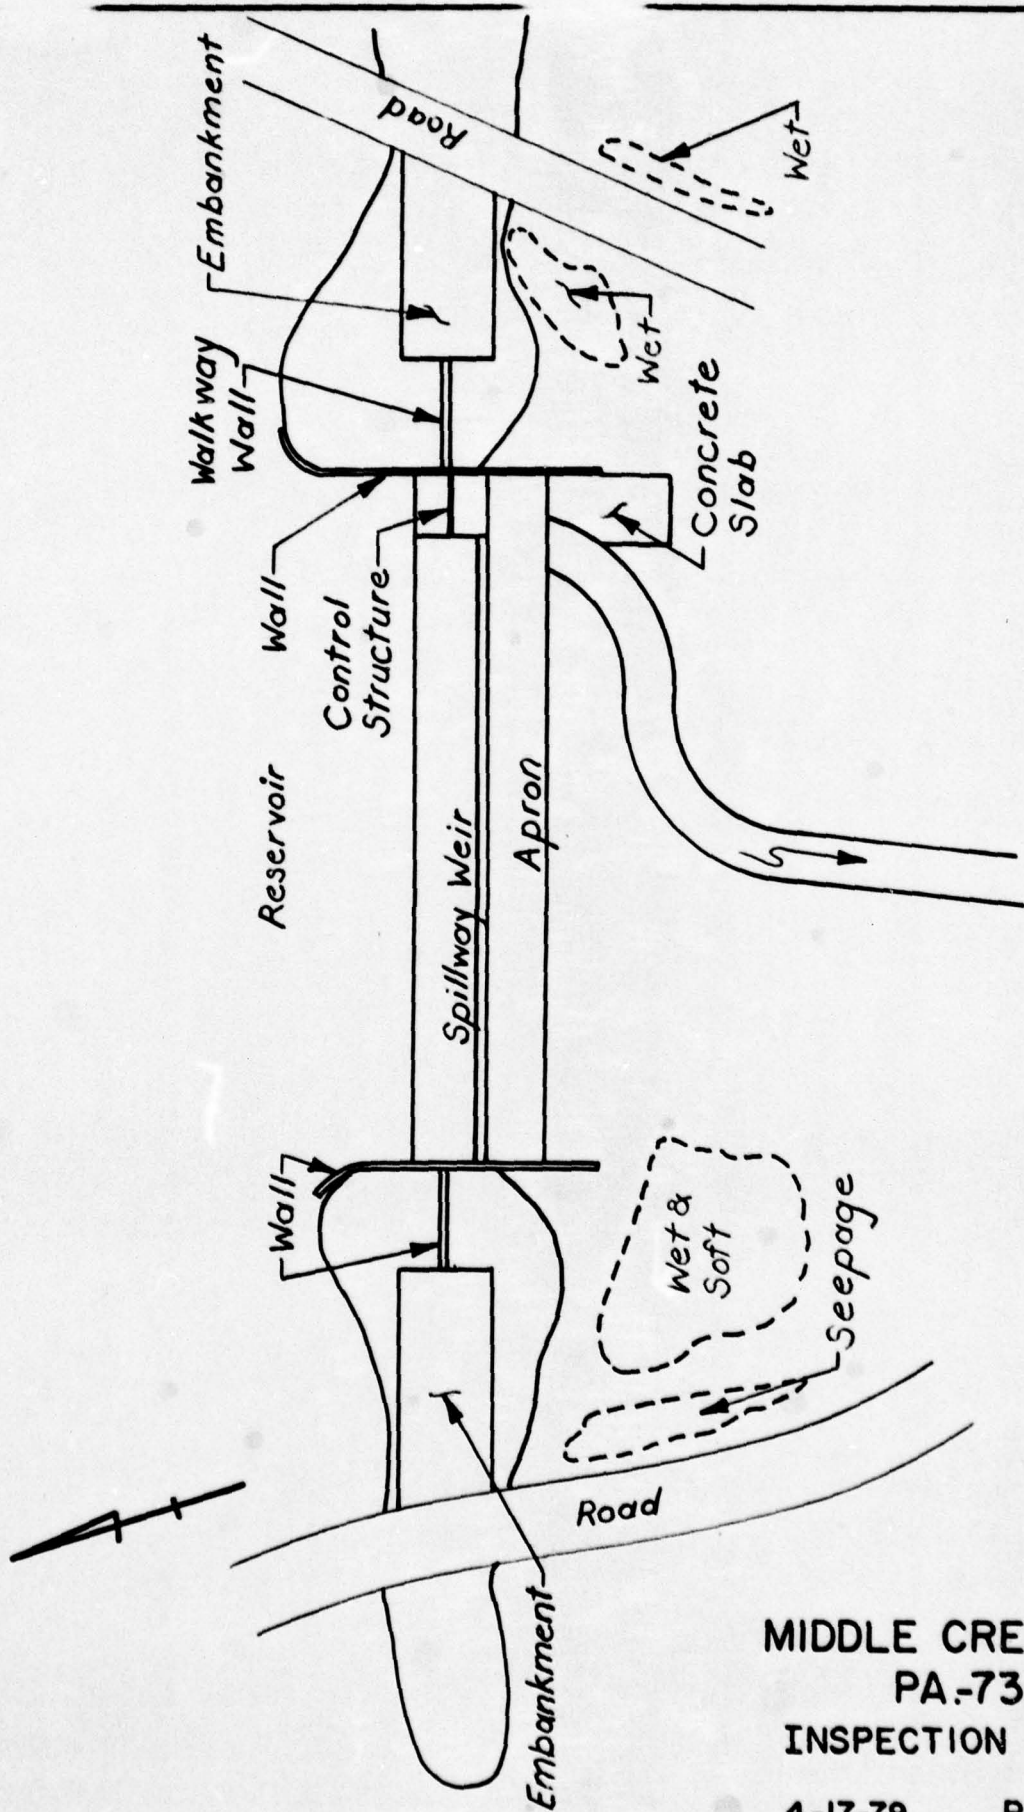
PLATE A-I

D. ALIGNMENT OF CREST: HORIZONTAL: VERTICAL:	Horizontal alignment - good. Good (Refer to Plate A-I, Appendix A).
E. RIPRAP FAILURES	None.
F. JUNCTION EMBANKMENT & ABUTMENT OR SPILLWAY	All junctions appear to be in good condition.

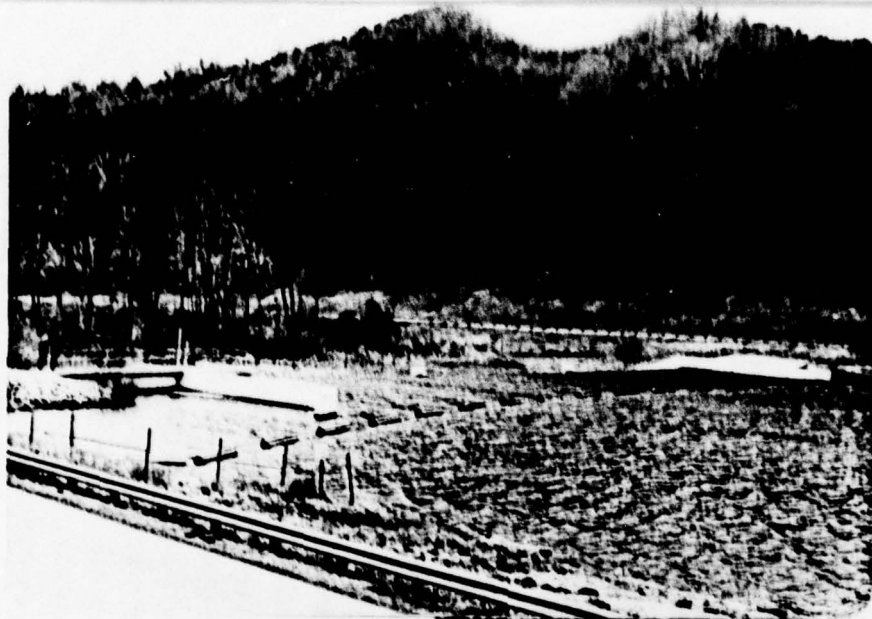
Forebay Walls

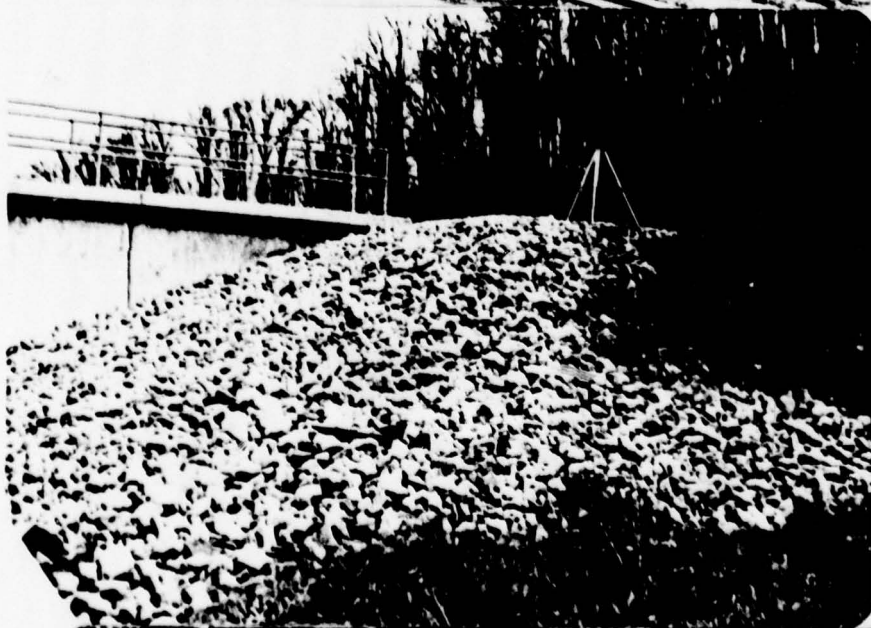
Left Abutment
Downstream

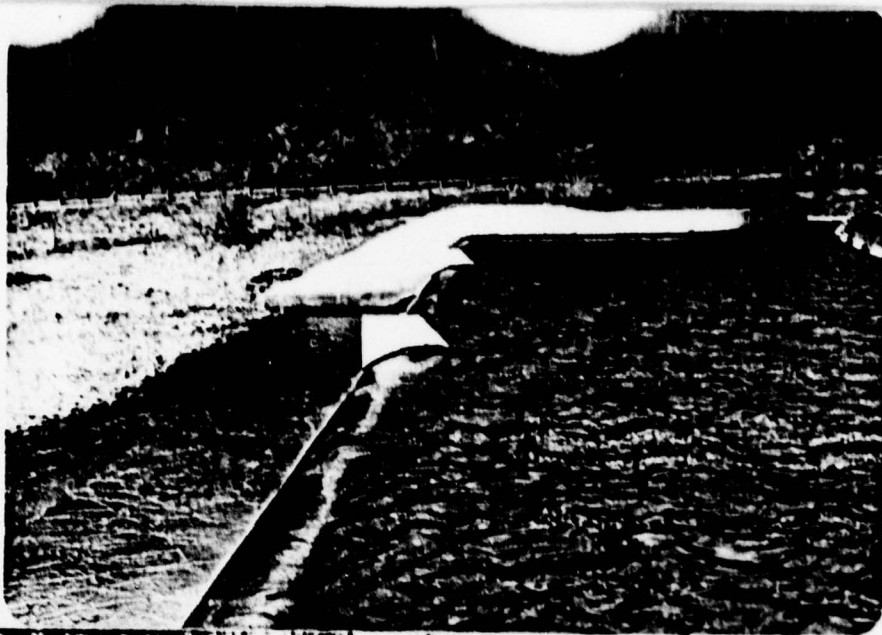
concrete surfaces appeared in good condition. The top of the weir has two small piers, acting as ice breaking devices. Although the flow of water was small, some tailwater was over the slab, thus, breaking the force of the falling water.

Spillway Overflow
and
Ice Breakers

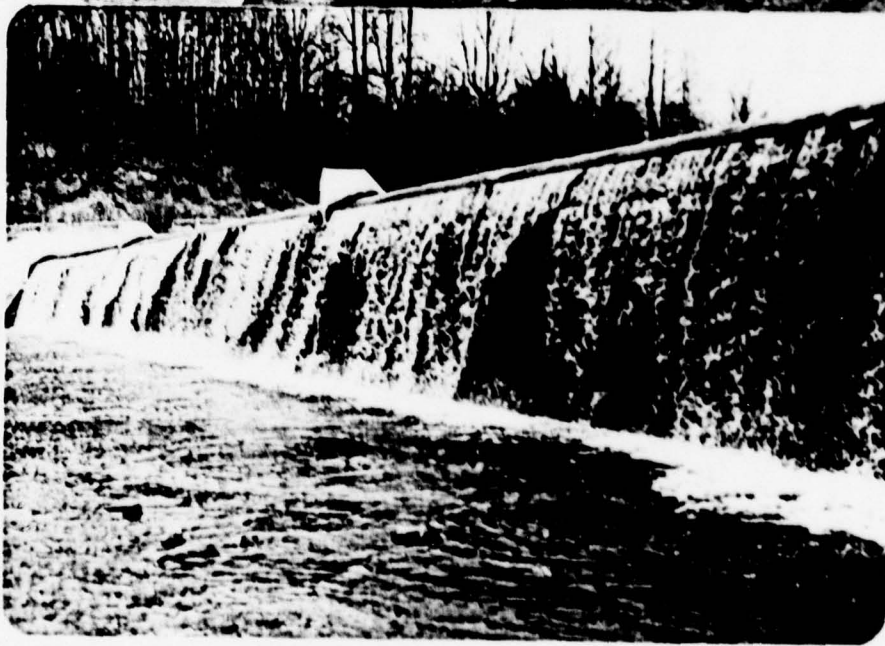
The spillway and the operational facilities are all in good condition. The visual observation did not notice any problems in stability or wall movements. All concrete surfaces were in excellent condition. Downstream erosion has not occurred.

Downstream View
of
Spillway

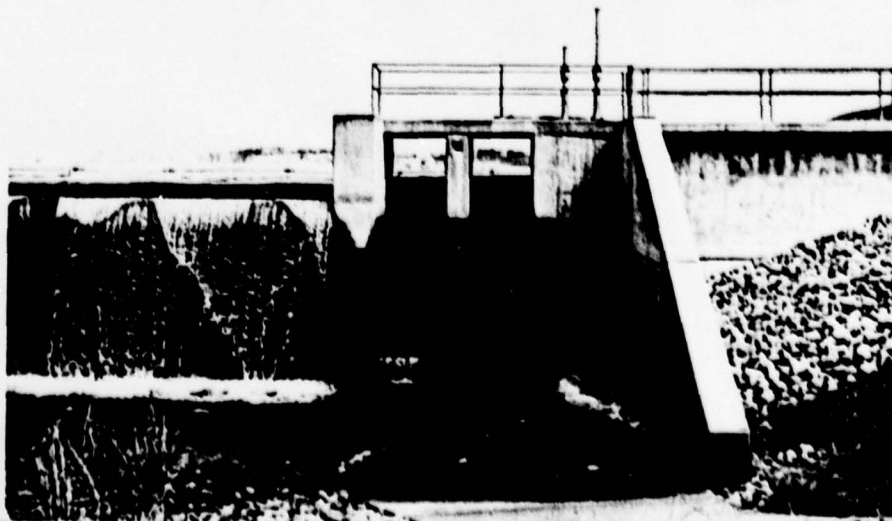
Left Side of
Spillway
With
Control Structure

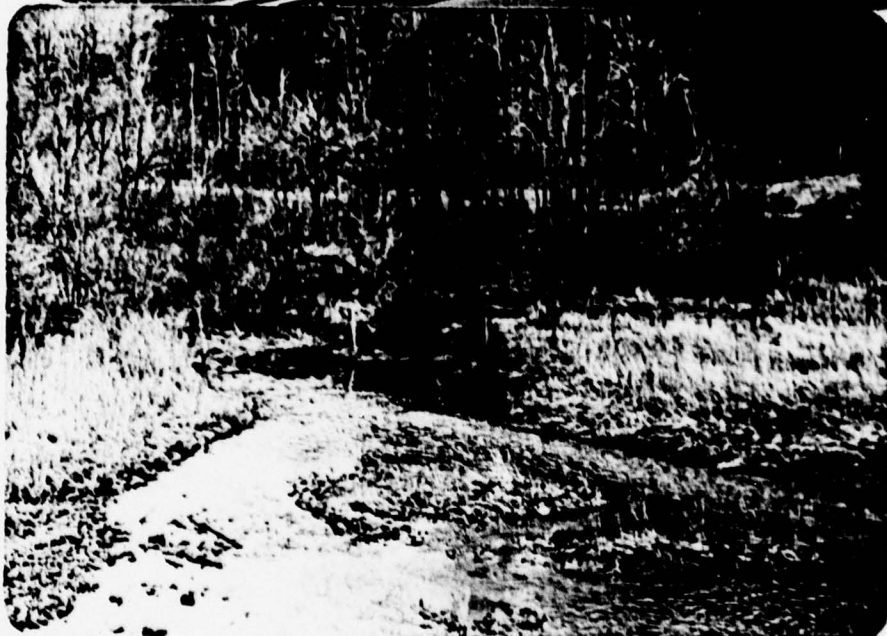
Downstream Channel

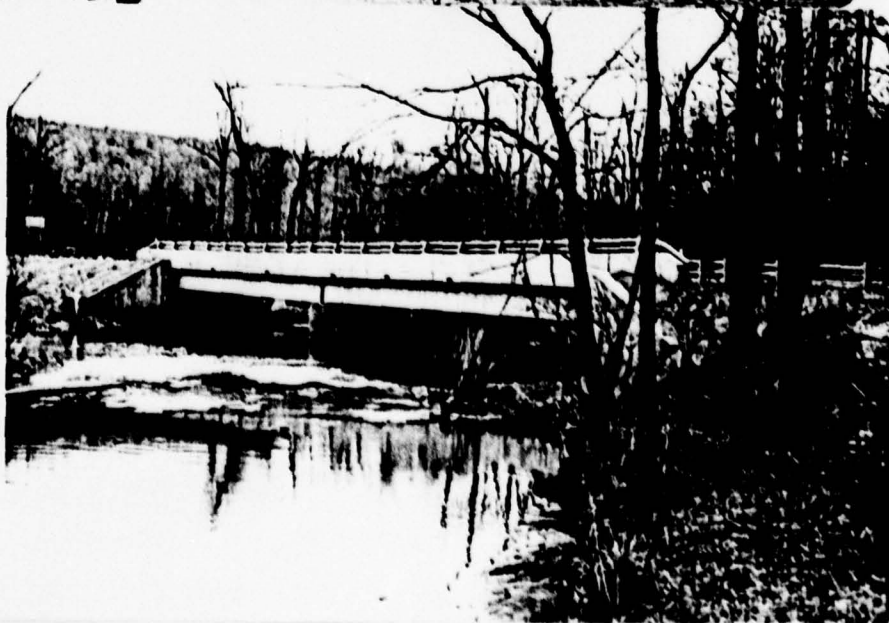
The designer had evaluated the effect of the bridge located just downstream of the dam, and determined that the resulting backwater from the design flood would cause the tailwater at the dam to be at about elevation 542.9. This would not affect the discharge capacity.

Two Span Bridge
Downstream Channel
