REXMONT NO. 2 DAM

NDI NO. PA-00594

**PHASE I INSPECTION REPORT
NATIONAL DAM INSPECTION PROGRAM**

Berger Associates, Inc.
Harrisburg, Pennsylvania
MAY 1979

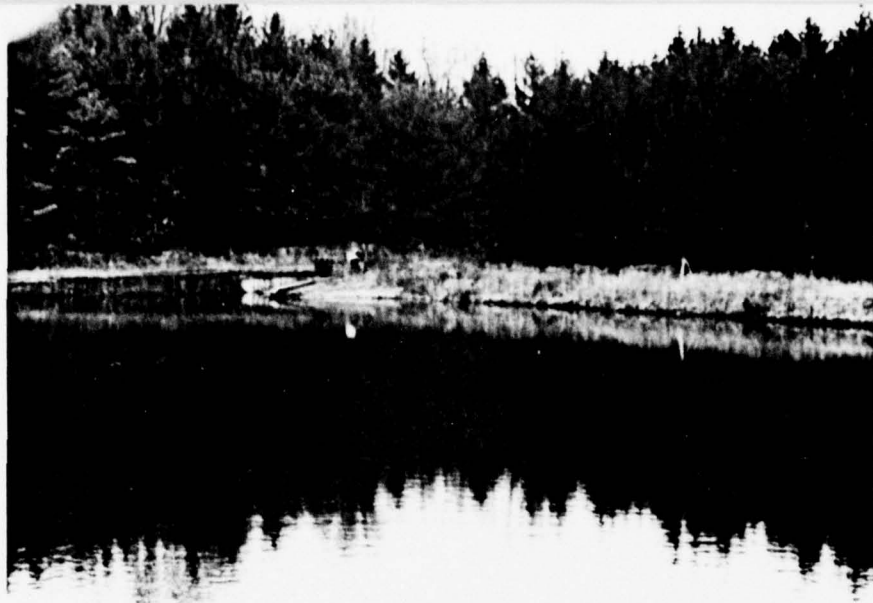
The upstream slope is brick paved and appears to be in excellent condition. Above the normal pool level, grass and some weed growth is covering the brick. The top of the dam has high grass and a footpath. The edges are somewhat rounded off and a slight variation in width was noticeable, but this was not considered serious. The horizontal alignment of the dam was good, with a sharp turn near the left end of the embankment. A survey of the dam profile indicates a fairly level embankment with only one point below the design elevation of 680.0 (see Appendix A).

Upstream Slope
and Forebay

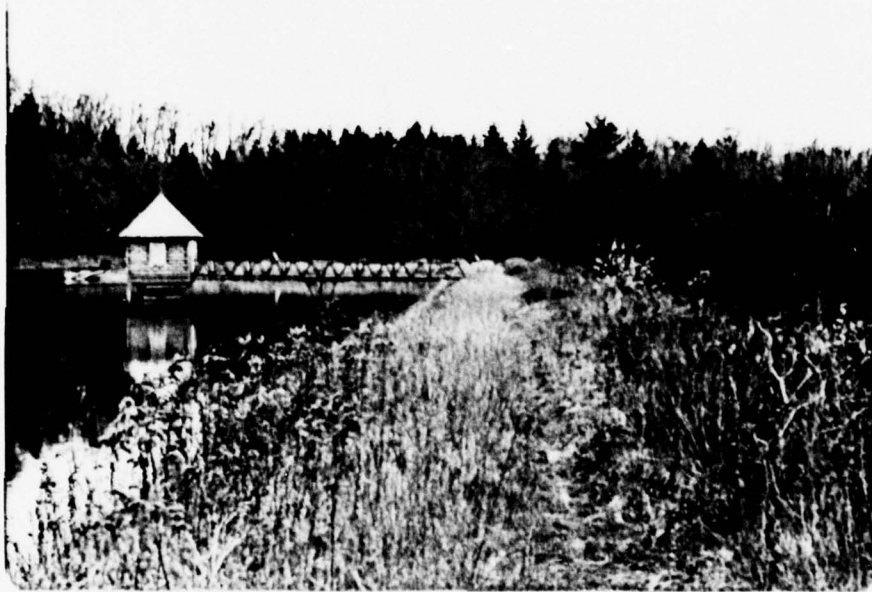
Top of Dam

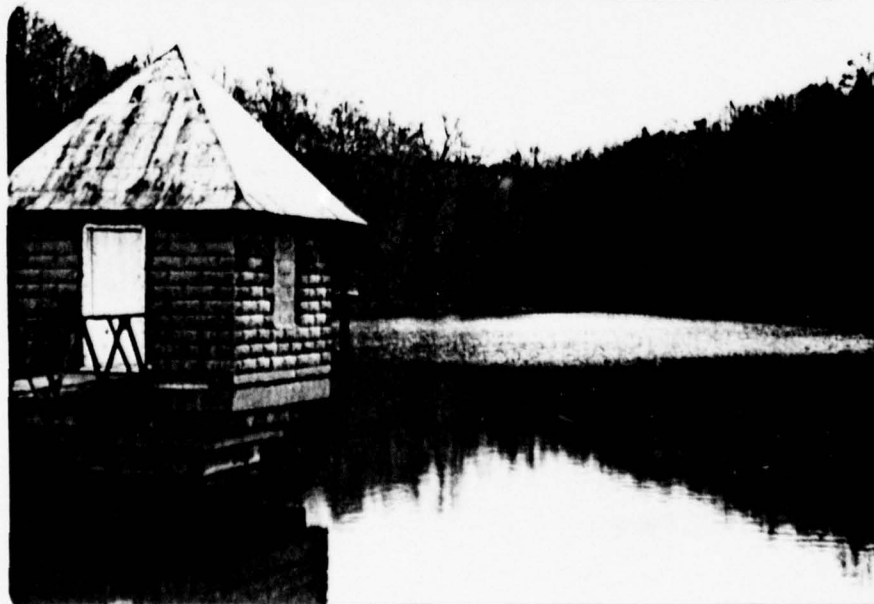
The intake structure is located on the upstream side of the embankment and consists of a concrete tower with a stone building enclosing the operators platform. Access from the breast of the dam is by a steel truss footbridge. The structure and bridge were in good condition. There are three gate operator stands inside of the building. The lower sluice gate, installed for drawdown purposes, was partially opened during the inspection. Drawings indicate that a 16-inch and a 20-inch pipe lead to the downstream Rexmont No.1 reservoir or directly to the City of Lebanon. The reservoir was drawn down in 1970, but the owner's representative did not recall how this was accomplished. The valve pit is located on the downstream slope. This structure was raised when the downstream slope was flattened; however, no ladder is available to descend inside and no inspection was made. Drawings indicate that

Reservoir and
Control Tower

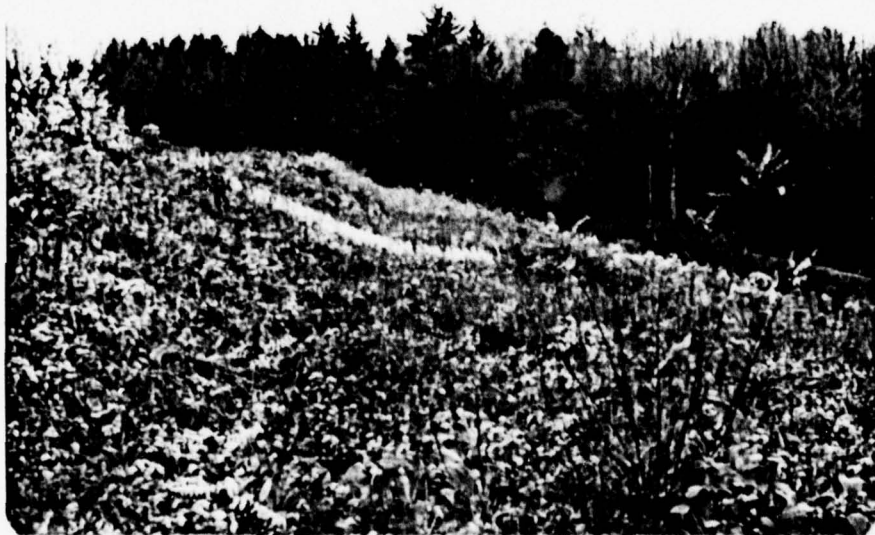
Downstream Berm

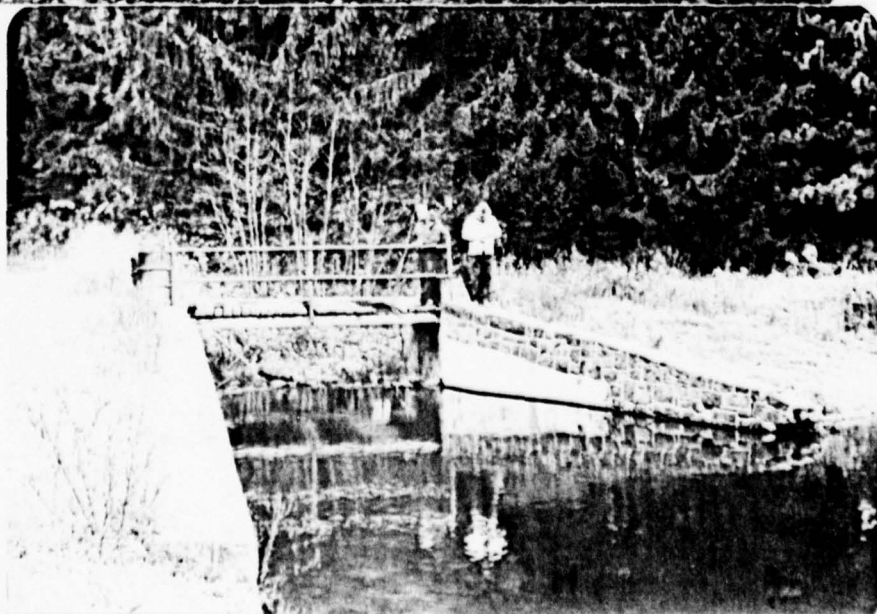
The spillway is located in the left abutment. The approach to the spillway weir is shallow and has stone training walls. The weir crest is in good condition with only minor deterioration. The abutments consist of cemented stone walls. The discharge channel of the spillway makes an abrupt 90° turn about thirty feet beyond the weir. The channel narrows down to a rock protected ditch, paralleling the toe of the dam over a length of about 200 feet, at which point the embankment turns away from the ditch. A footbridge provides access over the spillway to the dam breast. The planking on this bridge is in very poor condition. No records of maximum flow over the spillway were available or recollected.

Spillway Entrance
& Bridge

2. That the footbridge across the spillway be repaired to provide a safe walking path for emergency access.
3. That all brush cuttings on the downstream slope should be removed.
4. That the downstream slope footpath be reseeded to prevent erosion.
5. That the debris in the spillway be removed.
6. That the walls of the spillway chute be closely inspected after the removal of the brush overgrowth.

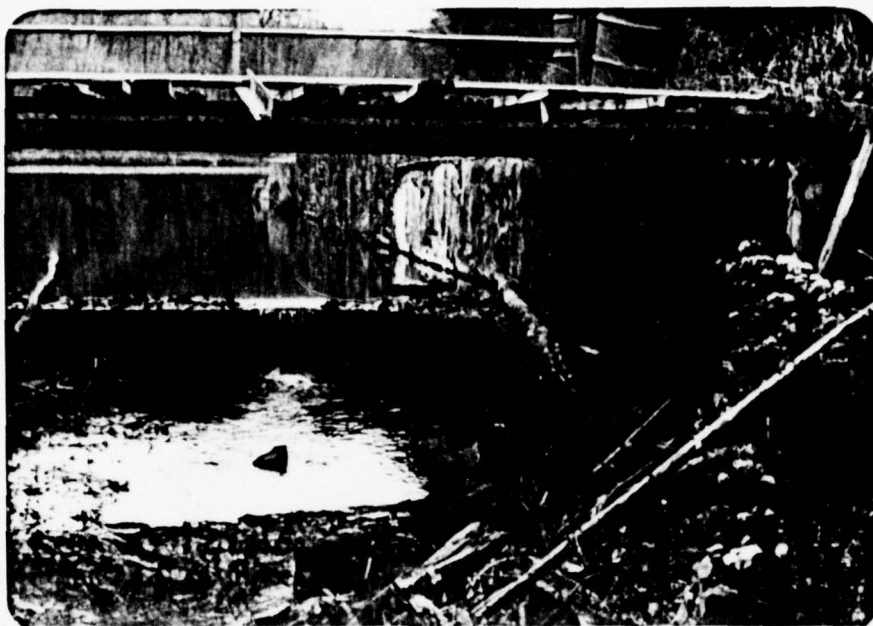
Spillway Looking Upstream Under Bridge

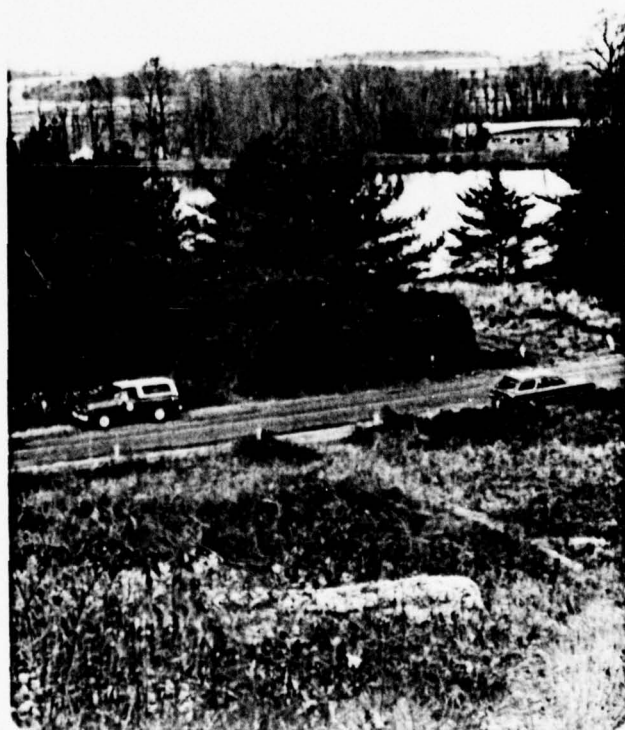
Under normal conditions, the spillway discharges through a small ditch and pipe underneath a road into the next reservoir (Rexmont No.1). If the dam of Rexmont No.2 would fail due to overtopping, the released water would cross the road, destroy the downstream dam and hit several farms and houses located within 4,000 feet of the dam. The hazard category of the dam is considered to be "High", due to the additional loss of life to be expected.

Looking From Dam To Downstream Reservoir

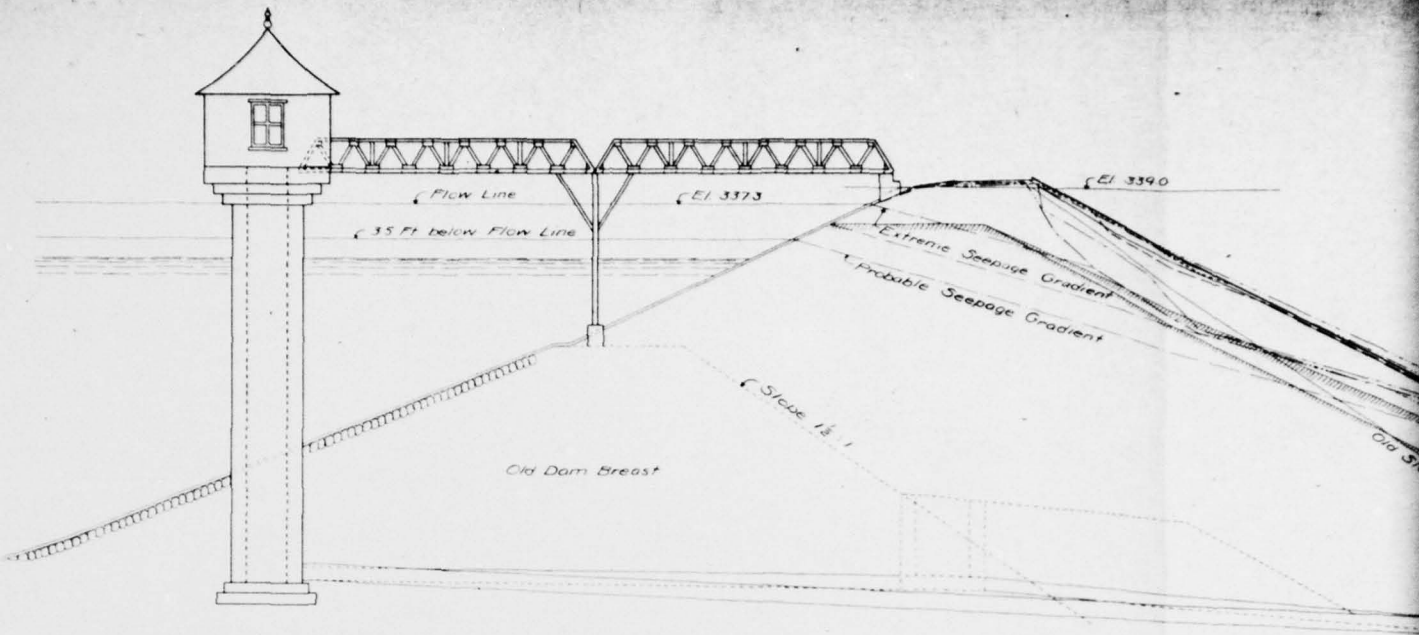
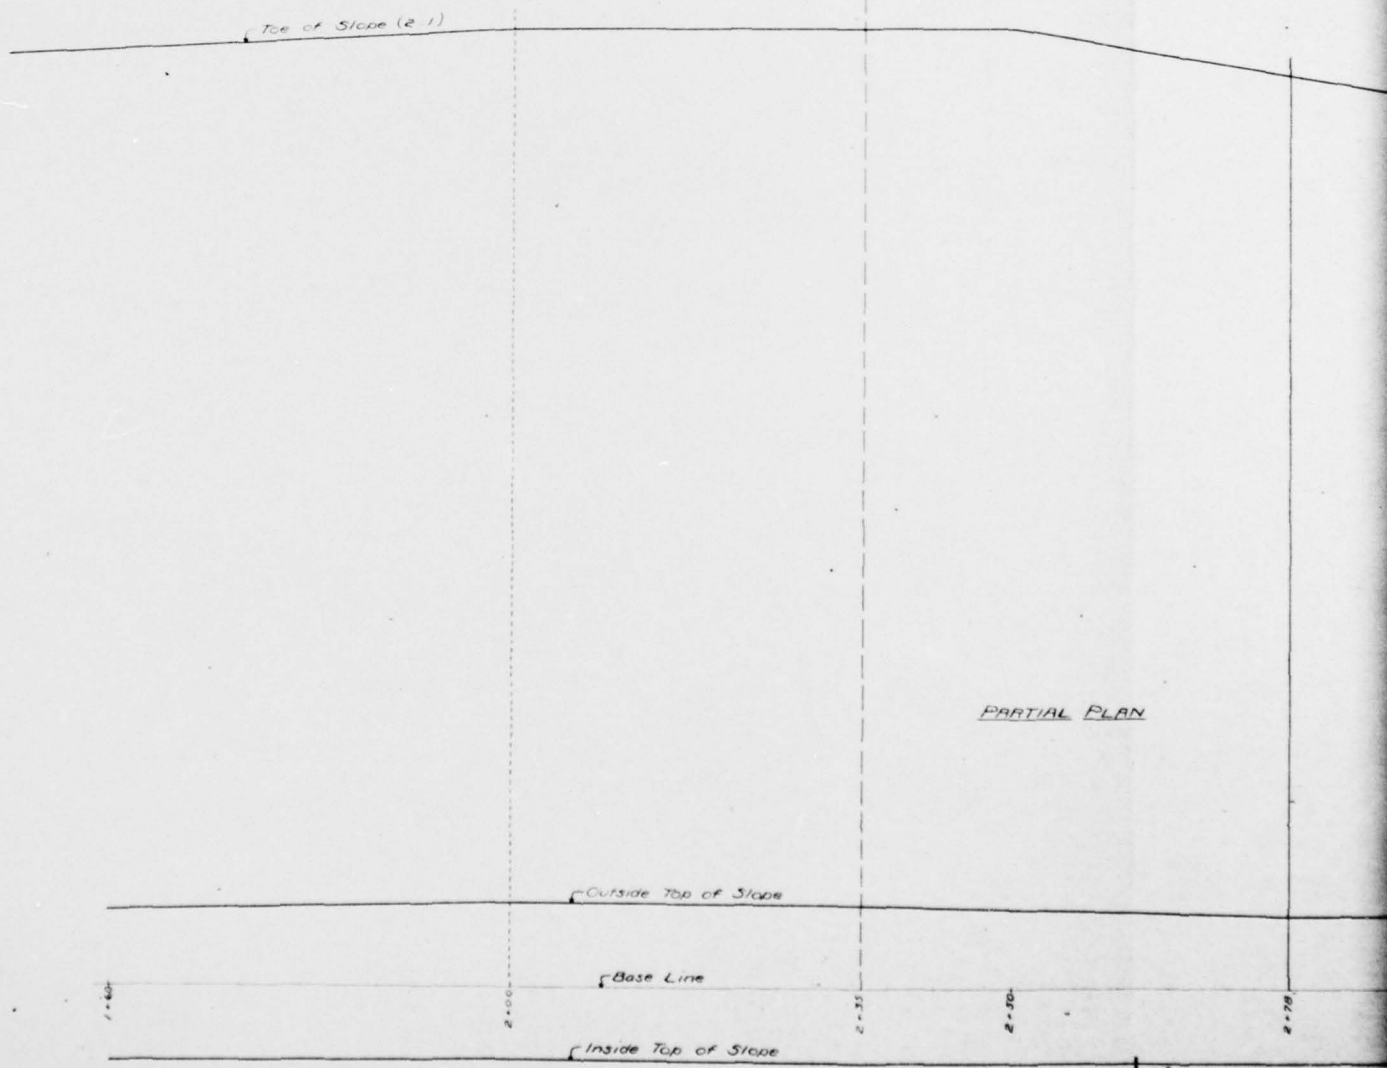
On April 4, 1912, a crack appeared at the downstream edge of the top of the embankment and the embankment settled some and bulged below this settlement about 70 feet west of the gate house. A large slide occurred on April 8, 1912 (Plate VI and VIII, Appendix F). This slide was about 120 feet from the east end of the dam and was about 65 feet long. The riprap and concrete cover and vitrified brick on the upstream slope was supposed to form a membrane against seepage. Numerous cracks and imperfections in this membrane allows water to freely enter the embankment.

CITY OF LEBANON, PA
 SECTION THROUGH DAM NO. 2 AND PARTIAL PLAN
 SHOWING
 SLIP OF APRIL 8, 1912 ON OUTER SLOPE, ETC.
 APRIL 16, 1912 SCALE $\frac{1}{2}$ "=1'-0"
 Approved [Signature] City Engineer
 S.H. Smith, Del.

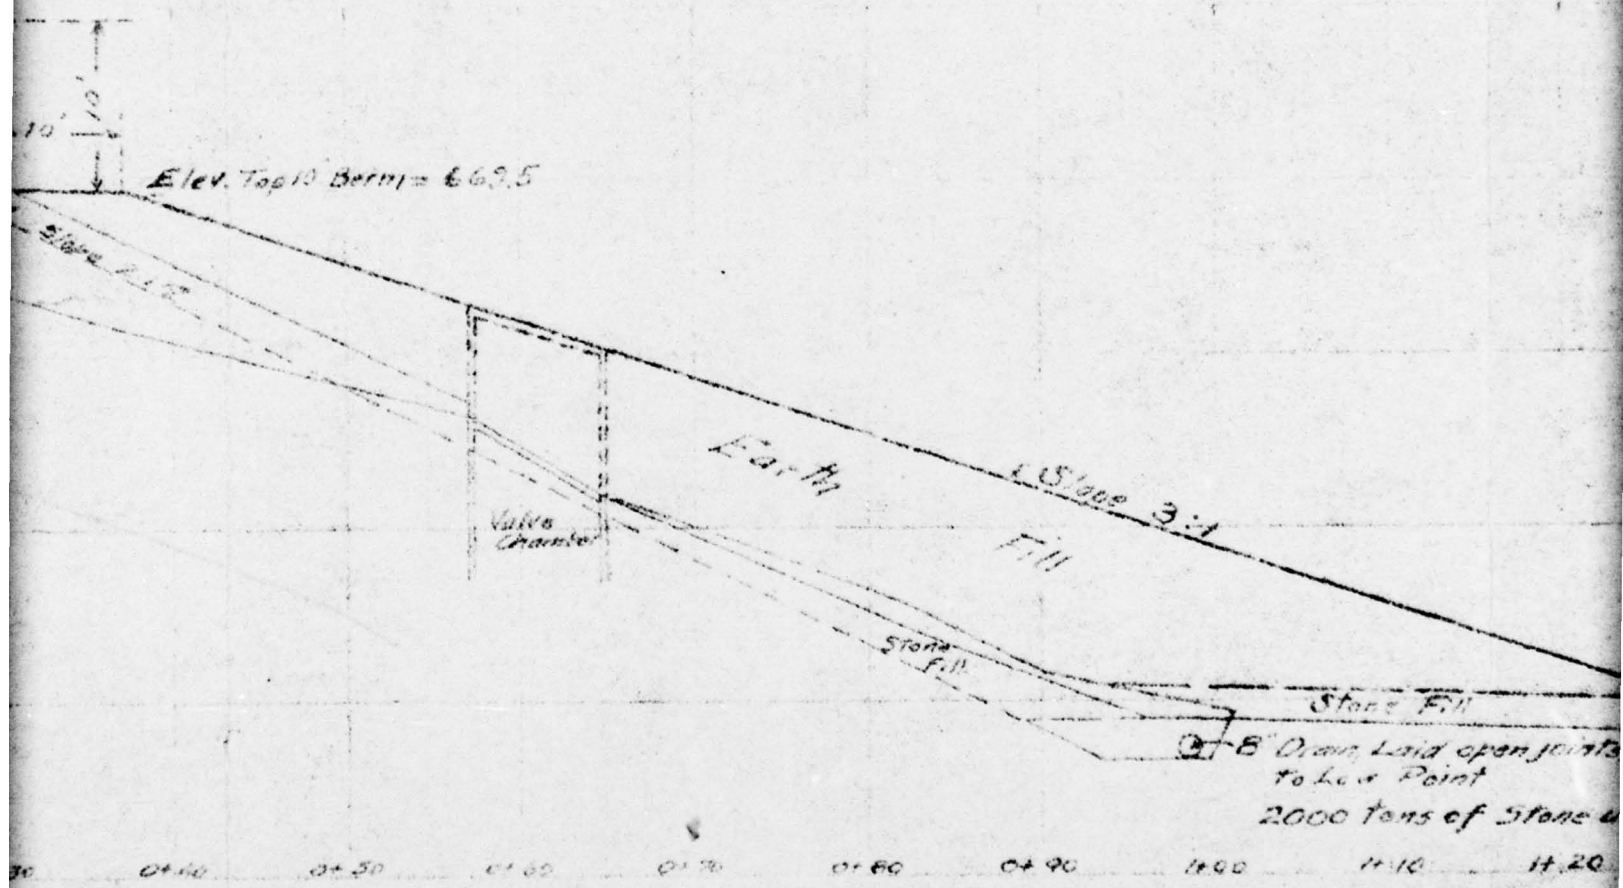
The slide area was backfilled with stone and the spillway crest was lowered 2.5 feet. Although it was recommended to flatten the downstream slope, no changes were made. On July 25, 1925, a serious slide occurred over a length of 110 feet (Plate VIII, Appendix F) at the top of the dam. The width of the slide narrows down to about 70 feet at the toe of the dam. The material flowed beyond the toe over a length of 150 feet, pushing over a wire fence along the highway. Maximum depth of the slide was about 10 feet with a nearly vertical upstream edge and showing distinctly the horizontal layers in the embankment. Considerable seepage appeared to be coming from the embankment with the water in the reservoir at normal pool level. The material of the slide was soft and saturated and could not bear the weight of a person on July 27, 1925. The estimated maximum reservoir level was 2 feet above spillway crest. The slide area was backfilled in the summer of 1925 with stone.

BUREAU OF ENGINEERING.
 CITY OF LEBANON, PA
 Section of Slide of Dam #2
 of City Supply Dams.
 Drawn by - J.B.
 Check by - W.S.D.
 Traced by - J.B.
 Approved by *William J. Sant*
 City Engineer
 Date Oct 19, 1925
 Scale 1" = 10'
