OHIO RIVER BASIN  
SERVICE CREEK, BEAVER COUNTY

J.C. BACON DAM

NDI I.D. NO: PA-260

PHASE I INSPECTION REPORT  
NATIONAL DAM INSPECTION PROGRAM

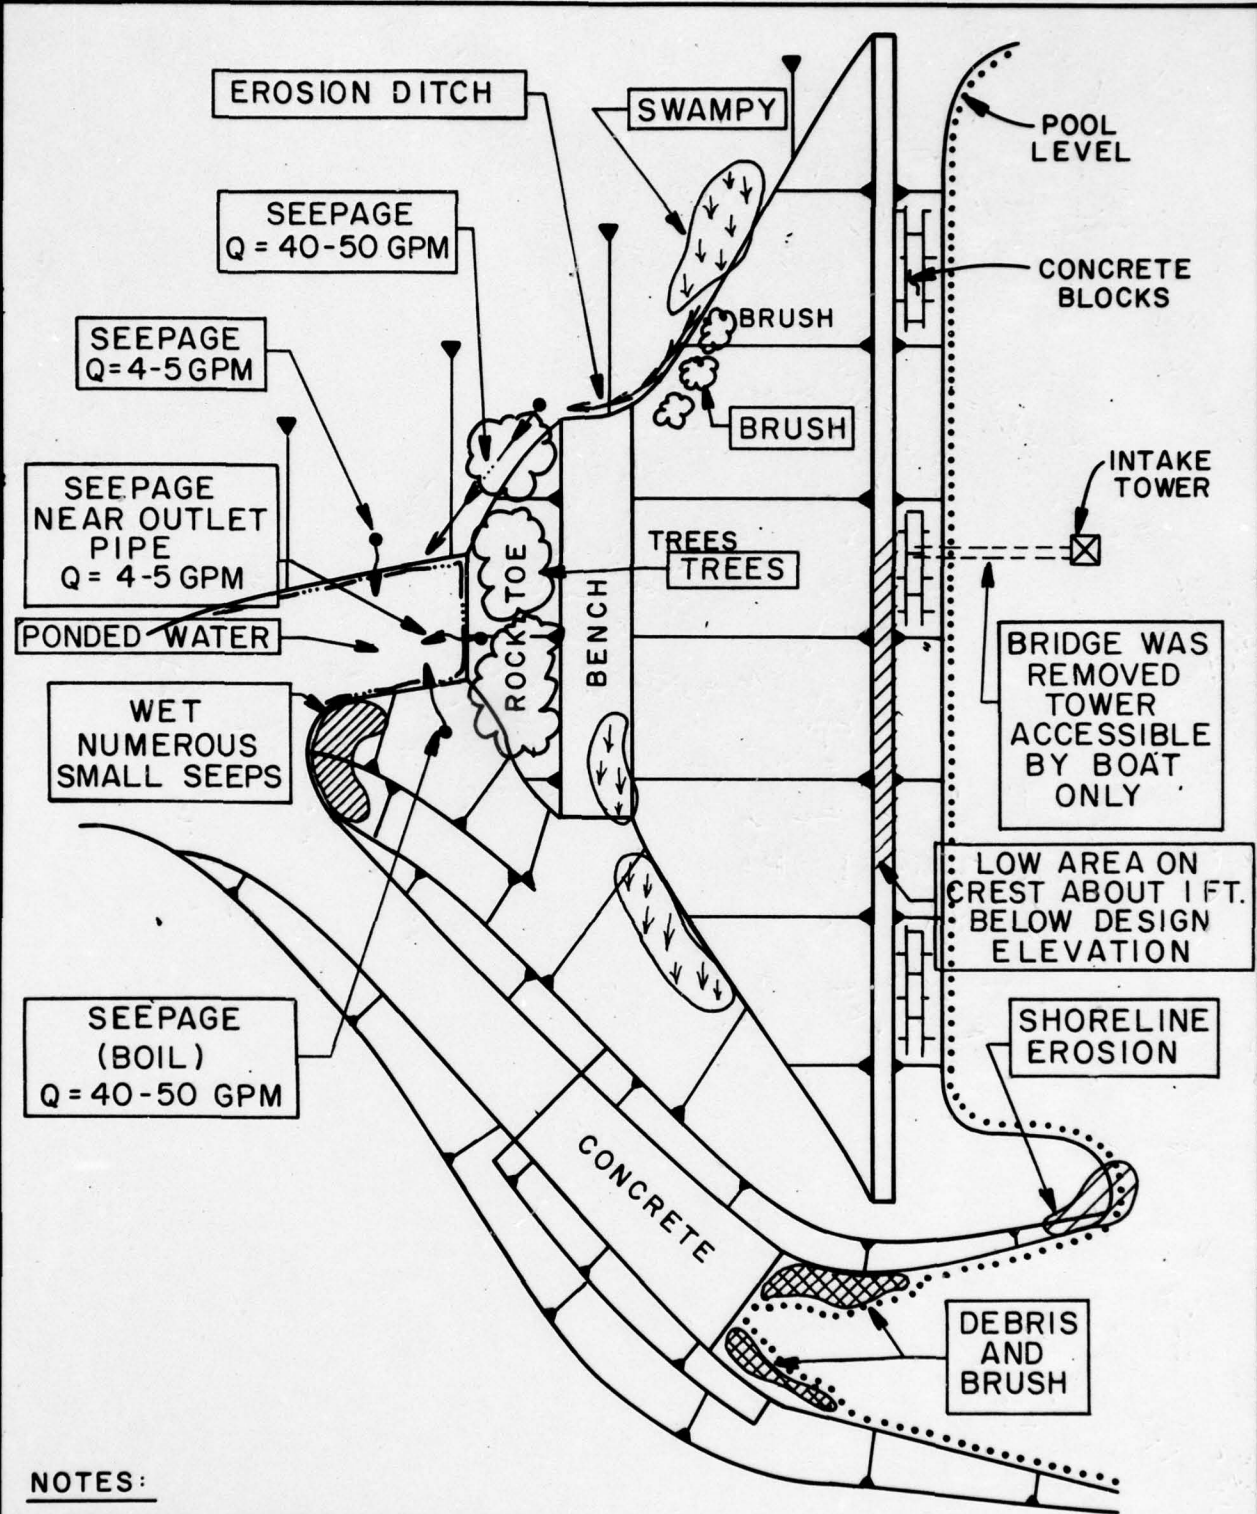
The top of the dam was surveyed relative to the spillway crest elevation and was found to be generally below the design crest elevation with some vertical irregularities. While the design freeboard for the dam was 10 feet, the survey indicated freeboards ranging from 8.8 to 9.8 feet. The lowest area occurred at the center of the embankment.

1. SPILLWAY FREEBOARD = 8.8 FEET
2. POOL LEVEL DATE OF INSPECTION:  
8.6 FEET BELOW LOW AREA DAM  
CREST.

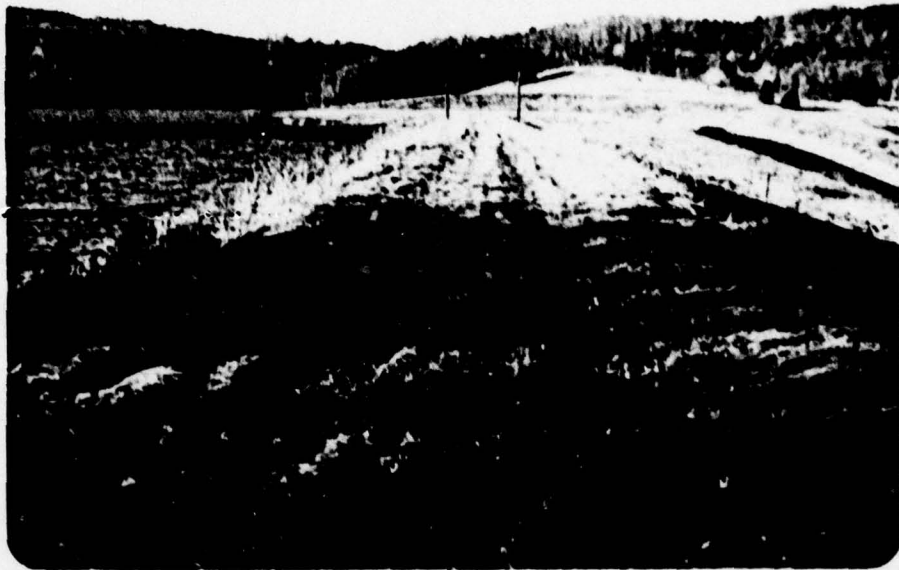
Photograph No. 1  
Crest (looking north).

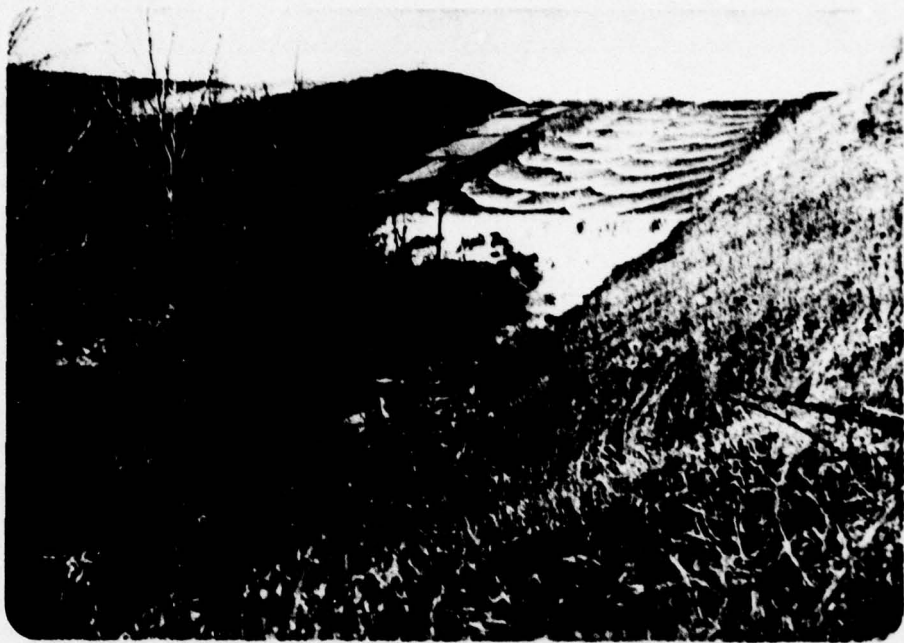
The most significant condition noted was the presence of brush and debris in the spillway approach channel. This condition is considered to pose a potential for obstruction of flow through the spillway. The rocks at the downstream end of the outlet conduit constitute an obstruction of flow through the outlet works.

Photograph No. 3  
Spillway crest. Note debris at crest.

It was observed that debris and brush have accumulated at the spillway approach channel. This area should be cleared to avoid obstruction of flow through the spillway.

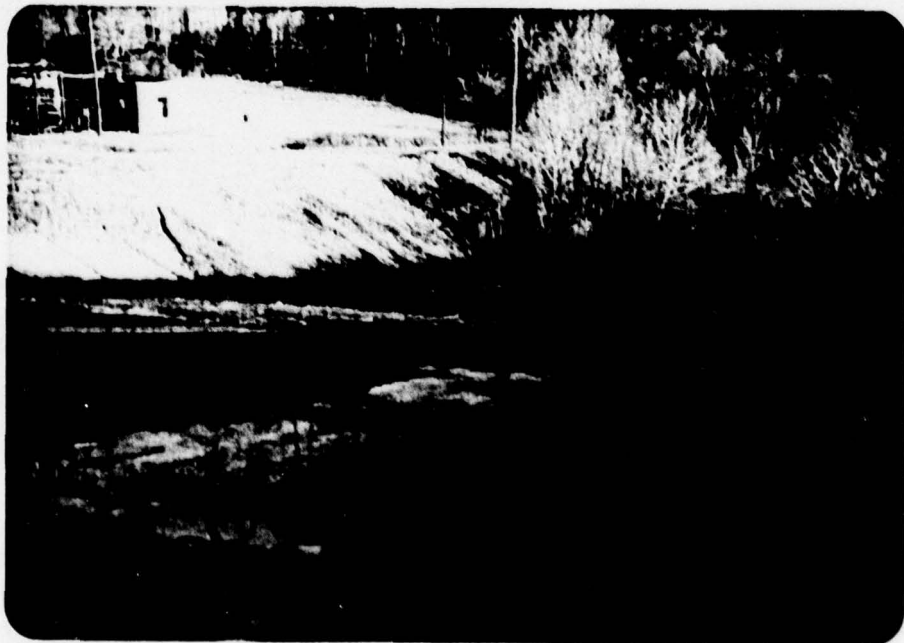
Photograph No. 4  
Spillway discharge channel.

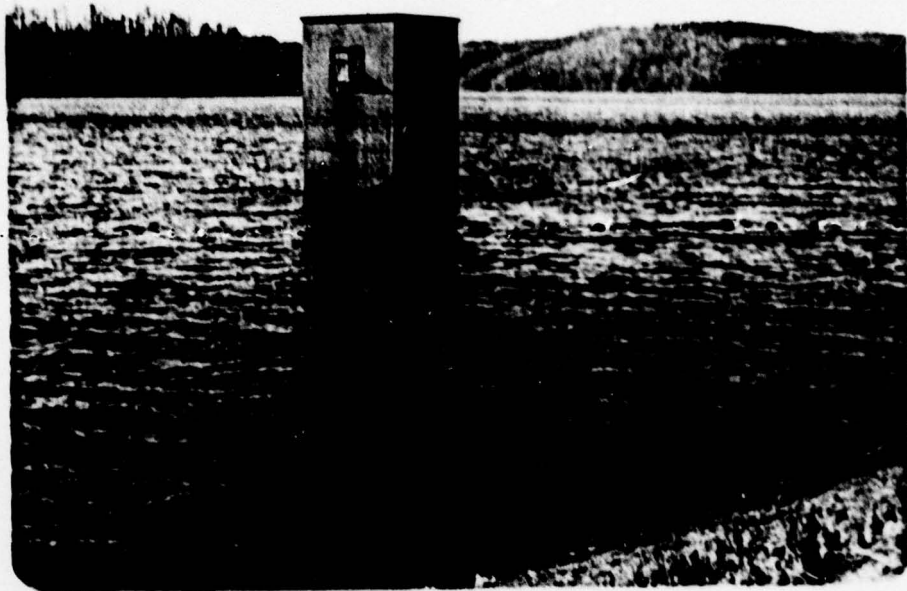
Water authority personnel reported that the access bridge to the control tower had partially collapsed and was removed. Therefore, the control tower was not accessible for inspection. Water authority personnel also reported that, to their knowledge, the outlet conduit sluice gate has not been operated since construction of the dam. The operation of the outlet conduit sluice gate was not observed.

Photograph No. 5  
Intake tower.

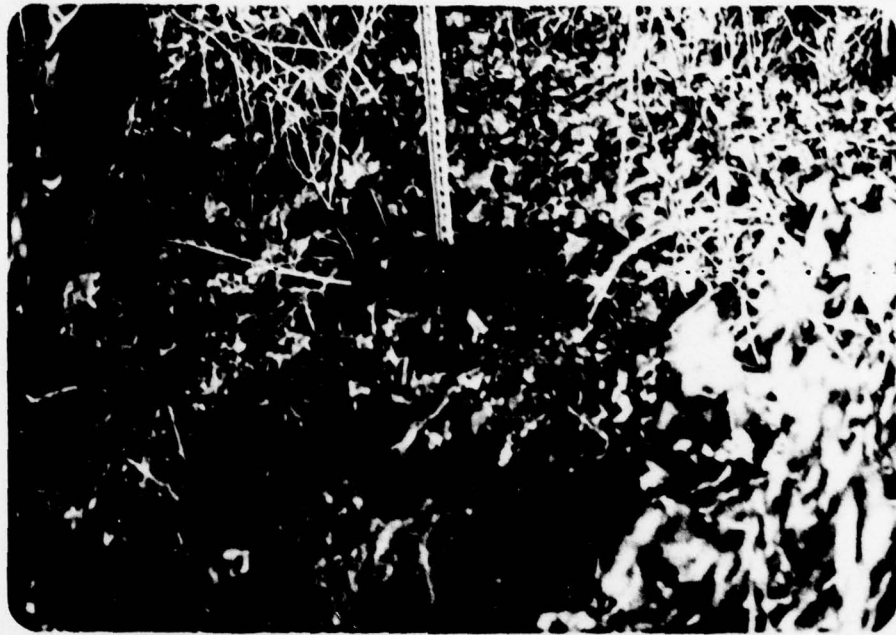
Photograph No. 7

Numerous seepage points and wet areas were found below the toe of the dam and on the right and left abutments. Two major seepage points were identified. One is located at the toe level of the dam on the left abutment approximately 50 feet downstream from the toe of the dam. The other is located on the right abutment embankment interface approximately 20 feet upstream from the toe level of the dam. Flows in both seepage points were estimated to be on the order of 40 to 50 gallons per minute. Discharges were clear, indicating that seepage flows are not causing internal erosion of the embankment or foundation materials. The location of other seepage points discharging approximate 4 to 5 gallons per minute or less is identified on Plate 8. The swampy areas on the right and left abutments were found to be located mostly on the natural ground of the abutments and only partially reaching the junction of the embankment and abutments. While no seepage flow appeared to be associated with the swampy area on the left abutment, a flow of 4 to 5 gallons per minute was found to be discharging from the swampy area.

Boil on left abutment at toe level.

Numerous seepage points were observed below the toe of the dam. These seepage points should be monitored to determine if seepage flows are increasing.
