6 National Dam Inspection Program.
Strack's Dam (NDI Number PA-00596,
DER Number 38-20), Delaware River Basin,
Lebanon County, Pennsylvania. Phase I
Inspection Report.

PHASE I REPORT
NATIONAL DAM INSPECTION PROGRAM
BRIEF ASSESSMENT OF GENERAL CONDITIONS
AND RECOMMENDATIONS

Name of Dam: STRACK'S DAM, NDI NO. PA-00596
State & State No: PENNSYLVANIA, 38-20
County: LEBANON
Stream: TRIBUTARY TO TULPEHOCKEN CREEK
Date of Inspection: April 6, 1979

STRACK'S DAM

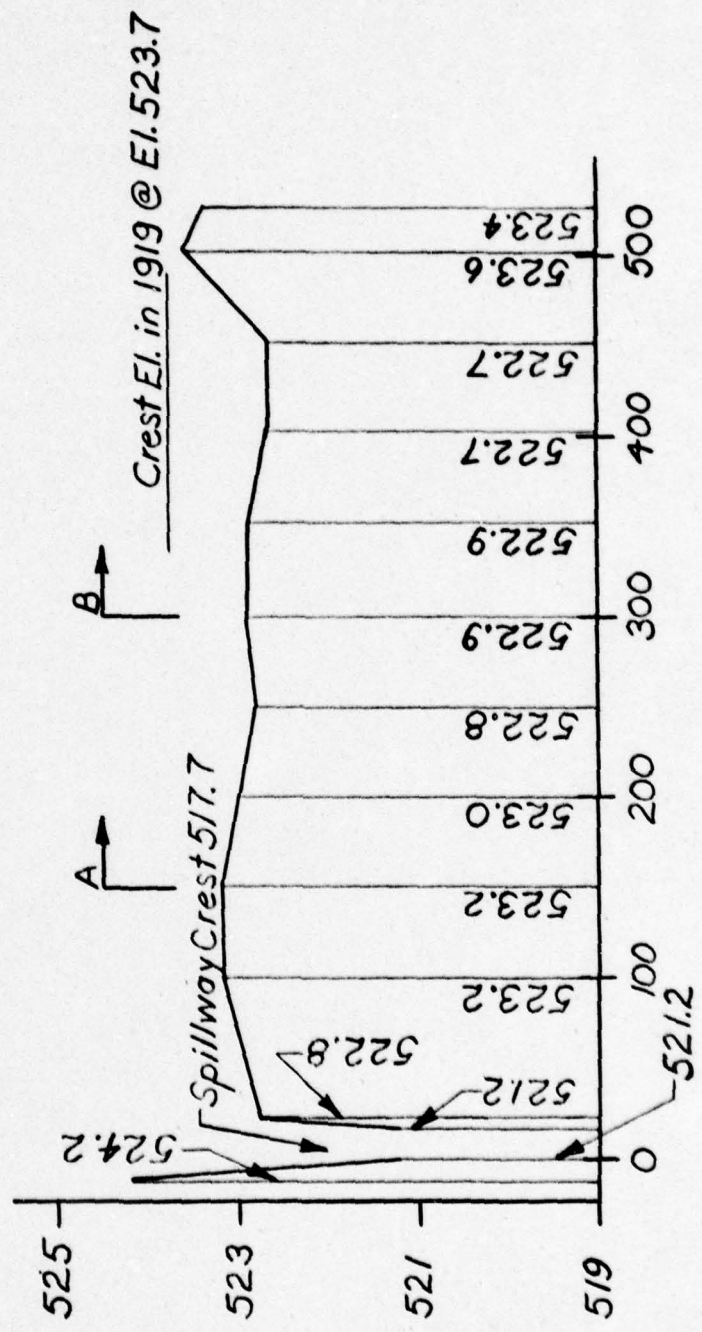
EMBANKMENT PROFILE

The upstream slope of the dam was in fair condition and appears to be stable. Several gullies were evident at the top and several trees on the slope should be removed. Old stumps of previously cut trees indicate that many large trees were on this slope. The top of the dam has some light brush and a dirt footpath, indicating that the breast is extensively used by fishermen. The profile of the crest was surveyed (see Plate A-II, Appendix A) and appears to be below the design elevation.

2. That the embankment crest be raised immediately to a uniform height of elevation 523.2 (.5 feet above present low point) to improve the capacity of the spillway.
3. That all trees, brush and weeds be removed from the embankment.
4. That adequate protection be installed to prevent further undermining of spillway slab and erosion of spillway chute.
5. That a regular maintenance procedure be established for the embankment and spillway.
6. That a regular inspection program be established for the facilities, which should include a weekly visit to the site by representatives of the owner.
7. That a formal surveillance and downstream warning system be developed to be used during periods of high or prolonged rainfall or during other emergency conditions.

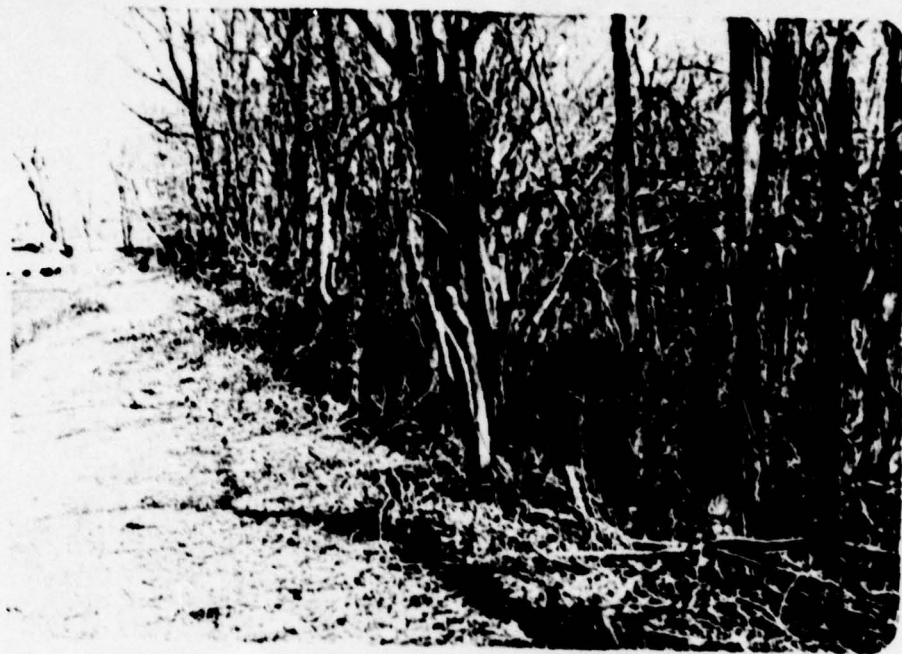
The downstream slope has a dense growth of brush and trees, with trees up to 18 inches in diameter. The brush prevents close observation of the slope and sloughage or slippage areas were not noticed. The slope is, however, saturated and soft over most of its height. At the toe and downstream of the toe, the ground is totally saturated, marshy and soft. The soft condition of the slope has caused some trees to be uprooted and it is feared that additional uprooting of trees could occur. The subsurface drainage system installed on the downstream slope and in the toe is not functioning properly.

Dam Crest and Downstream Slope

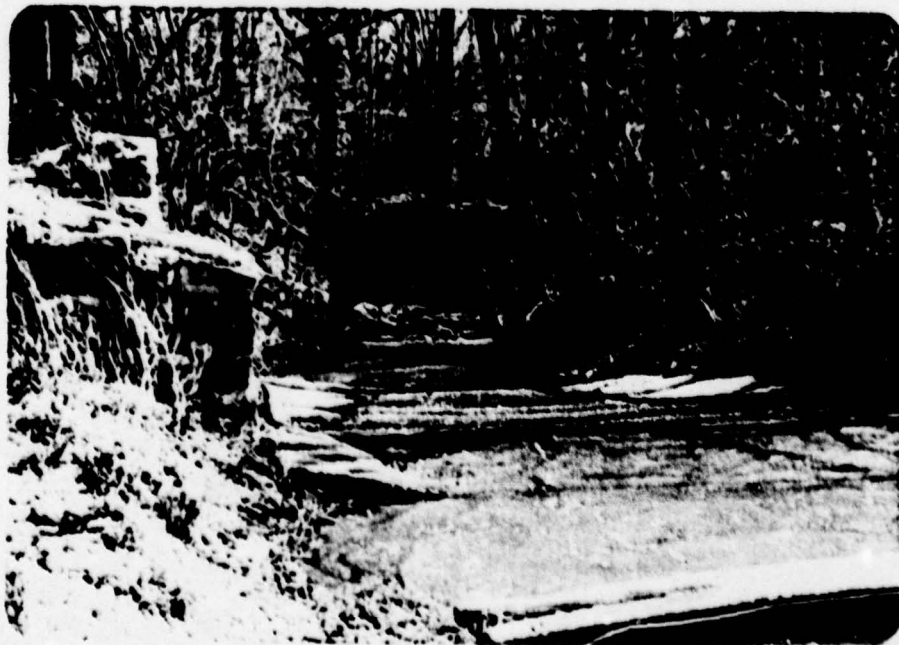
The spillway weir was in fair condition and slightly dipped towards the center. The approach has no training walls and a large discharge over the weir could cause erosion to the right of the spillway. The abutment walls of the spillway are short and low. The spillway chute is paved over 35 feet of its length and further erosion of this channel, downstream of the weir, can be expected.

Spillway

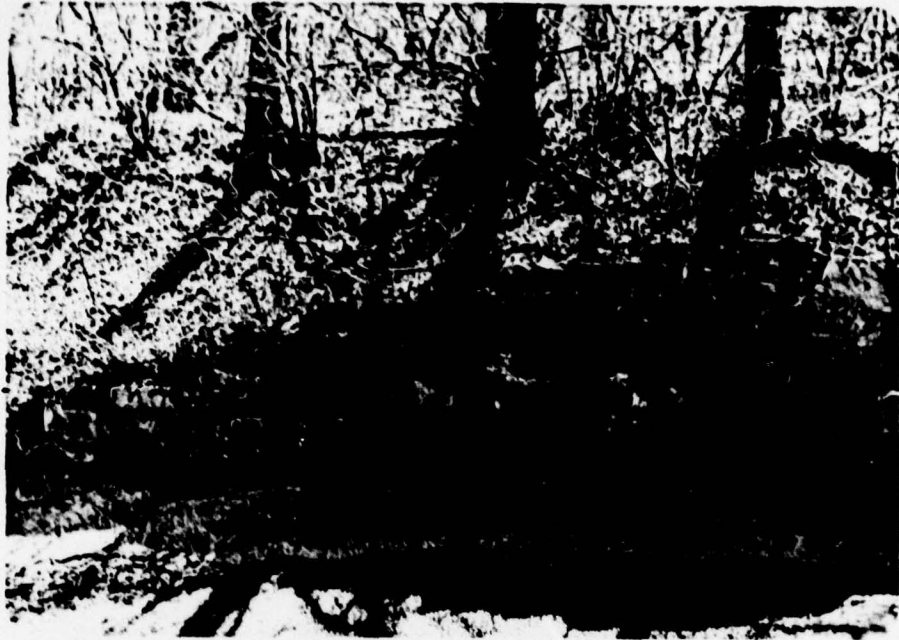
Right Abutment of Spillway

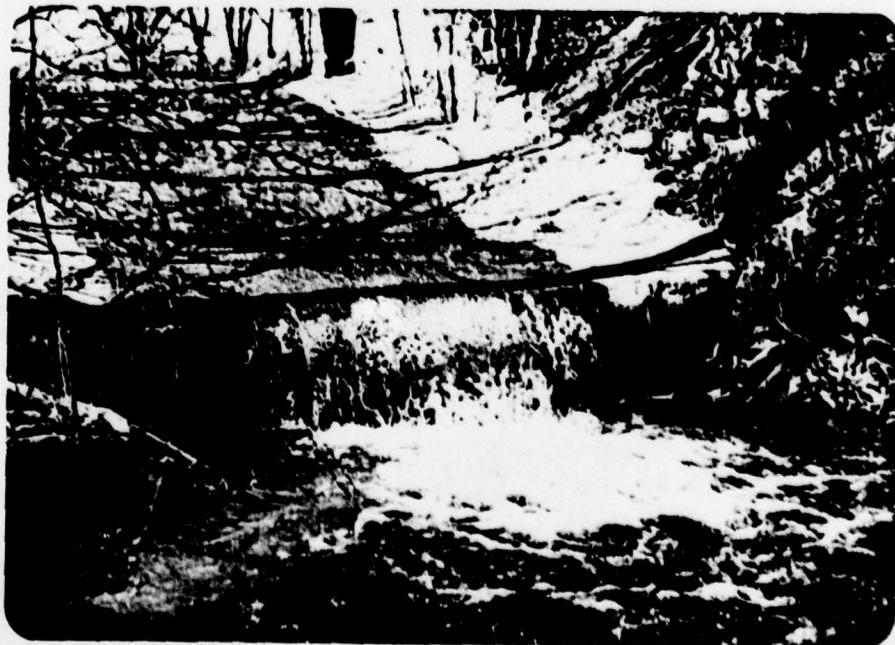
End of Spillway Chute

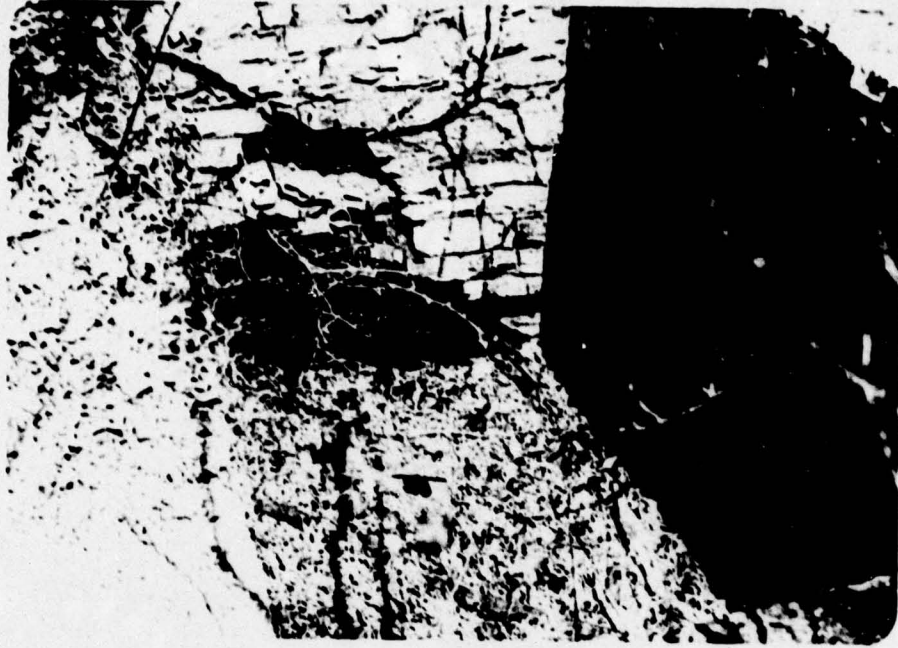
The reservoir has no intake structure. Only the foundation of an old pumphouse is left at the downstream toe near the right abutment. The rusty remains of an unidentified mechanism, possibly a gear valve, is located in the ruins of the pumphouse. It appears that the reservoir does not have any drawdown facilities.

Old Pump House
